Modular titanium alloy neck adapter failures in hip replacement - failure mode analysis and influence of implant material

Thomas M Grupp^{1*}, Thomas Weik^{1†}, Wilhelm Bloemer¹, Hanns-Peter Knaebel²

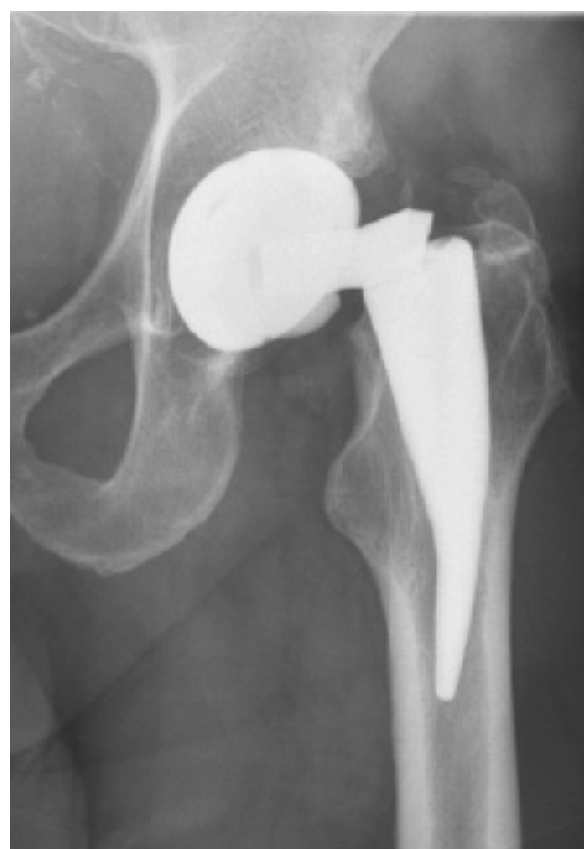
The failed neck adapters were implanted between August 2004 and November 2006. After the third incident, the titanium neck adapters were replaced by adapters out of cobalt-chromium [8]. A typical x-ray of a failed titanium neck adapter is shown in Figure 1.

Figure 1 X-ray of a hip with a failed neck.

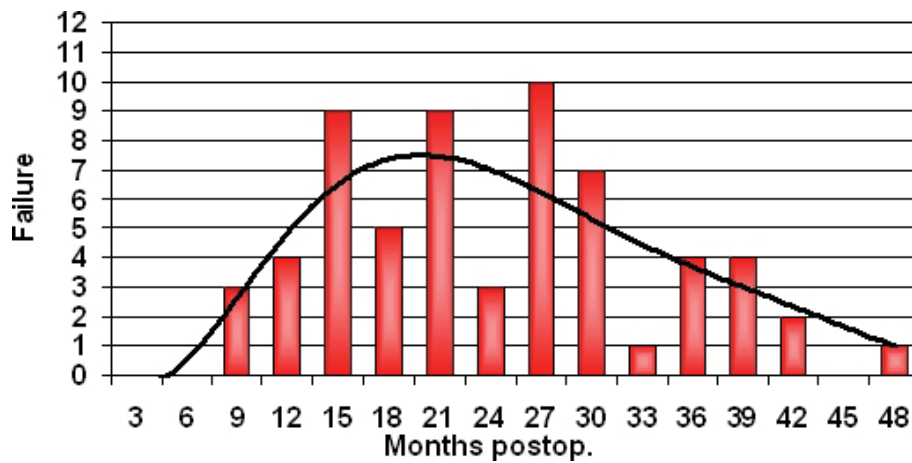
Figure 2 Occurrence of clinical neck failures in a postoperative time period in months.

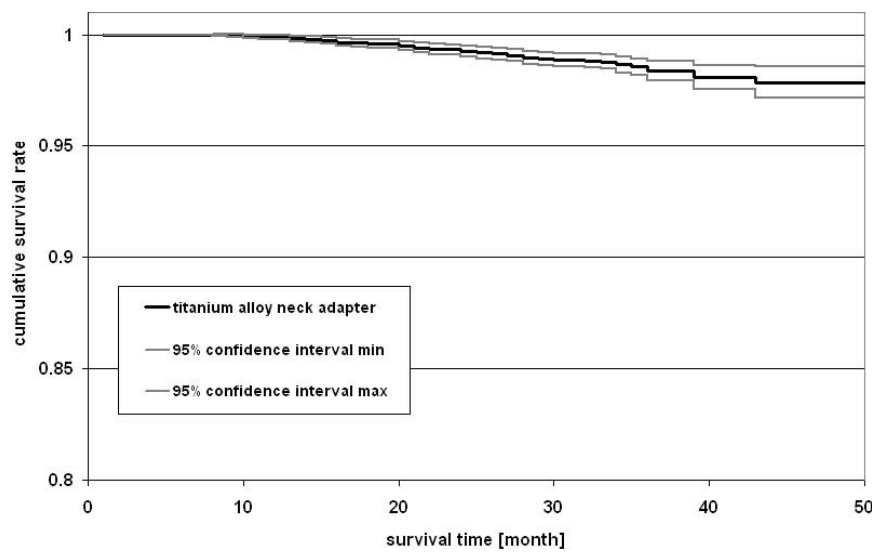
with revision due to failed neck adapter as an endpoint (confidence interval $\pm 95\%$). A cumulative survival rate of 98.6% was calculated with fractured neck adapter as the causative factor of failure (Figure 4).

Figure 4 Kaplan-Meier survival analysis for failed neck adapter as reason of revision (\pm 95% confidence interval).

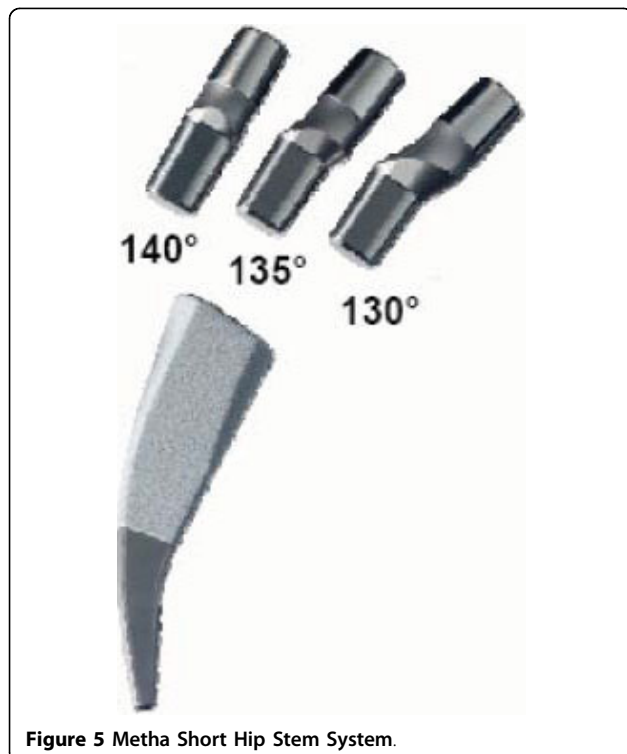
The modular neck adapters and stems used in our study were in all cases the Metha Short Hip Stem Prosthesis (Aesculap AG, Tuttlingen, Germany). Adapters and stems were made of titanium alloy. With its circumferential pure titanium porous coating and additive thin layer of dicalcium phosphate dehydrate (Plasmapore® μCaP , Aesculap, Tuttlingen, Germany), the stem is designed for cementless anchorage (Figure 5). The modular neck adapters were used in three different CCD-angles (130°, 135° and 140°) in combination with neutral, anteverted and retroverted ($\pm 7.5^\circ$) versions to adjust the CCD-angle intraoperatively [4].

Figure 5 Metha Short Hip Stem System.

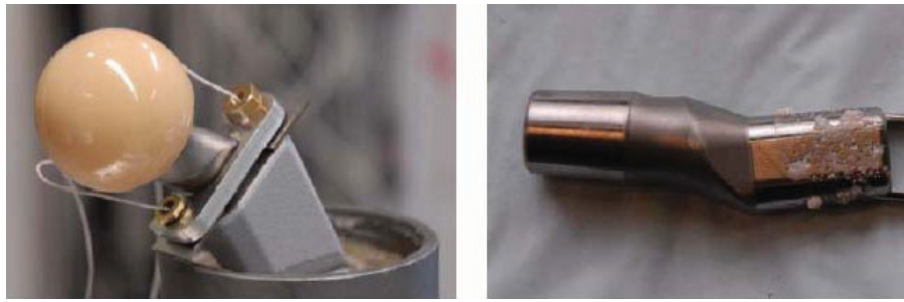
Figure 6 Test setup for measurement of micromotions in the modular cone connection (left) and particle-contaminated joining area (right) [18,19].

specimens with neck adapters out of titanium alloy and cobalt-chromium alloy were examined. As it appears that intraoperative contamination of the cone connection with bone particles has an considerable impact on the magnitude of fretting in the interface due to increased micromotions, a specific test setup was developed at the Biomechanics Section of the Hamburg University of Technology (Prof. Michael M. Morlock) and each device being tested with a clean and with a particle contaminated joining area (small porcine bone grafts approximately 1 mm in diameter) [18,19]. To determine the relative motion between neck adapter and stem a contactless measurement system (Micro-Epsilon Type U05(78) Messtechnik Ortenburg, Germany) was used. Two sensors with a range of 500 μm and a sensitivity of 0.025 μm were fixed on an aluminium plate and mounted on the neck adapter. Two steel plates fixed on the resection plane of the stem served as targets for the sensors (Figure 6).

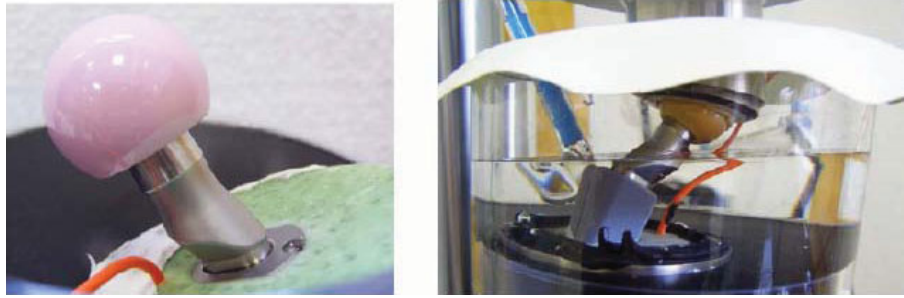
To evaluate the coaction of the stem/neck modularity with the hip stem, the modular stems were tilted both in the frontal plane ($\alpha = 10^\circ$) and in the sagittal plane ($\beta = 9^\circ$). Based on CT scans on several human femurs and the specific stem design the level of embedding was set to 45 mm below the centre of the head to simulate a deficiency of proximal support due to bone loss in the neck and trochanter region (Figure 7).

Figure 7 Test setup for neck test (left) and stem test (right) with reference electrode to measure corrosion potential.

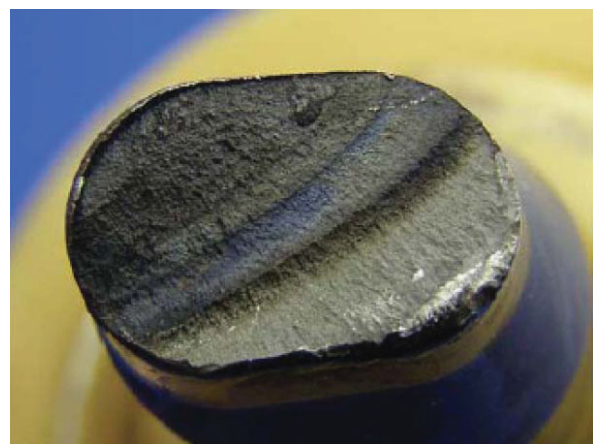
All retrieved modular adapters showed similar breakage cross-sections. The fatigue fracture starts in the anterolateral area at the upper part of the conical connection, the area subjected to maximum biomechanical stress. The fatigue fracture is followed by the residual forced fracture (Figure 8).

Figure 8 Fatigue fracture surface of a clinically failed titanium neck adapter.

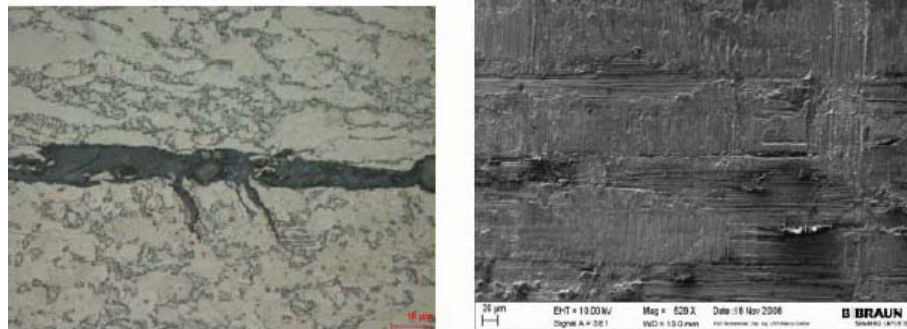
Metallographic analyses showed that microcracks developed on the surface of the cone in the clamping range (Figure 9). It appears that these microcracks induced the fatigue crack which finally led to the implant failure. Microcracks were analyzed using a scanning electron microscope. Figure 9 shows a potential micro crack in an area where fretting marks can be seen on the surface of the cone.

Figure 9 Metallographic analyses revealed microcracks on the cone surface (left) and a potential microcrack in a fretting area (right).

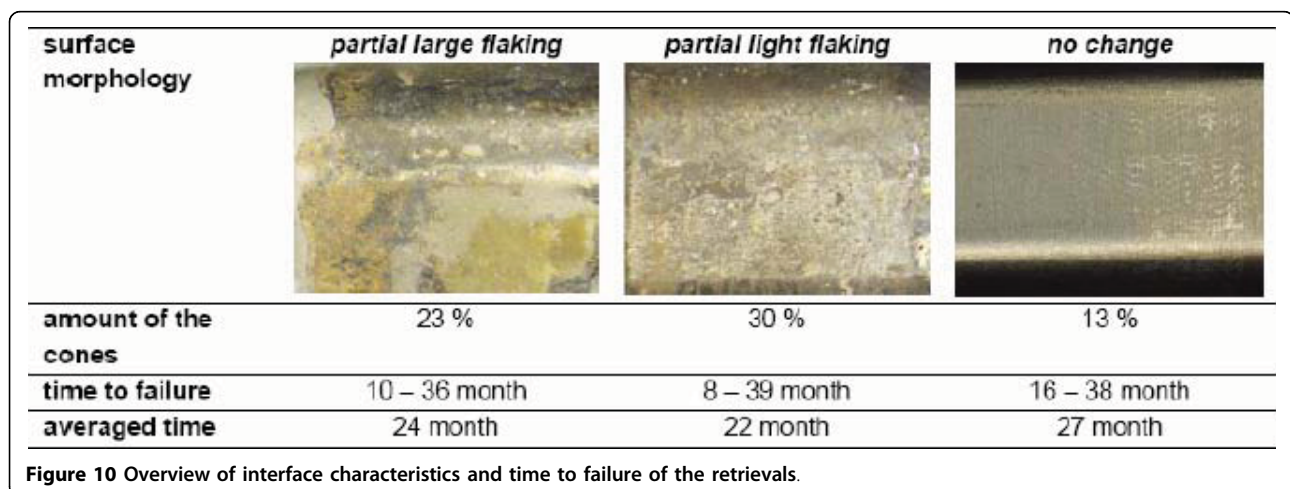
The examination did not indicate any product deviation, manufacturing failure or batch correlation, thus excluding any manufacturing influence as cause for implant breakage. In the majority of cases, the surface of the cones was significantly modified and showed signs of fretting corrosion. Among the forty-seven of the revised cones available for examination, a total of 87%

presented substantial fretting overlaid by laminar corrosion of different intensity (Figure 10).

Figure 10 Overview of interface characteristics and time to failure of the retrievals.

Due to mechanical perturbation in the modular connection, micro-movements caused fretting on the surface. Microcracks developed in the fretting zone, ultimately leading to the dynamic fatigue fracture of the implant. In 87% of the cases, fretting was accompanied by corrosion [17,20-25] as it initiates crevice corrosion [26,27]. The combination of fretting and crevice corrosion destroys the passive layer permanently. The electrochemical reactions provoke a shift in the pH value into the acidic range. The corrosion process generates a fissured surface of the connecting cone and can also generate microcracks. The examinations revealed that corrosion does not trigger the implant failure but does accelerate the process [26]. Cone adapters free from corrosive attack last the longest period up to failure (Figure 10).

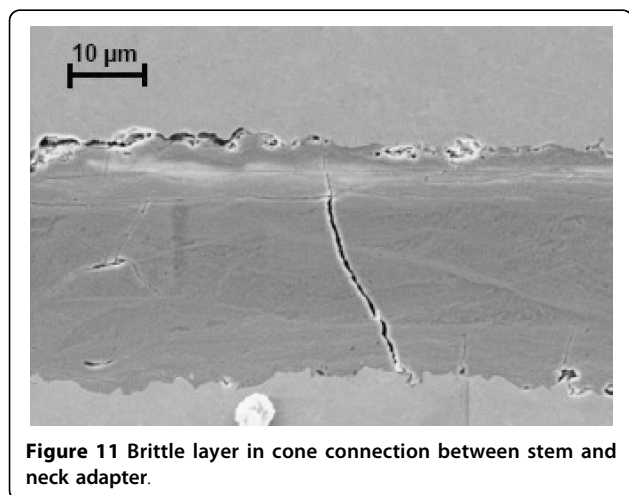
The findings of the corrosive alteration apart of fretting have not been corroborated by biomechanical tests so far [8,14]. Metallographic cross sections of the cone show a 20 µm up to 30 µm thick layer developing in the modular joining area of most of the revised implants (Figure 11), a layer composed of different abrasive and corrosive substances including a high amount of titanium dioxide. The layer was formed due to abrasion of the passive oxide layer protecting the titanium alloy against corrosion. Continued abrasion and repeated repassivation of the titanium alloy surface produced the oxide layer's characteristic thickness.

Figure 11 Brittle layer in cone connection between stem and neck adapter.

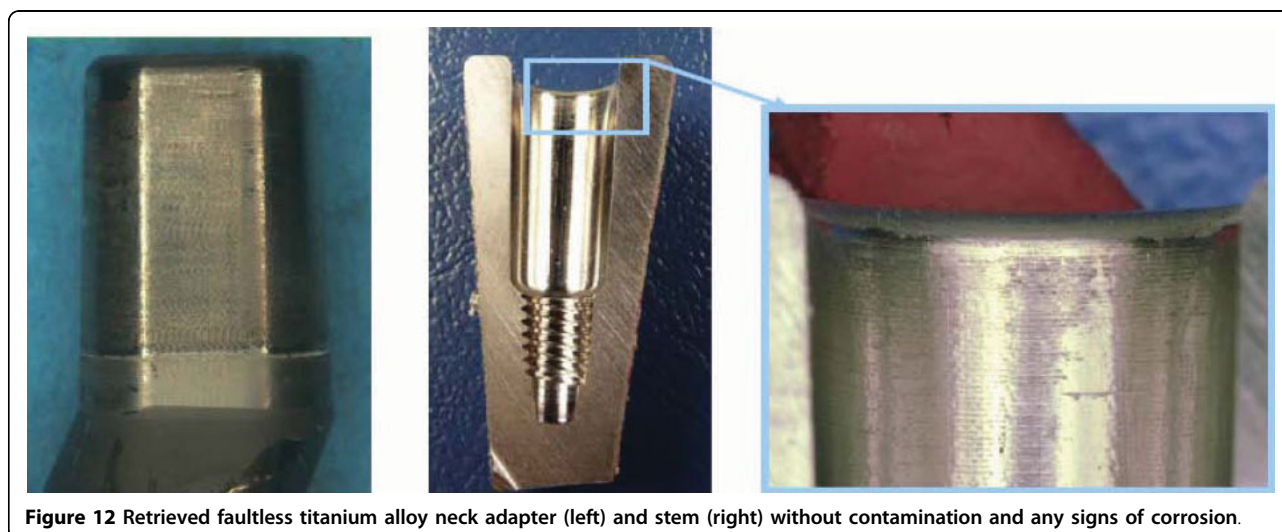
In one patient weighing 100 kg, a revision had to be carried out after 26 months to improve the offset due to cup loosening, thus providing the possibility to examine a faultless titanium adapter. (Figure 12).

microscope. No calcium or phosphor could be detected. There was no indication of a contamination of the cone connection by bone particles. Besides mild abrasion on the surface, no signs of fretting corrosion could be found.

Figure 12 Retrieved faultless titanium alloy neck adapter (left) and stem (right) without contamination and any signs of corrosion.

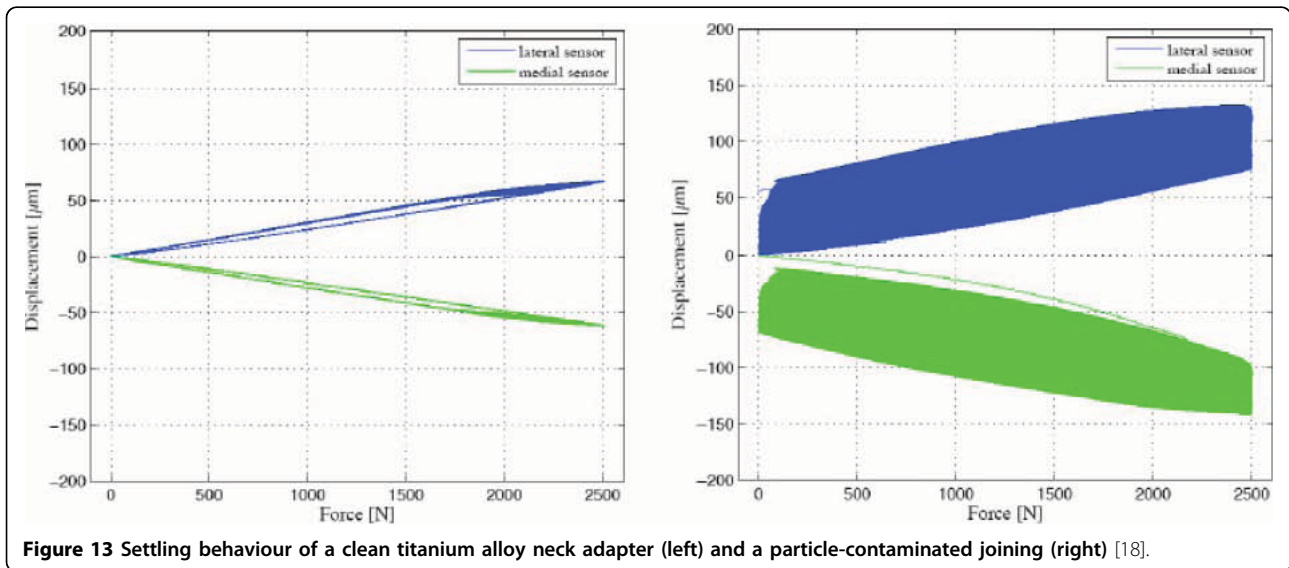
The major part of the observed displacement was caused by elastic deformation of the neck adapter. The micromotions of the titanium neck adapter were in a clean condition $6 \pm 4 \mu\text{m}$ (medial) and $6 \pm 2 \mu\text{m}$ (lateral) and with particle contamination $18 \pm 3 \mu\text{m}$ (medial) and $15 \pm 4 \mu\text{m}$ (lateral). In each contaminated joining area, the displacement and the micromotions were larger than in a clean condition. The fully uncontaminated components showed a distinct and definitive settling within the first 20 cycles. In case of a contaminated joining area the settling process of the neck adapter did not come to an end and lasted over the entire test duration (2000 cycles) (Figure 13).

Figure 13 Settling behaviour of a clean titanium alloy neck adapter (left) and a particle-contaminated joining (right) [18].

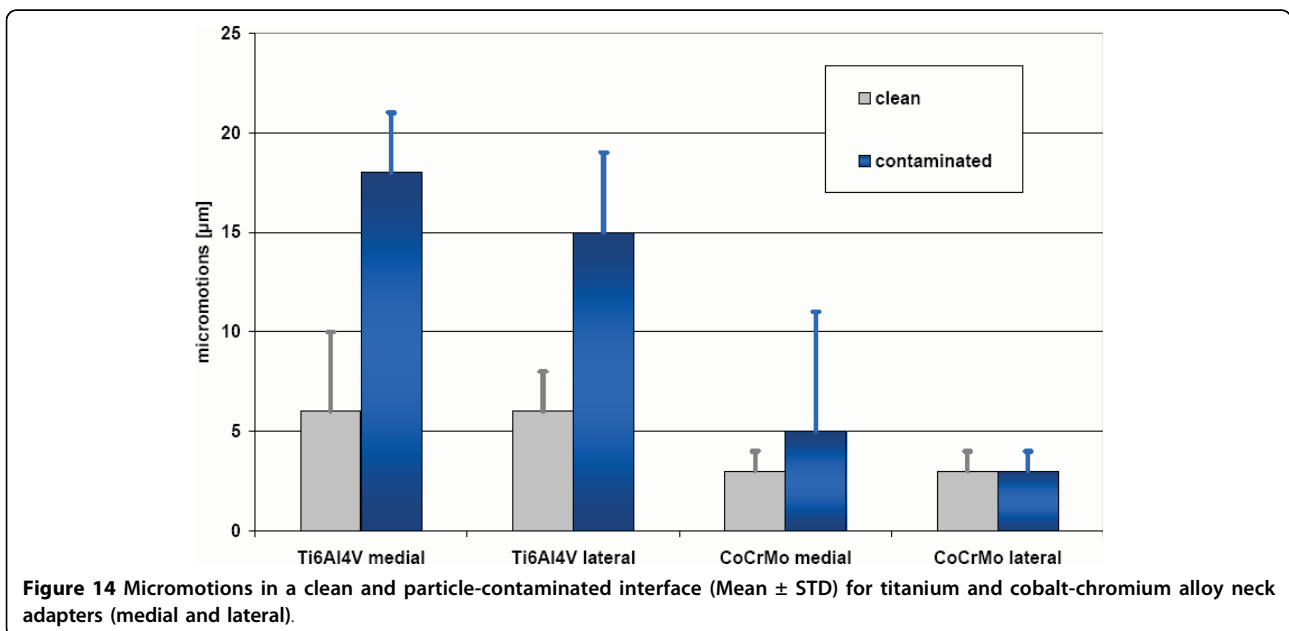
The titanium alloy neck adapter showed a significant increase of micromotions in the interface of the particle-contaminated joining ($p < 0.01$) in comparison to clean conditions (Figure 14). The micromotions of the

neck adapter out of cobalt-chromium were in a clean condition $3 \pm 1 \mu\text{m}$ (medial) and $3 \pm 1 \mu\text{m}$ (lateral) and with particle contamination $5 \pm 6 \mu\text{m}$ (medial) and $3 \pm 2 \mu\text{m}$ (lateral).

In the case of the cobalt-chromium alloy neck adapter, the contamination of the joining area did not influence the micromotions significantly ($p = 0.43$).

Figure 14 Micromotions in a clean and particle-contaminated interface (Mean ± STD) for titanium and cobalt-chromium alloy neck adapters (medial and lateral).

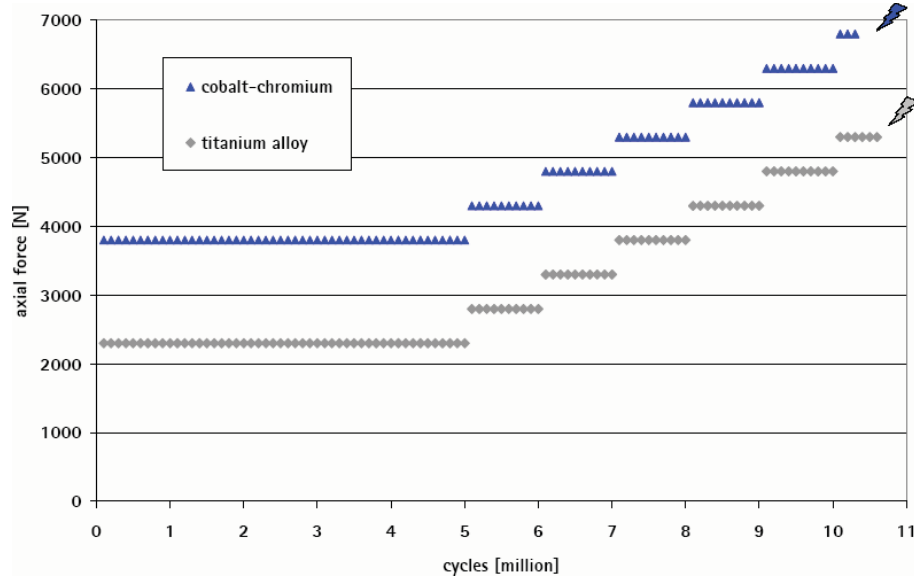
Simulating a deficiency in proximal stem support the fatigue behaviour of the coaction of the stem/neck modularity with the hip stem was examined in a customised test setup. The titanium alloy neck adapters fulfilled the ISO 7206-8: 1995(E) requirements (2300 N for 5 million cycles) and failed during a stepwise increase of the applied force (Locati method) at a high load level of 5300 N after 0.7 million cycles (range 0.63 to 0.75). In a

direct comparison, the cobalt-chromium neck adapters did not fail in the Locati test until the stem fractured at 6800 N load after 0.3 million cycles (Figure 15). Furthermore, the cobalt-chromium neck components did not fracture at 5300 N during 10 million cycles.

Figure 15 Endurance behaviour of the modular stem and different failure mechanisms for neck components made of titanium (failure of the neck adapter) and of cobalt-chromium alloy (fractured stem at a level below the embedding).

The change of the material of the adapter from titanium alloy to a cobalt-based alloy (CoCr29Mo6) increases the safety of the cone connection significantly. The combination of the cobalt-based alloy and the titanium alloy of the shaft shows a considerably higher rigidity. The smaller micro-movements reduce abrasion. Furthermore, the highly stable passive layer of the cobalt-based alloy provides an improved resistance against fretting. Due to its structure, the cobalt alloy has a much lower notch sensitivity compared to the titanium alloy. This enhances fatigue strength.

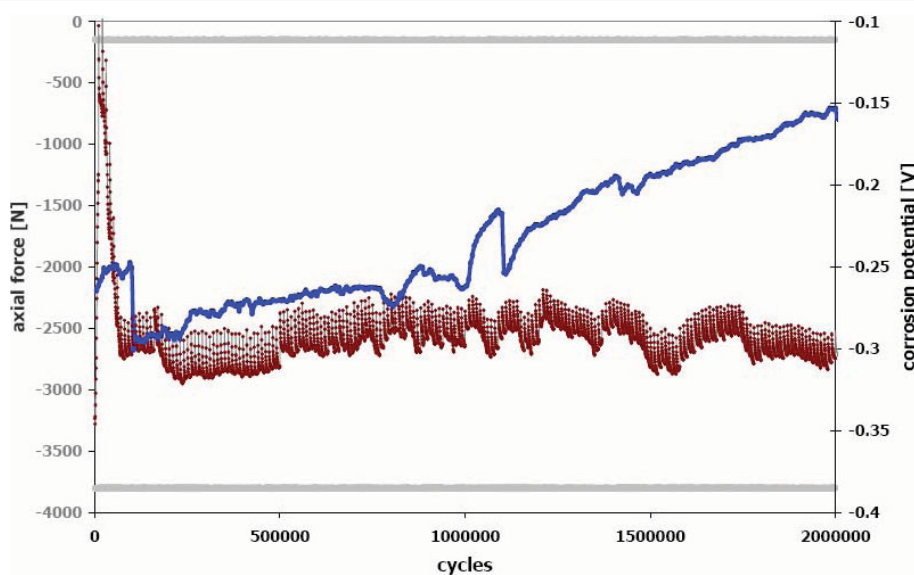
Contamination with cortical bone particles in the interface was found to be the main influence factor on the fatigue behaviour of the titanium alloy neck adapter. With a hip contact force of 3800 N the contaminated titanium alloy neck adapters failed after 3 million cycles (range 2.7 to 3.3) while no failure occurred under clean interface conditions (run-out limit 10 million cycles). This is mainly due to the increase of micromotions and the resulting fretting corrosion in the modular neck interface. In clean conditions, the load has to be increased up to 5300 N to provoke a similar failure mode. The redox potential measures fretting corrosion and repassivation on metallic surfaces. It shows impressively that introducing cortical particles into the modular neck interface generates a

mechanical disturbance which triggers repassivation processes in high frequency (Figure 16).

Figure 16 Free redox potential with frequent repassivation processes in the particle-contaminated modular neck interface (red curve) compared with a clean joining (blue curve).
