Femoral fracture following knee ligament reconstruction surgery due to an unpredictable complication of bioabsorbable screw fixation: a case report and review of literature

Abstract We report an unusual case of femoral fracture from minimal trauma, due to the rapid disappearance of a bioabsorbable interference screw used for reconstruction of the posterolateral corner of the knee. The literature on bone tunnel fractures following knee ligament reconstruction surgery is also reviewed.

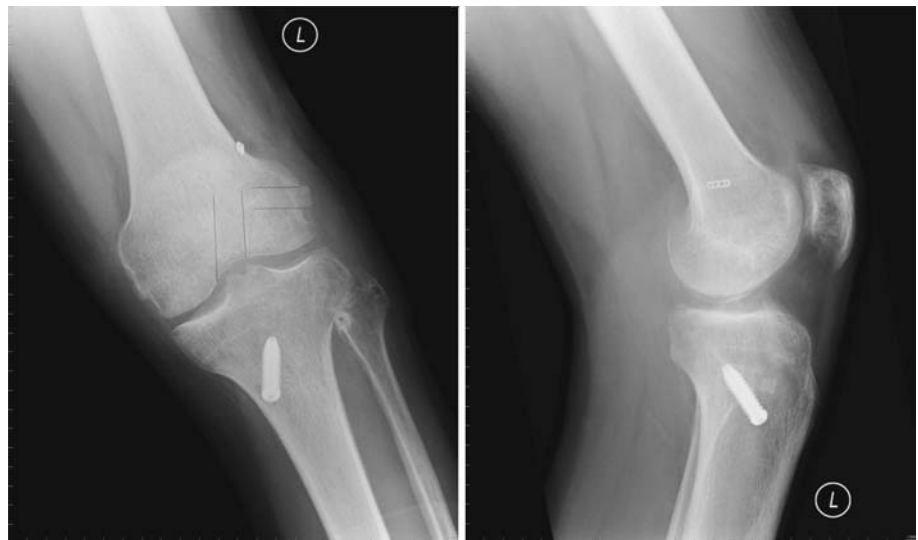
Fig. 1 Immediate postoperative plain radiographs with illustration of tunnel positions on the lateral femoral condyle illustrated on the AP view. The lateral tunnel is placed in a more anterior plane in relation to the ACL tunnel

using a 10 mm by 35 mm PLC (Calaxo, Smith & Nephew) screw. An image intensifier was used to guide the positioning of each screw. Meticulous care was taken to ensure that, when bone tunnels were adjacent, they were placed such that no compromise to bone strength would occur (see postoperative radiographs—Fig. 1). Excellent knee stability was noted on the table.

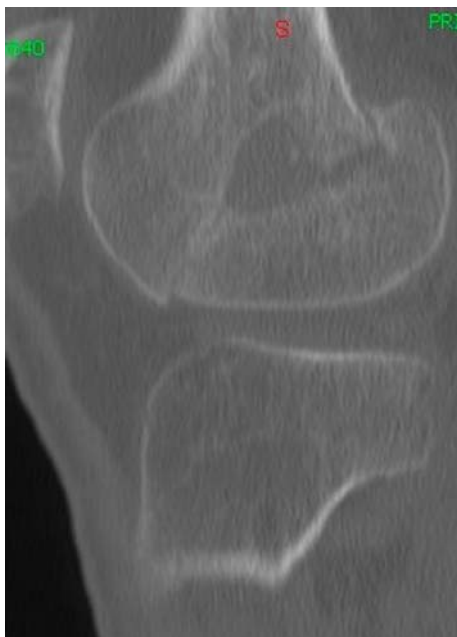
Fig. 2 CT image of the fracture in the femoral tunnel. Note the absence of the bioabsorbable screw

In our case, rapid degradation of the PLC screws in the osseous tunnel in the absence of any attempted bone integration may have predisposed to the fracture by a similar mechanism. Ongoing clinical concerns with the unpredictable absorption of the PLC screws (Calaxo, Smith & Nephew) lead to their withdrawal from the market in 2007. It is crucial to be aware of adverse effects where this particular interference screw has been used.

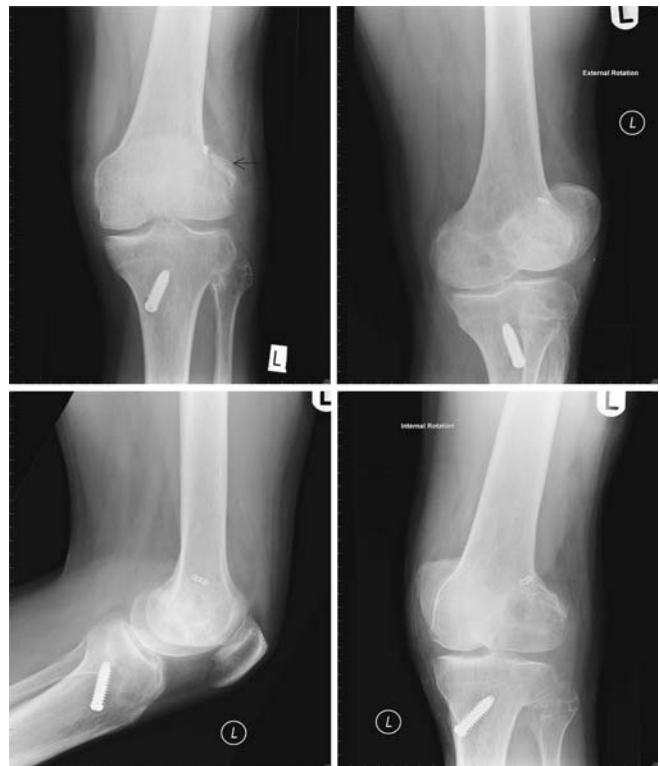
Fig. 3 Plain radiographs showing the minimally displaced fracture. Please note the “empty tunnels” on the rotation views

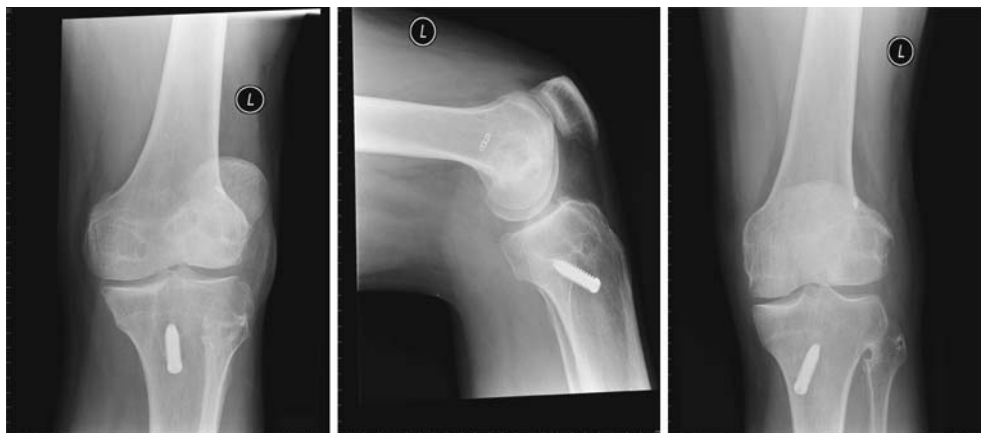
Fig. 4 Plain radiographs taken at 14 months suggest a healed fracture
