Mechanical Properties, Oxidation, and Clinical Performance of Retrieved Highly Crosslinked Crossfire Liners after Intermediate-Term Implantation

Steven M. Kurtz, Ph.D.^{1,2,*}, Matthew Austin, M.D.³, Khalid Azzam, M.D.³, Peter Sharkey, M.D.³, Daniel MacDonald, B.S.¹, Francisco J. Medel, Ph.D.¹, and William Hozack, M.D.³

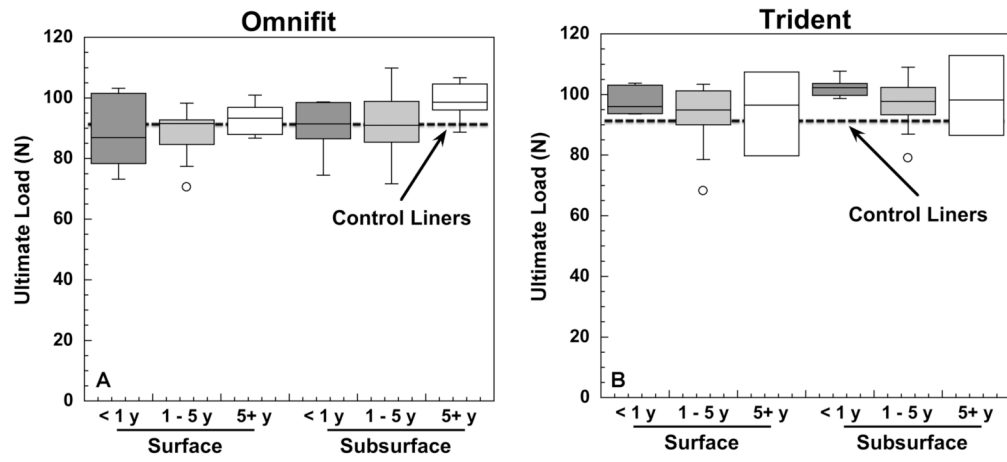
Figure 1.
A-B. Ultimate load results by sampling region (surface and subsurface) for retrieved Omnifit, (1A), and Trident, (1B), liners. Retrievals were classified into three categories (less than 1 year, one to five years, and five or plus year) according to their corresponding implantation time.

The mechanical behavior of Crossfire at the bearing surface was found to be insensitive to implantation time as well as to liner design for the two designs under consideration (Fig. 1A-B). Average ultimate loads near the bearing surface ranged from 70.6 to 103.2 N (mean \pm SD: 89.7 ± 8.2 N), and from 68.2 to 107.4 N (mean \pm SD: 94.5 ± 8.8 N), for Omnifit and Trident designs, respectively. Similarly, average subsurface mechanical properties were in the range from 71.7 to 109.8 N (mean \pm SD: 93.0 ± 9.6 N), and from 79.0 to 112.9 N (mean \pm SD: 98.7 ± 7.2 N), again for Omnifit and Trident liners, respectively. In contrast, the ultimate load of the unimplanted, control liners ranged between 76.6 and 97.9 N (mean \pm SD: 90.1 ± 8.8 N) near the surface and between 67.5 and 100.05 N (mean \pm SD: 91.1 ± 15.8) at the subsurface region. We found no statistical association between implantation time and the ultimate strength of the polyethylene near the surface or at subsurface locations of the explants ($p > 0.05$). Trident liners showed comparable ultimate strength to Omnifit retrievals.

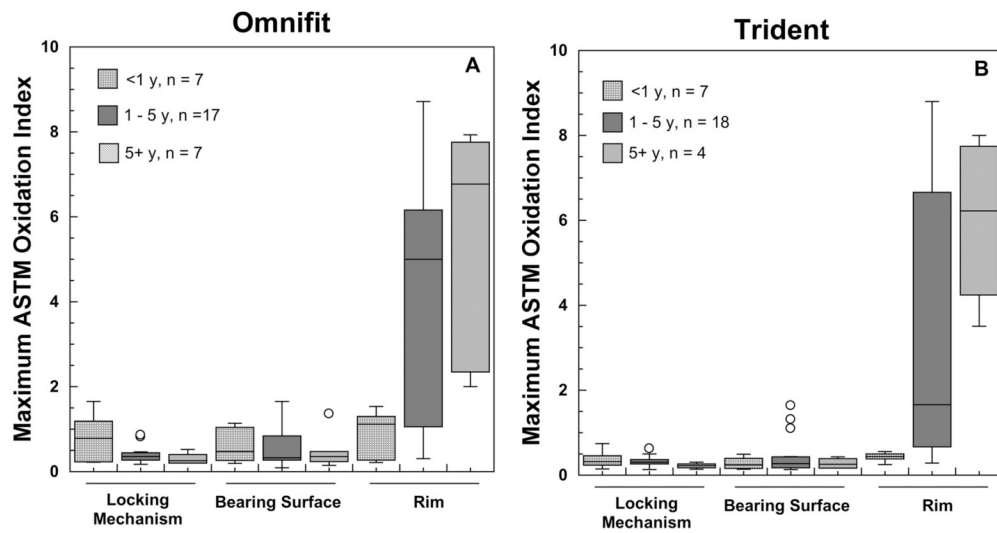
Figure 2.
A-B. Maximum oxidation index measured at three different regions in the retrieved Omnifit, (2A), and Trident, (2B), liners. The average oxidation level of control, never-implanted, Crossfire liners is shown for the sake of comparison.

Significant regional variation was observed in the magnitude of oxidation in the retrieved Crossfire liners (Fig. 2A-B), with the highest oxidation index located at the rim face (range: 0.2-8.8; mean±SD: 3.4±2.9). In contrast, the oxidation values at the bearing surface (range: 0.1-1.7; mean±SD: 0.5±0.4), around the locking mechanism (range:0.1-1.7; mean±SD: 0.4±0.3), and at the back surface (range:0.1-1.3; mean±SD: 0.4±0.2) of the liners were substantially lower than at the rim (Fig. 2A-B). Rim oxidation significantly increased with implantation time (Spearman's Correlation $\rho = 0.71$, $P < 0.0001$); a positive trend was not detected at the bearing surface ($P = 0.83$), backside ($\rho = -0.28$; $P = 0.03$) or the locking mechanism ($\rho = -0.31$; $P = 0.02$) of the liners. The progression of *in vivo* oxidation with implantation time at the rim and the articulating surface of Omnifit and Trident retrievals is depicted in Figures 3A-B. The temporal evolution of oxidation in Crossfire retrievals was consistent with an exponential growth trend with time *in vivo* at the rim ($R^2 = 0.48$; $p < 0.0001$), but not at the articulating surface ($R^2 = 0.00$; $p = 0.85$). Retrieved Crossfire liners implanted for less than five years had oxidation indices close to the oxidation levels of the control liners (range: 0.3-1.1; mean±SD: 0.5±0.4) in the locking mechanism (range: 0.1-1.7; mean±SD: 0.4±0.3) and bearing surface regions (range: 0.1-1.7; mean±SD: 0.5±0.5), as well as in the rim region for liners implanted for less than 1 year (range: 0.2-1.5; mean±SD: 0.7±0.4). In general, and despite the shorter duration of Trident liners, the regional variations of oxidation were comparable for both Omnifit and Trident liners (Fig. 2A-B). Polyethylene in the vicinity of the Trident locking mechanism had less oxidation and less variability in oxidation than in the Omnifit liner design for retrieved liners implanted for less than five years ($p = 0.02$, Fig. 2A-B).

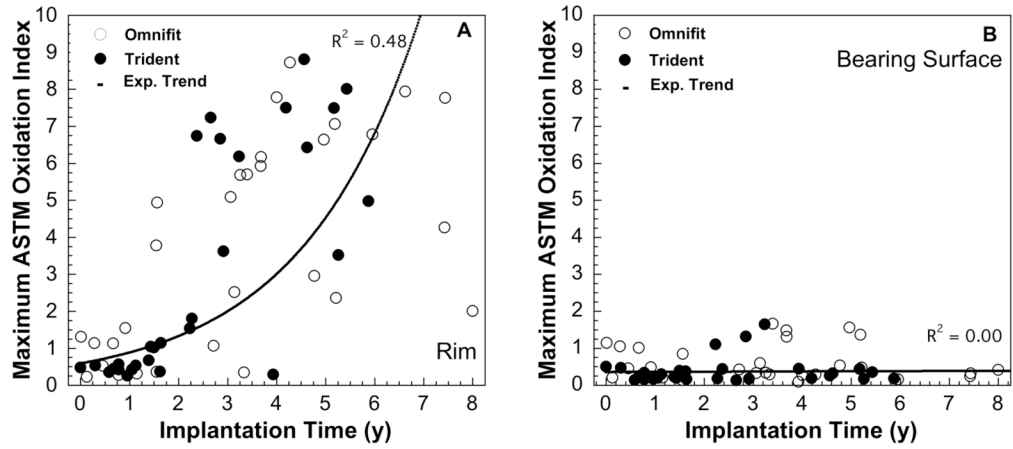
Figure 3.

A-B. The progression of maximum *in vivo* oxidation with implantation time at the rim, (3A), and at the articulating surface, (3B) for retrieved Omnifit and Trident liners. The evolution of oxidation in Crossfire retrievals was consistent with an exponential growth trend with time *in vivo* at the rim ($R^2 = 0.48$; $p < 0.0001$), but not at the articulating surface ($R^2 = 0.00$; $p = 0.85$).

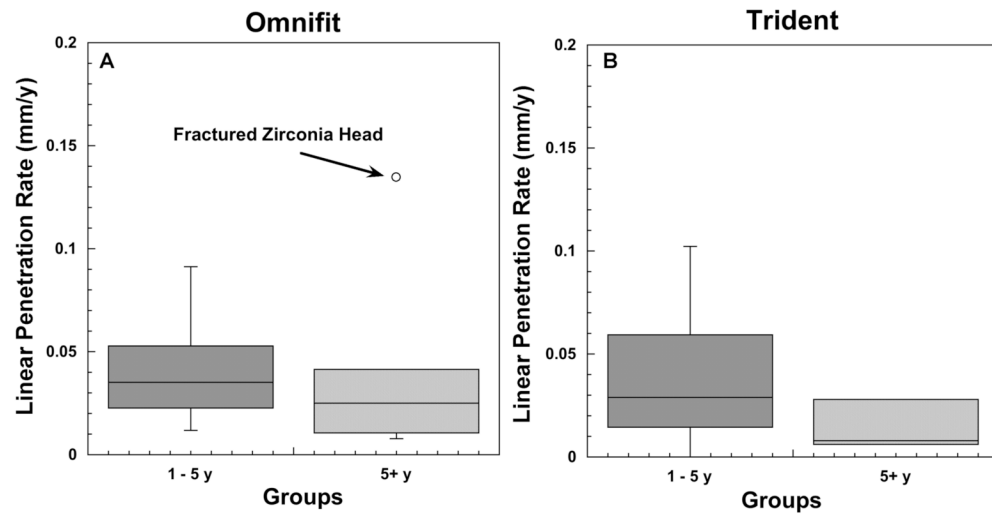
Figure 4.
A-B. Linear penetration measured in the retrieved Omnifit, (4A), and Trident, (4B), liners (n=42).

Retrieved Omnifit and Trident liners amenable to penetration measurements ($n = 21$ and $n = 21$, respectively) exhibited similar, relatively low linear penetration rates during the first eight years of implantation (Fig. 4A-B, Table 1). The linear penetration rates fell in the range of 0.01 to 0.09 mm/y (mean ± SD: 0.04±0.02 mm/y) for Omnifit liners ($n = 15$), and in the range from 0.00 to 0.10 mm/y (mean ± SD: 0.04±0.03 mm/y) for Trident liners ($n = 17$) implanted for five years or less. All retrieved liners implanted for more than five years exhibited lower average linear penetration rates than explants revised before that period (mean ± SD: 0.02±0.01 mm/y for 4 Omnifit liners amenable to measure; 0.01±0.01 mm/y for 4 Trident liners), the only exceptions being two Omnifit liners revised due to fractured zirconia femoral heads (0.13 and 0.04 mm/y). Moreover, there was a negative correlation between linear penetration rate and implantation time (Spearman's Correlation; $\rho = -0.35$, $P = 0.02$), confirming the decreasing trend of the penetration rate with time. Using analysis of covariance, general linear models for penetration rate including *in vivo* time, femoral head size, and femoral head material as covariates also revealed a significant influence of implantation time ($P = 0.002$; Power = 90%) and head material ($P = 0.03$; Power = 65%), but not for head size ($P = 0.2$; Power = 23%). Overall, implants with alumina ceramic heads ($n = 5$; 1 liner not amenable to measure due to iatrogenic damage) showed a trend of lower linear penetration rates (0.01±0.01 mm/y) in comparison with acetabular liners bearing against zirconia ceramic (0.04±0.04 mm/y; $n = 7$; including 2 liners revised due to fractured ceramic head) and cobalt chrome alloy heads (0.04±0.03 mm/y; $n = 30$). In addition, the average penetration rates were identical for the three head sizes available for analysis (0.04±0.03 mm/y; $n = 22$, 17 and 3 for 28, 32 and 36 mm heads, respectively). Finally, we observed no significant difference in the penetration rates of the two liner designs ($p = 0.23$), and no significant influences of shell size on penetration rate.

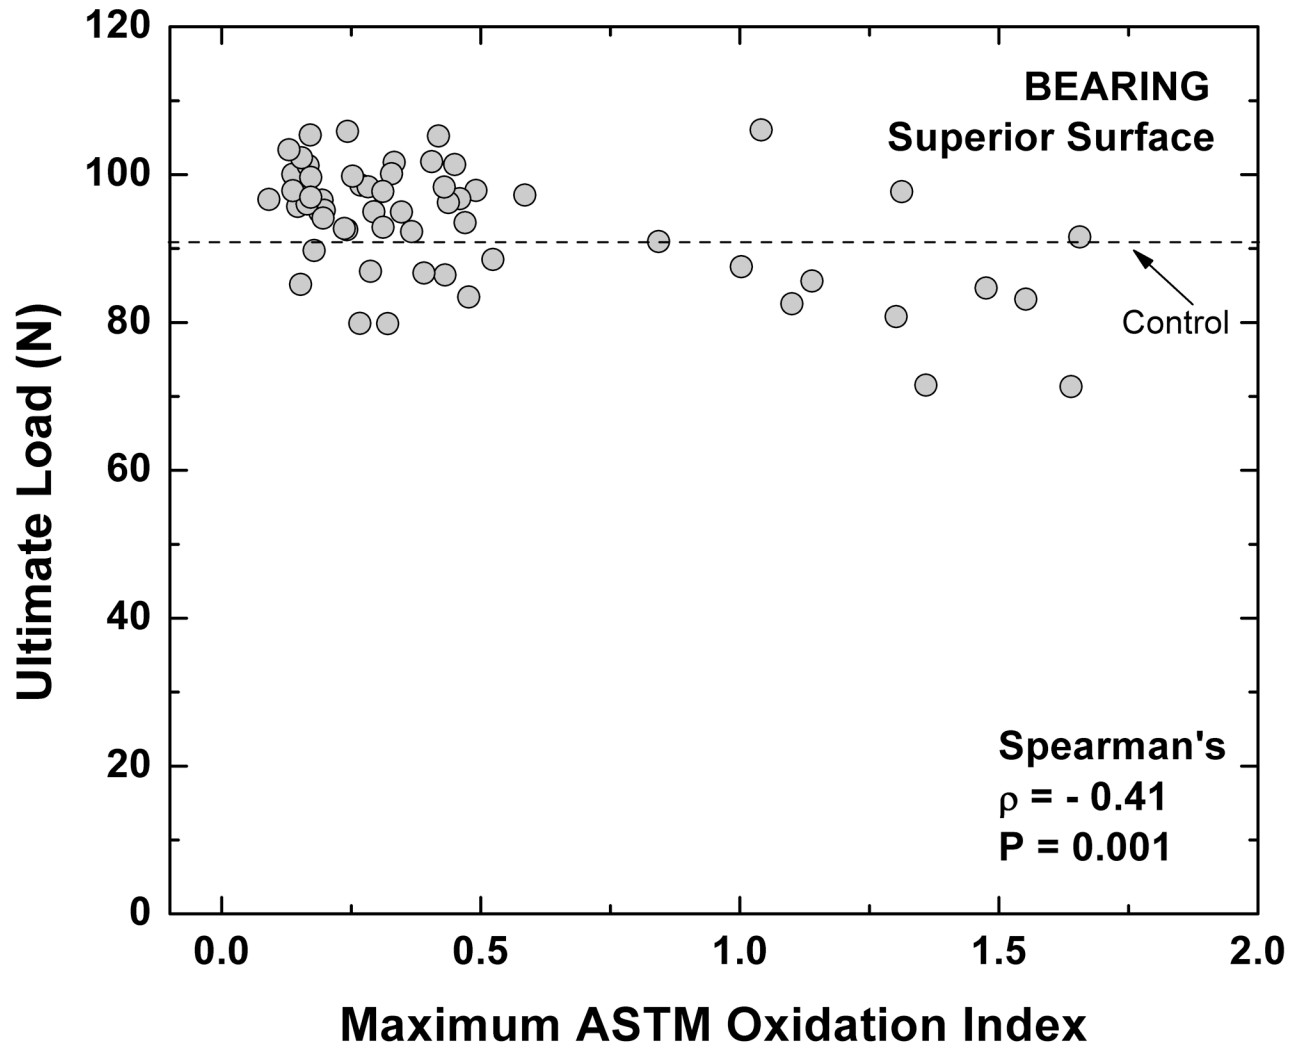
Figure 5. Correlation between ultimate load and maximum ASTM oxidation index at the superior surface of 60 retrieved Crossfire liners.

A significant correlation was observed between the maximum oxidation near the superior (worn) surface and the ultimate load of polyethylene near the superior bearing surface (Spearman's Correlation: $\rho = -0.41$, $P = 0.001$) in the retrieved Crossfire liners (Fig. 5). In spite of the aforementioned correlation, the penetration rate of the liners was not correlated with the ultimate load of polyethylene near the worn surface ($P = 0.64$). Likewise, no significant correlation was found between maximum oxidation near the worn surface and penetration rate

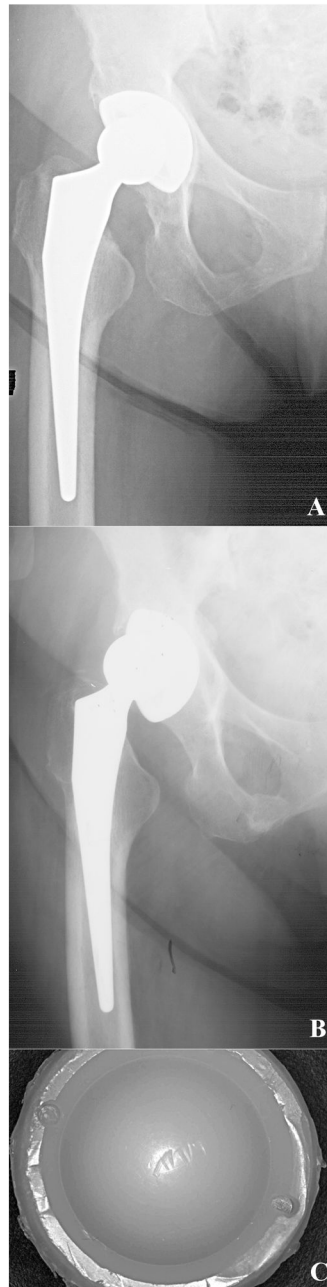
Figure 6.
A-C. Anterior-posterior radiographs for case study 1, a Crossfire liner revised after 3.1 years. 1.5 months postoperative radiograph, (6A), and 3 years postoperative, (6B). After implantation, the liner rim, (6C), showed localized plastic deformation and whitening (oxidation index ~ 5.0 at the rim).

Case Study 1 (Retrieval 343). This 61-year-old female patient was implanted with a 28-mm diameter CoCr alloy femoral head and a Crossfire Omnifit liner in 2001. The patient's body mass index (BMI) was 27 kg/m^2 , and according to the UCLA activity level questionnaire, she was mostly inactive, corresponding to a maximum UCLA score of 3 at any point after surgery. Her activity score was 2 within 3 months prior to surgery. The shell was initially well-positioned (Fig. 6A), but became dislodged from her acetabulum following a fall and oriented vertically with respect to her pelvis (Fig. 6B). The patient experienced groin and buttocks pain after the fall for 7 months until her revision surgery in 2004. Following 3.1 years of implantation, the liner rim showed localized plastic deformation and whitening, consistent with subsurface "white band" and localized oxidation index values of 5.0 (Fig. 6C). The average penetration rate for this liner was 0.06 mm/y , and the maximum oxidation index at the bearing surface was 0.5. The ultimate strength of the liner near the bearing surface was $82.4 \pm 3.6 \text{ N}$. The mechanism of rim damage appeared to be contact with the femoral head when the liner was oriented vertically. Thus, the rim damage in this case was judged to be unrelated to the reason for revision, which was precipitated by traumatic loosening of the shell.

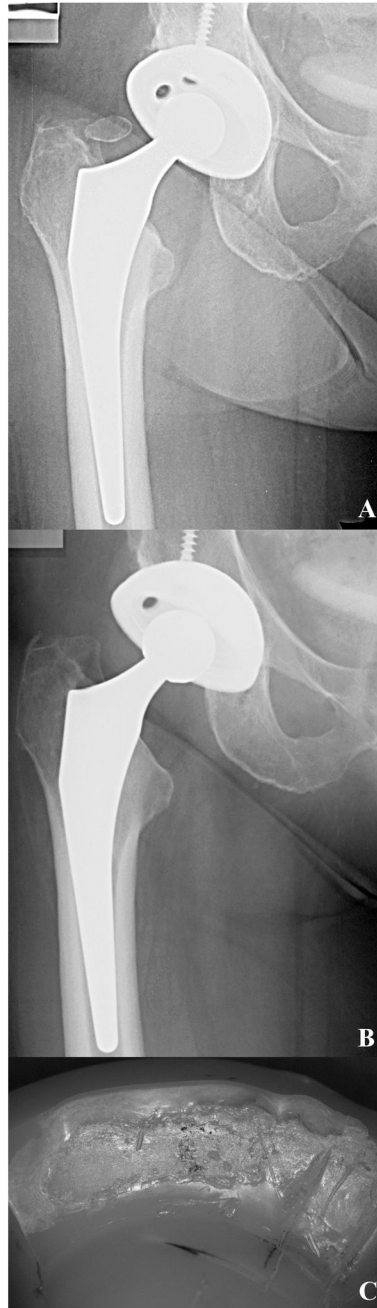
Figure 7.
A-C. Anterior-posterior radiographs for case study 2, a Crossfire liner revised after 3.3 years. 2.5 months postoperative radiograph, (7A), and 1.6 years postoperative, (7B). After implantation, the liner rim, (7C), showed a 90° arc of delamination, probably due to chronic dislocations of the femoral head over the rim.

Case study 2 (Retrieval 345). This 78-year-old female patient was implanted with a 28-mm diameter CoCr alloy femoral head and a Crossfire Omnifit liner in 2001. The patient's body mass index (BMI) was 33 kg/m^2 , and she was mildly active, corresponding to a maximum UCLA score of 4 at any point after surgery. Her activity score was 2 within 3 months of her revision surgery. The shell was initially well-positioned (Fig. 7A-B), but the patient suffered from chronic instability and dislocated between 5 and 10 times before her revision surgery in 2004. After 3.3 years *in vivo*, the liner rim showed a 90° arc of delamination (Fig. 7C). The average penetration rate for this liner was 0.05 mm/y , and the maximum oxidation index at the bearing surface was 0.5. The surface ultimate load of the Crossfire bearing was $87.3 \pm 18.1 \text{ N}$. Undamaged regions of the rim did not show evidence of delamination or white banding, and their associated maximum oxidation index was 0.3. The rim damage was likely produced during the chronic dislocations of the femoral head over the rim. Therefore, the rim damage in this case was generated secondary to the joint instability, which necessitated revision.

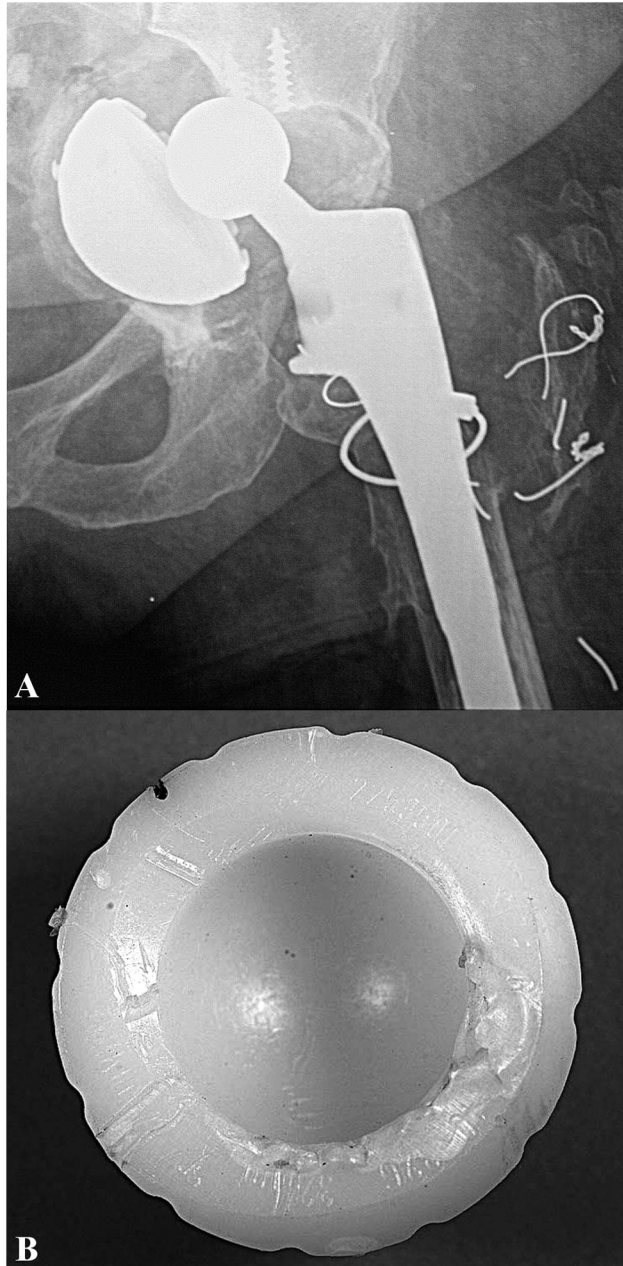
Figure 8.
A-B. Anterior-posterior radiograph, (8A), for case study 3, a Crossfire liner revised after 4.6 years *in situ*. This Crossfire liner had to be re-revised due to fracture of the medial wall of the pelvis. After implantation, the liner rim, (8B), showed a nearly 180° arc of delamination, probably due to dislocation of the femoral head secondary to fracture of the pelvis.

Case study 3 (Retrieval 578). This 60-year-old female patient was implanted with a 32-mm diameter CoCr alloy femoral head and a Crossfire Trident liner during revision surgery of primary left total hip arthroplasty in 2001. She weighed 225 lb, corresponding to a BMI of 34 kg/m^2 (clinically obese), and she was mostly inactive (maximum UCLA score of 3). After 4.6 years *in situ*, the second implant had to be re-revised due to fracture of the medial wall of the pelvis (Fig. 8A). Analysis of the radiographs did demonstrate complete protrusion of the acetabular component. The average penetration rate for this liner was 0.02 mm/y , and the maximum oxidation index at the bearing surface was 0.3. The surface ultimate load of the Crossfire bearing was $90.0 \pm 4.1 \text{ N}$. The liner rim showed a nearly 180° arc of surface damage and delamination, where the local peak oxidation was 6.4 (Fig. 8B). Neither delamination nor white banding was found in non-impinged areas of the rim. Abnormal loading of the femoral head likely caused the rim damage after fracture of the pelvis and dislocation of the implant.
