Placement and complications of cervical pedicle screws in 144 cervical trauma patients using pedicle axis view techniques by fluoroscope

Yasutsugu Yukawa · Fumihiko Kato ·
Keigo Ito · Yumiko Horie · Tetsurou Hida ·
Hiroaki Nakashima · Masaaki Machino

Received: 10 July 2008 / Revised: 30 March 2009 / Accepted: 10 May 2009 / Published online: 2 June 2009
© Springer-Verlag 2009

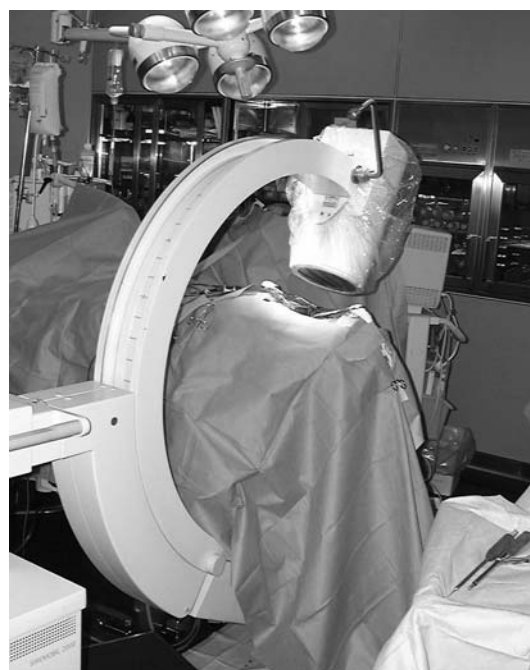
Fig. 1 Illustrative setting of fluoroscope in order to obtain the left pedicle axis view

All patients were placed on a Relton–Hall frame with their skull fixed in a Mayfield 3-point fixator and the cervical spine was positioned parallel to the floor. Shoulder girdles were pulled caudally and fixed by taping. A multiplanar fluoroscope was rotated so that an approximate circular portion of the pedicle cortex wall could be visualised in the transverse plane of the vertebral body, and the axis of rotation was set to the cervical longitudinal axis (Fig. 1). The screw insertion point was located at the centre of the circle on the cervical lateral mass (Fig. 2). The inclined axis of the fluoroscope showed that the pedicle axis matched with the insertion point. Usually, the axis inclines

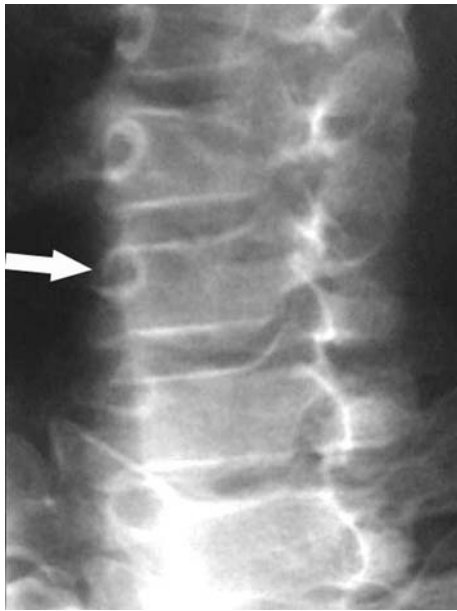
Fig. 2 Oblique radiograph shows the cortical circles of left C4–T1 pedicles. Left C6 pedicle is seen as a *round circle* just below the upper endplate and this is the pedicle axis view (*Arrow*)

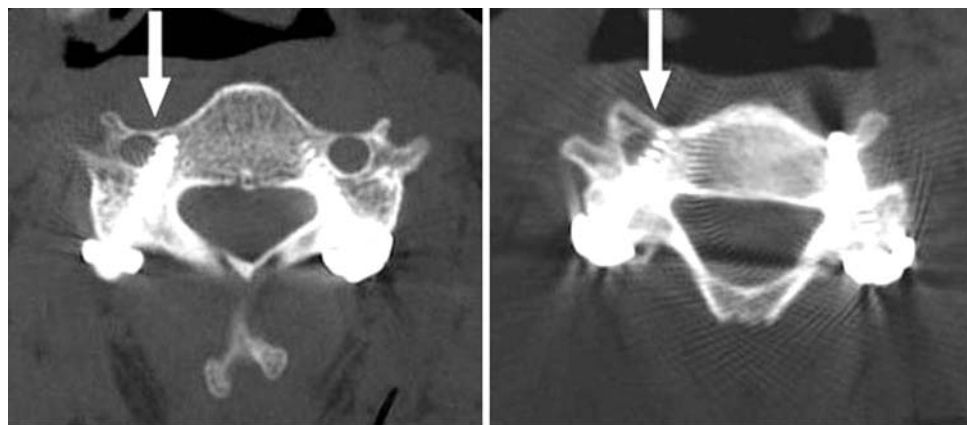
Fig. 4 Screw placement; screw exposure (*left*) and pedicle perforation (*right*) in axial CT scans

The accuracy of the placement of the pedicle screws into the medial/lateral pedicle walls was evaluated on axial CT scans (2-mm slices), whereas superior/inferior pedicle wall screw location was examined on oblique radiographs. The position of the cervical pedicle screws was assessed by an independent radiologist. Incorrect screw placement was classified as either screw exposure or pedicle perforation. A screw was exposed if it broke the pedicle wall, but more than 50% of the screw diameter remained within the pedicle. A pedicle perforation occurred if a screw breached the pedicle wall and more than 50% of the screw diameter was outside the pedicle. The latter indicated a potential risk for neurovascular injury (Fig. 4).

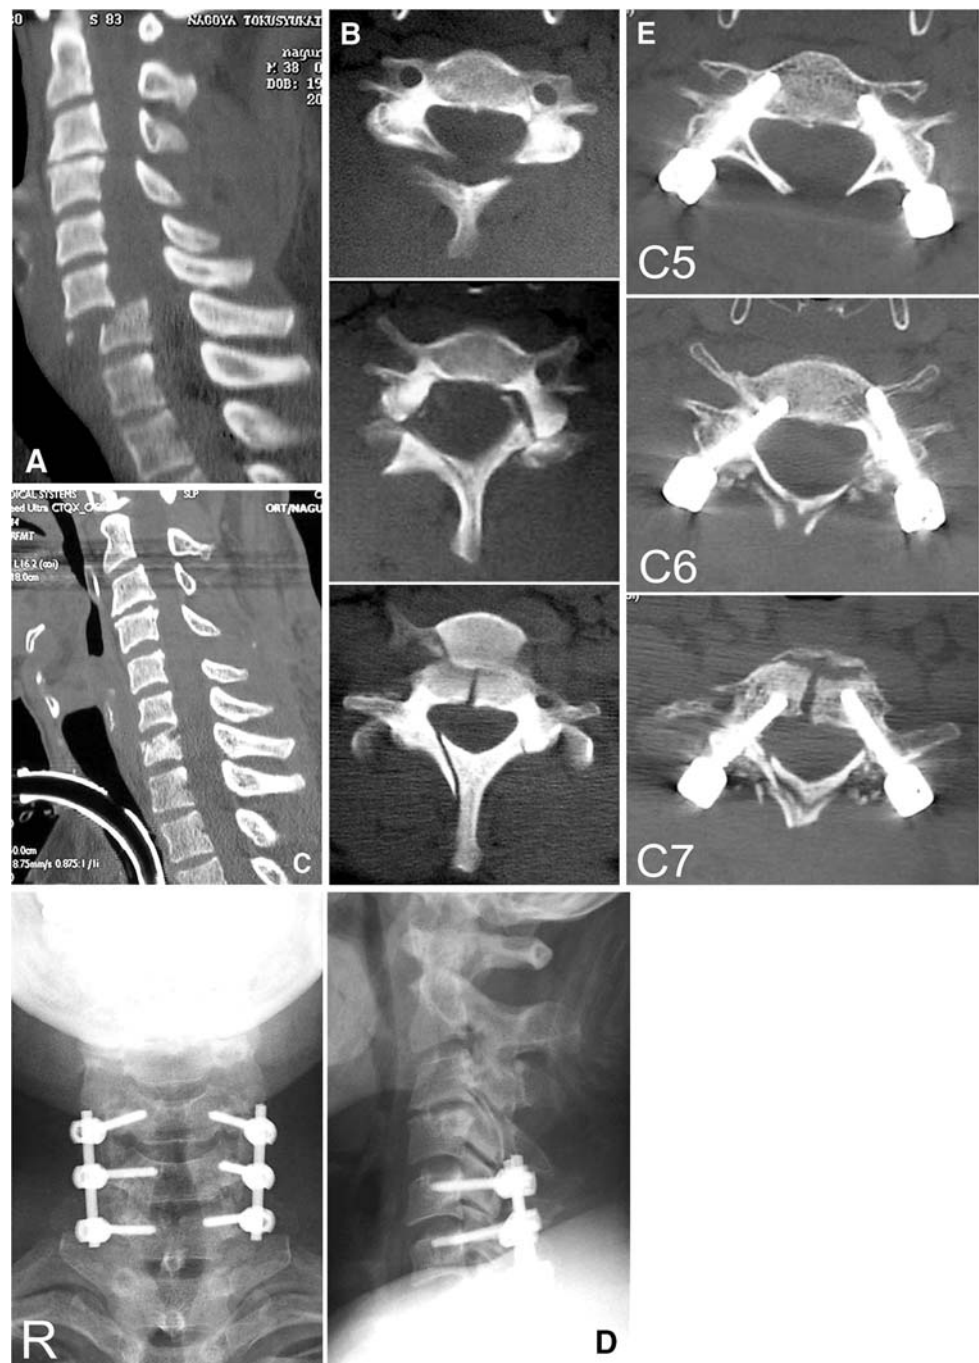
Fig. 5 Imaging studies of an illustrative case. Preoperative sagittal and axial image of CT shows C6/7 fracture—dislocation, C5–7 lamina—vertebral body separation and left C5 and right C6 pedicle fracture without displacement (**a, b**). Good alignment after open reduction and a tracheal tube anterior to the cervical spine are seen on another sagittal image (**c**). Postoperative AP and lateral radiograph show good alignment and C5–7 pedicle screw fixation (**d**). Postoperative CT scans show good placement of pedicle screws at C5, C6, C7 levels (**e**)

A 38-year-old man incurred a C5–7 fracture and dislocation (CE stage 5, Allen classification [4]) and an ASIA A neurological deficit. Sagittal and axial CT images showed C5–7 lamina fracture, left C5 and right C6 pedicle fracture, and C7 vertebral body fracture (Fig. 5a, b). Posterior open reduction, Halo vest fixation and tracheotomy due to respiratory failure were conducted in the regional hospital near the trauma site. After arriving at our hospital, a CT scan demonstrated good alignment and a tracheal tube anterior to the cervical spine. We performed C5–7 pedicle screw fixation (Fig. 5d). The patient started his rehabilitation a day following the surgery without external fixation. A postoperative CT scan showed good placement of the pedicle screws within the pedicle cortex (Fig. 5e).
