William L. Walter, Tim S. Waters, Mark Gillies, Shane Donohoo, Steven M. Kurtz, Amar S. Ranawat, William J. Hozack and Michael A. Tuke
J Bone Joint Surg Am. 2008;90:102-111. doi:10.2106/JBJS.H.00867

Squeaking Hips

By William L. Walter, MBBS, FRACS, PhD, Tim S. Waters, FRCS(Tr&Orth), Mark Gillies, PhD, Shane Donohoo, BEng, Steven M. Kurtz, PhD, Amar S. Ranawat, MD, William J. Hozack, MD, and Michael A. Tuke, HNC, ME

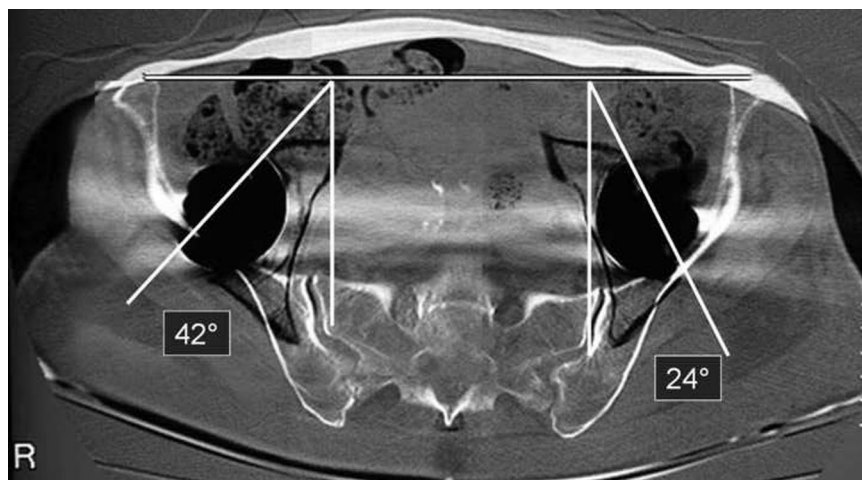
Fig. 1

A computed tomography scan of bilateral ABG II ceramic-on-ceramic hip replacements (Stryker Howmedica Osteonics, Allendale, New Jersey). In the previously reported case of this patient²⁴, the right hip had excessive acetabular anteversion and it squeaked with walking. The left hip with ideal anteversion did not squeak. (Reprinted, with permission, from: Walter WL, O'Toole GC, Walter WK, Ellis A, Zicat BA. Squeaking in ceramic-on-ceramic hips: the importance of acetabular component orientation. *J Arthroplasty*. 2007;22:496-503.)

The anteversion and inclination of the acetabular component were calculated on radiographs. Eleven patients also had a computed tomography scan performed of the squeaking hip (Fig. 1). If the acceptable ranges are defined to be between 15° and 35° of anteversion and between 35° and 55° of inclination, only six (35%) of the seventeen squeaking hips were in the acceptable range, whereas sixteen (94%) of the seventeen control hips were in the acceptable range ($p = 0.0003$). Therefore, if the acetabular orientation is outside this range, the hip is twenty-nine times (95% confidence interval, 3 to 279) more

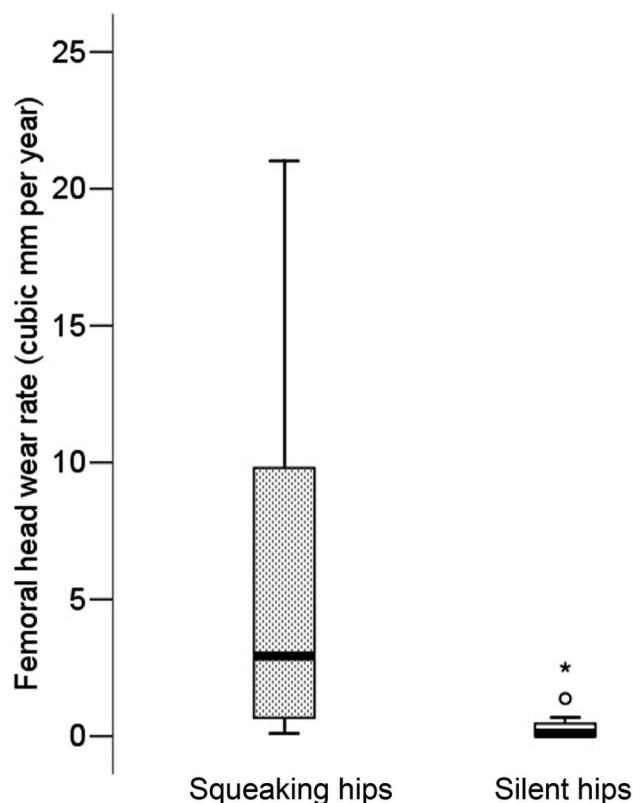
Fig. 2
Box plot comparing the volumetric wear rate of the squeaking retrievals¹³ with that of a historical control¹⁴.

(range, 0.1 to 21.0 mm³) on the femoral heads and 3.4 mm³ (range, 0.2 to 20.6 mm³) on the acetabular components. This is much higher than a median of 0.1 mm³ and 0.04 mm³, respectively, for the thirty-three silent retrievals previously reported¹⁴ (Fig. 2). The mean clearance was 94 μm (range, 61 to 153 μm) in the squeaking retrievals and 72 μm (range, 59 to 87 μm) in the silent control group. This difference was not significant ($p = 0.23$).

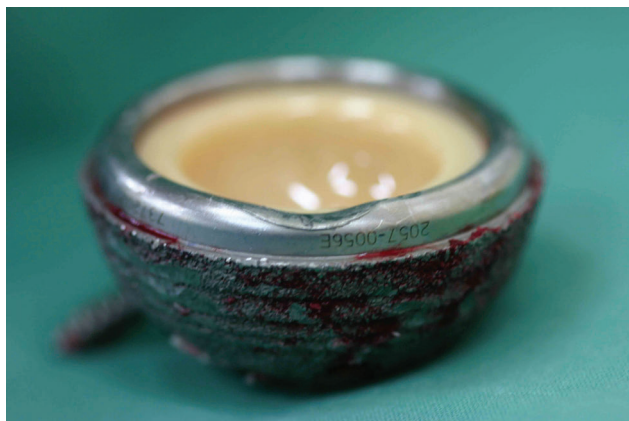
Figs. 3-A through 3-D Previously described in a case report⁶, these components were retrieved from a patient after sixty months because of pain and squeaking. (Reprinted, with permission, from: Murali R, Bonar SF, Kirsh G, Walter WK, Walter WL. Osteolysis in third-generation alumina ceramic-on-ceramic hip bearings with severe impingement and titanium metallosis. *J Arthroplasty*. 2008 Apr 2. E pub ahead of print.)

Fig. 3-A There is evidence of impingement of the neck of the femoral component against the retrieved acetabular shell. **Fig. 3-B** Opposite the point of impingement on the rim, there is edge loading of the ceramic insert and a corresponding area of wear on the femoral head (the wear area has been colored with a blue surgical marking pen).

The numbers were too small to compare the wear among the 36-mm, 32-mm, or 28-mm bearings. There was no chipping or fracture of any of the ceramic components. Seven of the twelve implants also had evidence of impingement of the femoral neck against the elevated metallic rim or the ceramic insert or both (Figs. 3-A and 3-B). Closer inspection of the backside of the ceramic inserts revealed evidence of movement of the ceramic inserts within the titanium shell in several squeaking retrievals (Figs. 3-C and 3-D).

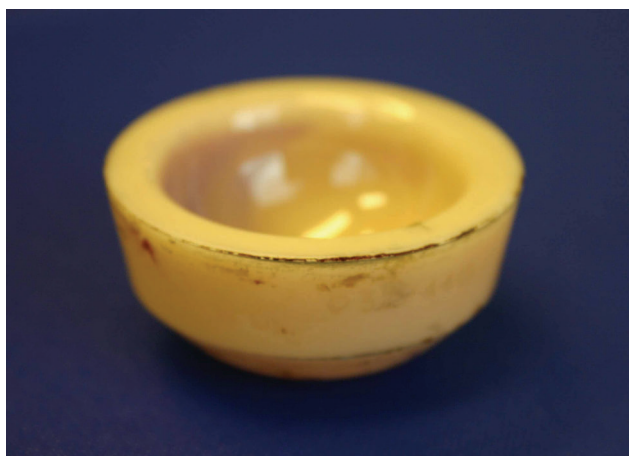
Fig. 3-C Closer inspection of the backside of the ceramic insert shows titanium metal transfer onto the edge. **Fig. 3-D** The titanium metal transfer onto the edge corresponds to a scored line (identified between the arrows) inside the titanium shell, evidence of tilting of the ceramic insert in the titanium shell.

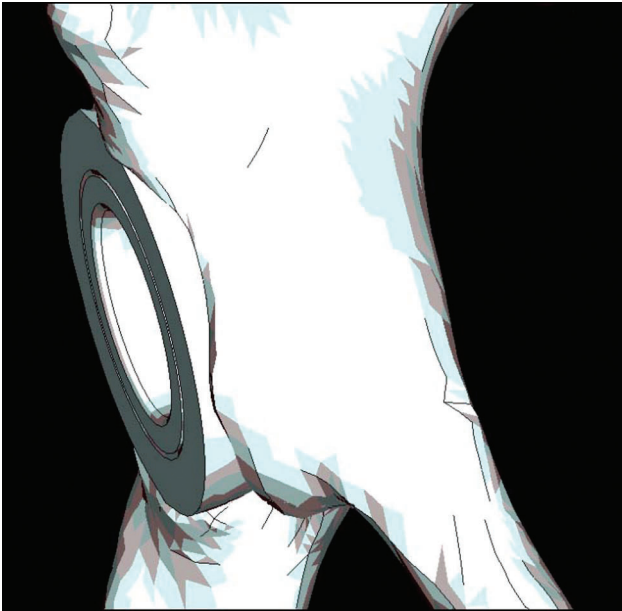
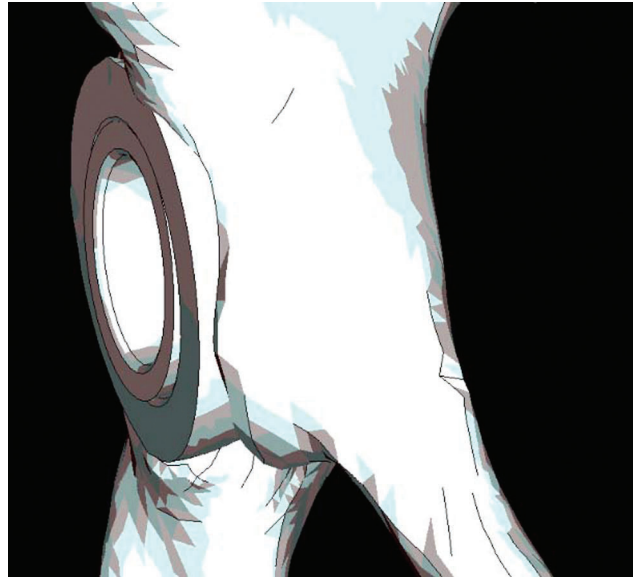
Figs. 4-A and 4-B Finite element analysis of edge loading. **Fig. 4-A** The liner is in its normal position. **Fig. 4-B** The liner is “tilting” within the shell during edge loading.

The liner tends to tilt out of the acetabular shell opposite the applied load (Figs. 4-A and 4-B). With 42° of anteversion, there was 40 µm of separation of the surfaces opposite the load, and, with 24° of anteversion, there was only 4 µm of separation. It is this separation that may allow the acetabular shell to become an oscillator and emit a squeaking sound. The next section investigates this further.

or perhaps other causes. Finite element analysis demonstrated that, with edge loading, the shell deforms and the shell-liner system uncouples, with the liner tilting in the shell. The friction of the movement between the liner and the shell is another potential driving force.

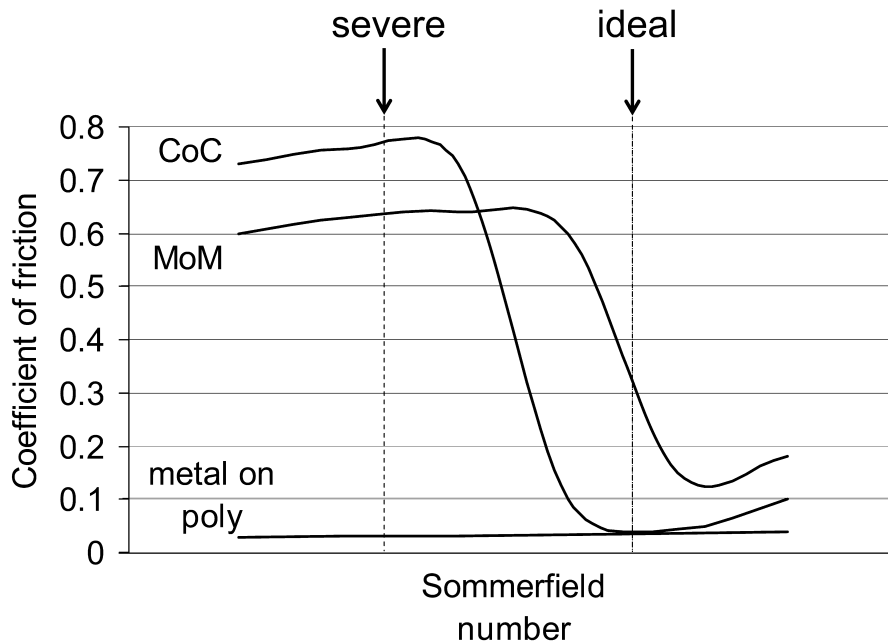
Fig. 5

This graph illustrates the Stribeck curves for different bearing combination materials. Under ideal in vivo conditions, we assume that a ceramic-on-ceramic (CoC) bearing will be operating with fluid film lubrication with a coefficient of friction of around 0.06¹⁸. Metal-on-polyethylene bearings, on the other hand, operate under conditions of boundary lubrication with a coefficient of friction of around 0.04^{18,25}, and an increase in contact pressure in this situation does not lead to an increase in the coefficient of friction²⁵. In ceramic articulations, a loss of fluid film lubrication may result in a coefficient of friction as high as 0.7 or 1.0¹⁹. MoM = metal on metal.

there is a loss of fluid film lubrication¹⁷⁻¹⁹ (Fig. 5). Fluid film lubrication requires a rather delicate balance of a number of factors, including sliding speed, lubricating fluid viscosity, bearing roughness, clearance, and contact pressure^{19,20}. A

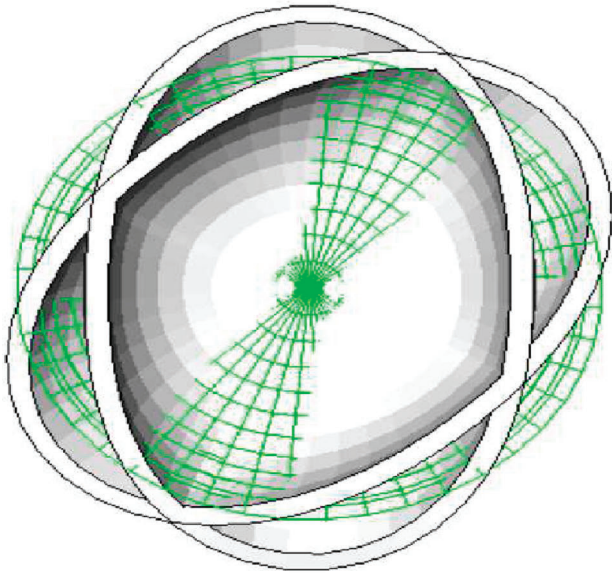
Fig. 7
Modal analysis of a thin-walled generic acetabular shell resonating in the (2,0) mode.

The acetabular shell as a separate piece resonated in an elliptical configuration known as the (2,0) mode, which is typical of wine glasses and bells (Fig. 7). The ceramic liner as a separate piece also resonated in the (2,0) mode but at a substantially higher frequency because of the material and geometric differences.

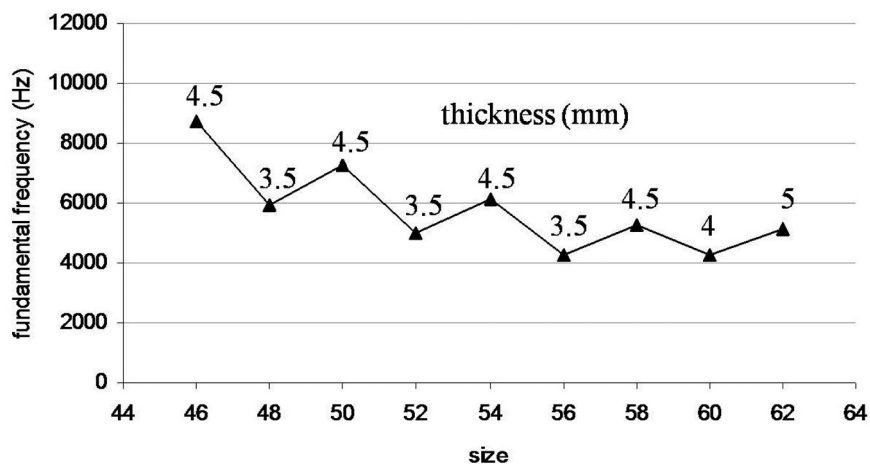
Fig. 8
Graph representing the frequency of titanium shells resonating in the (2,0) mode. This design of titanium shell is typical in that the external diameter of the shell (which corresponds to the size in millimeters) changes by 2 mm every size, but the internal diameter changes every second size. Therefore, the thickness alternately increases and decreases usually by 1 mm. This results in a saw-tooth pattern.

Audible resonance was detected in all of the titanium shells when they were tested unassembled. The fundamental frequency of the titanium shell ranged from 4300 Hz to 9800 Hz, with higher modes extending into the higher frequencies. The thinner and larger shells tested had the lower frequency. We found a saw-tooth pattern of frequency variation as a result of changing shell thickness with increasing size (Fig. 8).

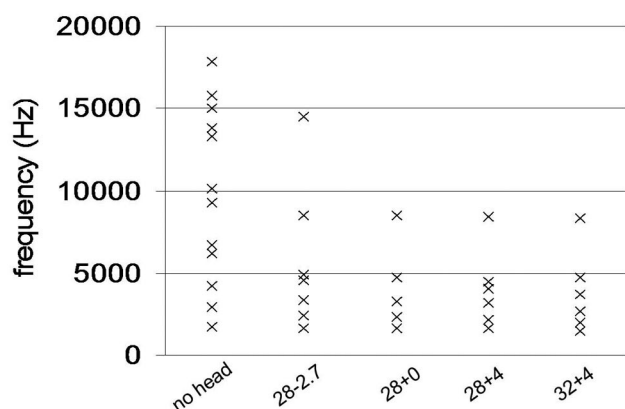
Fig. 9

Natural frequencies for this titanium stem are shown with and without a ceramic head attached. Attachment of the head makes very little difference to the frequency, although only the lower modes could be detected in some cases.

The titanium femoral components have a minimum frequency of approximately 1500 Hz and multiple natural frequencies in the human audible range between 2 kHz and 20 kHz (Fig. 9).

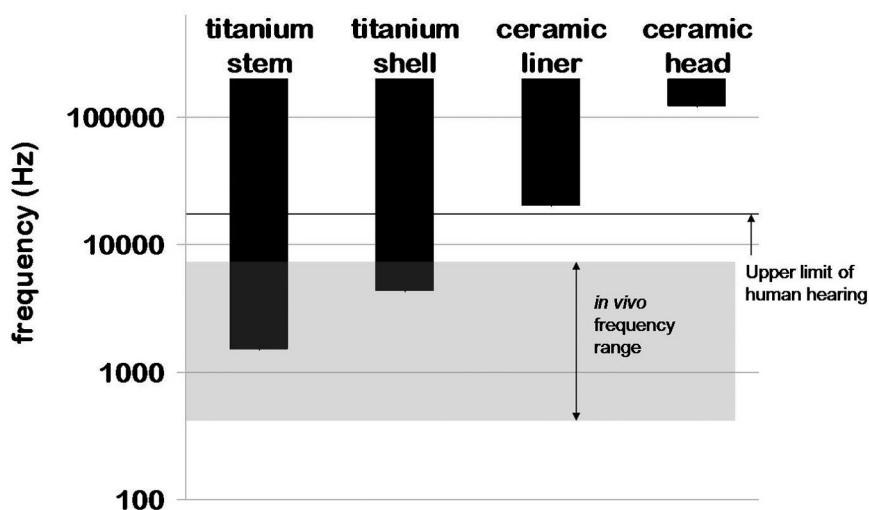
Fig. 10

Graph of the natural frequencies of total hip replacement components. These frequencies, which were recorded in air, are modulated *in vivo*. The damping effect of the viscoelastic tissues tends to lower the frequency.

In the case of ceramic-on-ceramic bearings, the natural frequency of the ceramic parts is ≥ 20 kHz, and therefore resonance of these parts is not likely to play a role in squeaking. The natural frequencies, however, of the titanium shells and metallic femoral components are much lower and more likely to be factors (Fig. 10).
