Laparoscopic Removal of an Intrauterine Device Following Colon Perforation

Arie Bitterman, MD, Oleg Lefel, MD, Yakir Segev, MD, MSc, Ofer Lavie, MD

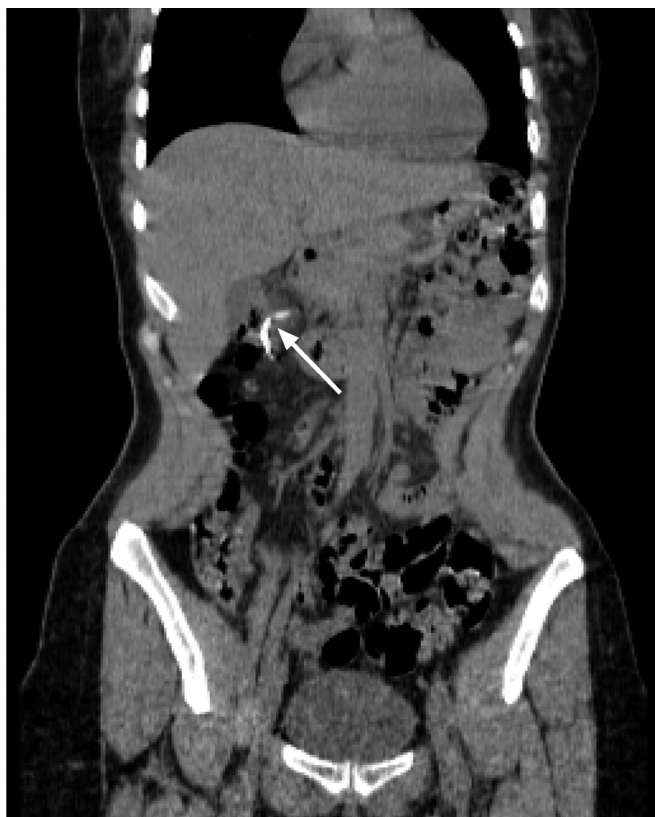
Figure 1. CT scan reveals the location of the IUD. A coronal section of the patient's abdominal CT scan. Note the hyperintense IUD-shaped object lodged within the colon just below the hepatic flexure (arrow).

Upon admission, she underwent a physical examination that detected no abnormalities, apart from light tenderness upon abdominal palpation of the RUQ. Vital signs were in the normal range. Her blood workup was normal with a white blood cell count=5180 (cells/ μ L) and neutrophils=3040(cells/ μ L). An abdominal roentgenogram was performed that demonstrated a metallic foreign body in the abdominal cavity. An abdominal computerized tomography (CT) scan revealed an IUD located posterior and medial to the hepatic flexure, with light fat blurring of the surrounding tissues (**Figure 1**). Colonoscopy revealed normal colonic mucosa.

We present a case of intestinal perforation by an IUD one year after its insertion. The device was located by using a colonoscopy and abdominal CT scan that showed it to be lodged within the large intestine, below the intestinal mucosa, under the hepatic flexure. The device was successfully removed by a laparoscopic approach.

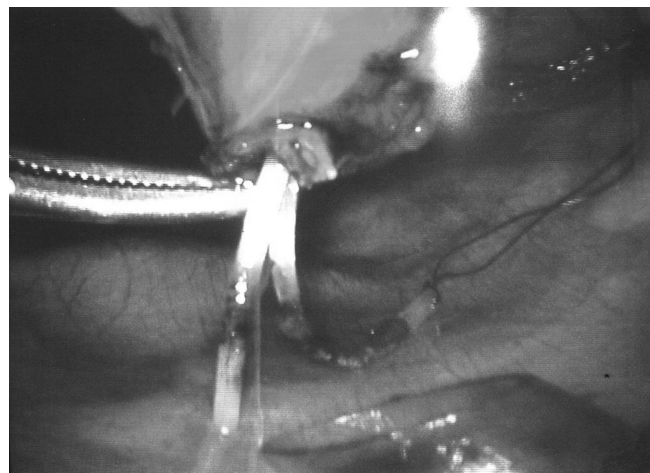
Figure 2. Laparoscopic removal of the IUD. The IUD was extracted from the colon through an incision made in the colon wall. Note that the IUD was removed intact including the attached strings.

created: a 10-mm diameter opening at the umbilicus, a 5-mm opening in the right lateral abdomen, and a 10-mm opening in the right middle abdomen area. During the operation, an IUD thread was noted in the mesocolon region of the hepatic flexure. Laparoscopic exploration revealed the IUD lodged in the colon serosa under the hepatic flexure (**Figure 2**). The IUD was excised, and the colonic defect was repaired using an EndoGIA. The operation was uneventful, and the patient made a full recovery. She was released 3 days after surgery.
