A Squeaky Reputation: The Problem May Be Design-dependent

Javad Parvizi MD, FRCS, Bahar Adeli BA,
Justin C. Wong MD, Camilo Restrepo MD,
Richard H. Rothman MD, PhD

Published online: 28 January 2011
© The Association of Bone and Joint Surgeons® 2011

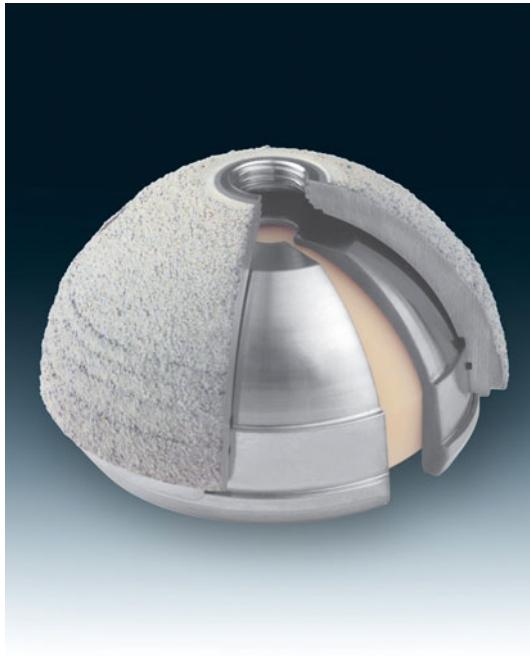
Fig. 1 Trident® Acetabular System from Stryker Orthopaedics (Mahwah, NJ) displaying the acetabular titanium-aluminum-vanadium (TAV) alloy shell, which accepts a ceramic liner that has a commercially pure titanium sleeve surrounding it.

We performed a retrospective review of 1507 patients (1756 hips) who underwent THA using COC bearings between January 2002 and December 2009. All COC bearings used were manufactured from alumina (Biolox Forte®; Ceramtec AG, Plochingen, Germany). We divided the patients into two cohorts based solely on whether the implant had or did not have an elevated rim from the

titanium metal sleeve surrounding the ceramic liner. Group 1 consisted of 1291 patients and 1508 hips who received a COC THA using the Stryker Orthopaedics-manufactured Trident® Acetabular System. Of this group, 506 were female (average age, 50 years; range, 17–80 years) and 785 were male (average age, 50 years; range, 15–76 years). Group 2 consisted of 216 patients with 248 hips who received COC THA using acetabular cup designs lacking a titanium metal sleeve and manufactured by Biomet (Warsaw, IN), DePuy (New Brunswick, NJ), or Stelkast (McMurray, PA). Of this group, 91 were female (average age, 50 years; range, 21–79 years) and 125 were male (average age, 49 years; range, 18–69 years). Minimum followup was 1.1 years (mean, 4.2 years; range, 0.1–8.07 years). No patients were lost to followup. No patients were recalled specifically for this study; all data were obtained from medical records and radiographs. We had prior Institutional Review Board.
