Femoral and obturator nerves palsy caused by pelvic cement extrusion after hip arthroplasty

Pawel Zwolak, Peer Eysel,
Joern William-Patrick Michael

Department of Orthopaedic and Trauma
Surgery, University of Cologne, Cologne,
Germany

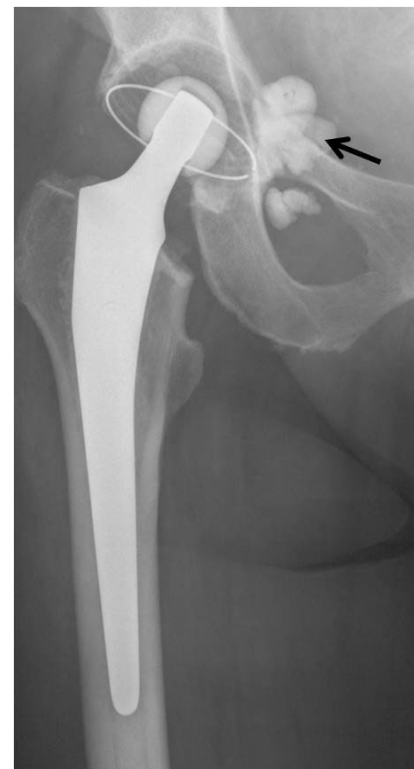
Figure 1. Postoperative anteroposterior X-ray demonstrates cement extrusion after total hip arthroplasty into the pelvis.

A 50-year-old female has been admitted to our department with weakness of the right psoas muscle and numbness of the medial aspect of the right thigh after a hip replacement surgery in October 2009. The patient had the surgery performed for degenerative joint disease. The surgeon used the standard anterolateral approach (Watson Jones). The acetabulum was packed with one mix (20 g) of Palacos cement and pressurized by hand then followed the insertion of the Pinnacle® Acetabular Cup (DePuy Orthopaedics). After Total hip arthroplasty (THA) she complained of the pain in the right groin and she had some problems to stabilize her hip during walking. The performed postoperative X-rays showed well-positioned components with cement mass extruding from right acetabulum into pelvis (Figure 1). The orthopedic surgeon decided to proceed with physical rehabilitation. Six month after surgery, the patient presented in our outpatient clinic for a follow-up. She complained of persistent pain in her right groin and weakness of the right hip flexors (Medical Research Council grade 3 out of 5) and adductor muscles (Medical Research Council 4 out of 5) with decreased sensation of the right medial thigh. Performed X-rays showed no evidence of implant loosening. Clinical examination showed atrophy of the quadriceps and adductor muscles. We performed the electromyography (EMG) which demonstrated decreased activity of the psoas major muscle and adductor muscle group. Nerve conduction velocity demonstrated decreased activity of the femoral and obturator nerves. The patient has been admitted to our department for surgical removal of the cement mass. Prior to surgery has been performed a CT-guided injection of the tissue around the cement mass with bupivacaine and triamcinolone. The diagnostic injection decreased immediately the patient's pain. This confirmed our primary suspicion that the cement was the source of the pain and atrophy of the flexor and adductor muscle groups. CT scans revealed atrophy of the adductor muscle and the cement mass lying in the superior aspect of the obturator foramen (Figure 2a and b). Three days after CT- injection we performed removal of the extruded

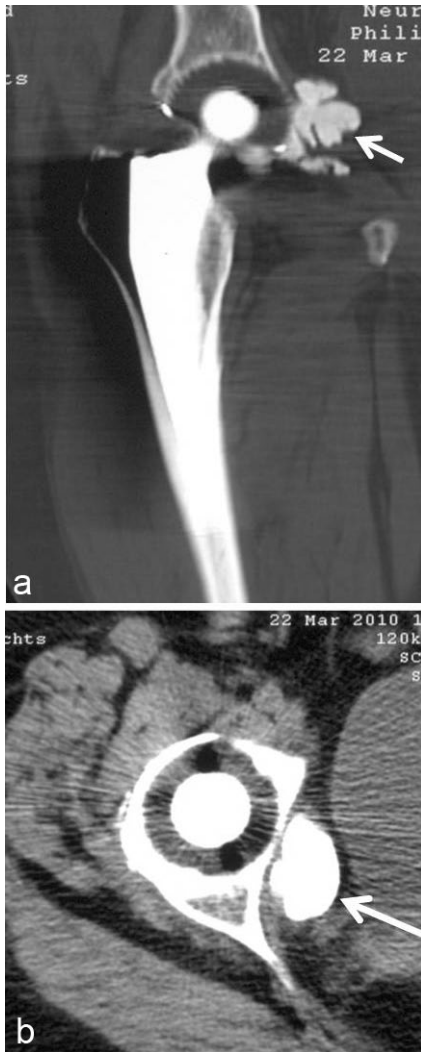
Figure 2. (a and b) Computed tomographic scans show the cement fragment in antero-inferior aspect of the right acetabulum.

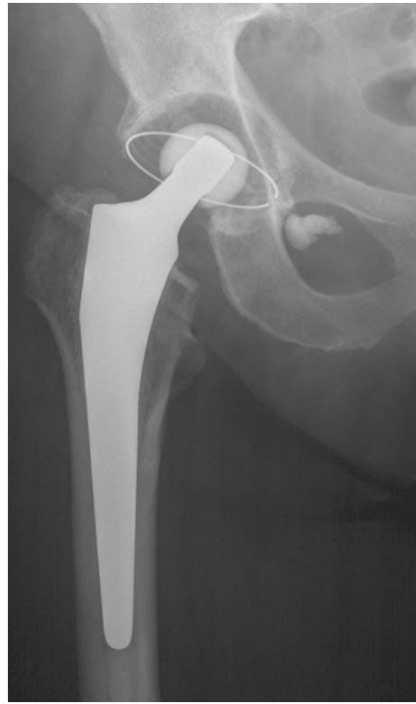
Figure 3. Postoperative X-ray taken after removal of the cement fragment.

cement mass using ilioinguinal approach. The cement mass has been removed with care from superior border of the obturator foramen (Figure 3). Postoperatively, patient's pain resolved completely. Moreover, 4 weeks after
