D. K. Sharma · Stuart Brooks

Long-term follow-up (11 years plus) results of JRI (Furlong) total hip arthroplasty in young patients: cause for concern regarding acetabular cup?

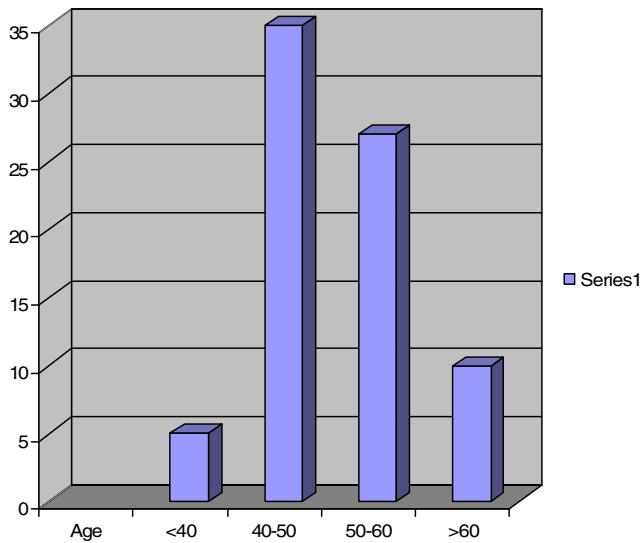
Fig. 1 Age distribution

Between March 1987 and February 1996, the JRI HA total hip replacement was implanted in 89 patients between the ages of 27 and 68 years (mean age 51; Fig. 1). Nearly 50% were less than 50 years old at the time of operation. Most

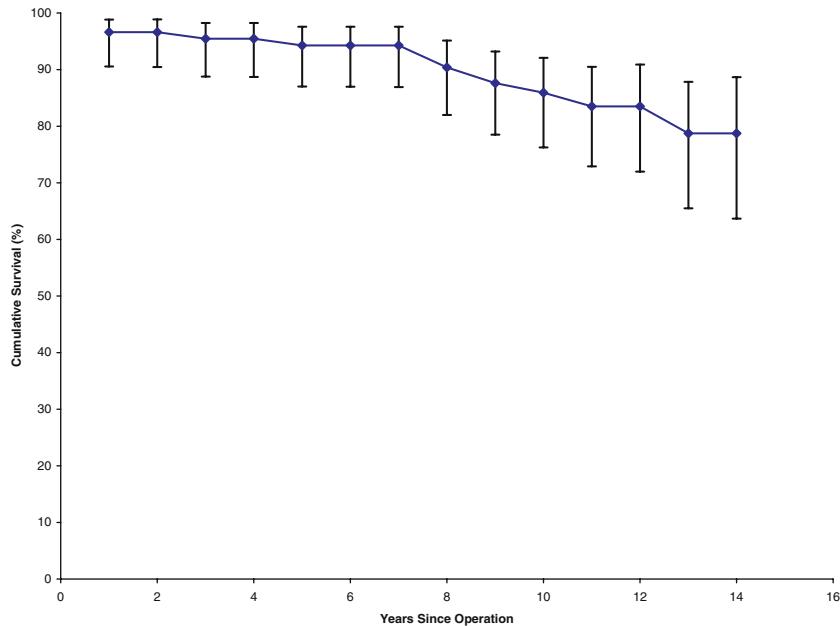
Fig. 2 Survival curve for both

was 2 months for recurrent dislocation following migration of the cup. The longest time to revision of the cup was 12 years. All of these cups were revised for aseptic loosening. We encountered no infection in our series. Out of the 17 revised cups, 16 were the threaded type and one was the CSF type. Furthermore, two cups showed evidence of aseptic loosening (osteolysis in ≥ 2 DeLee and Charnley zones) but had no symptoms; hence, we decided to keep them under observation until they become symptomatic, when to a Charnley cup is planned. Kaplan–Meier survivorship analysis revealed a cumulative survival of 77.8% for both components (Fig. 2), 78.7% for the acetabular cup (Table 1, Fig. 3), and 98.8% for the femoral stem (Fig. 4, Table 2).

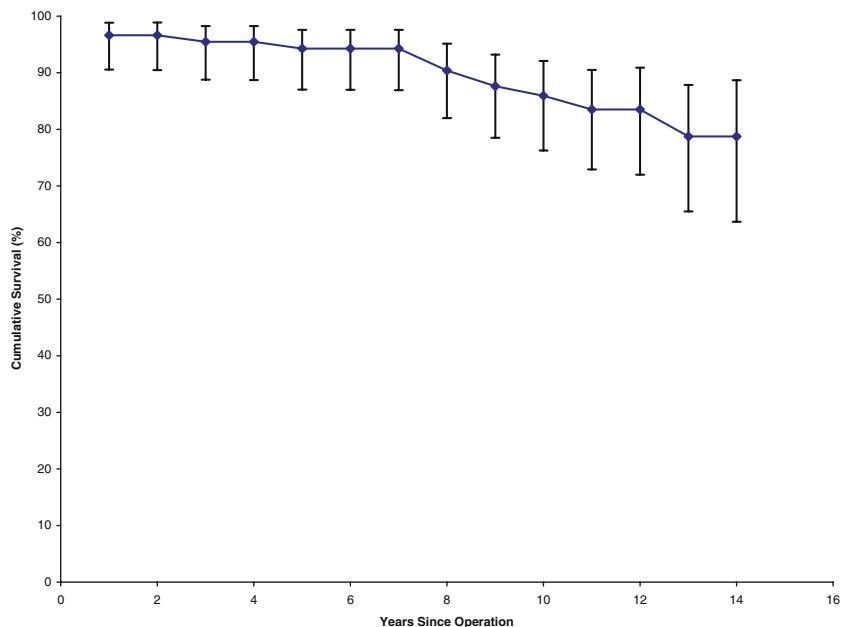
Fig. 3 Cup survival curve

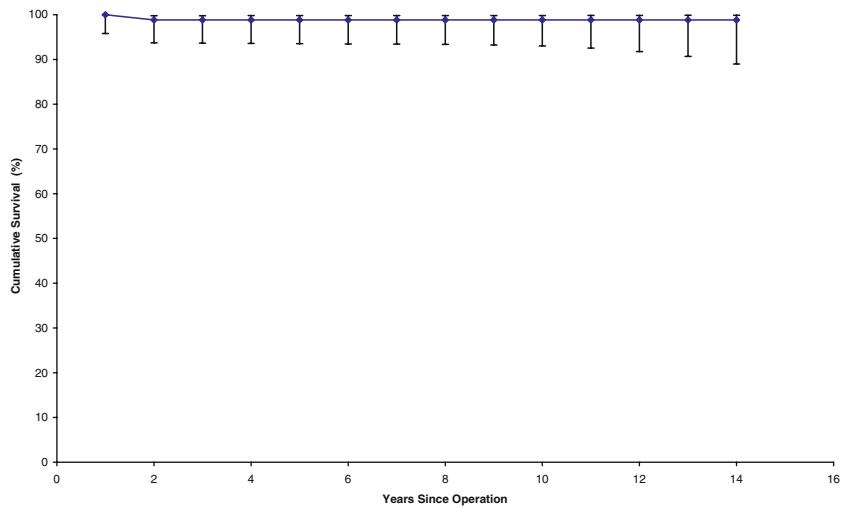
Fig. 4 Stem survival curve

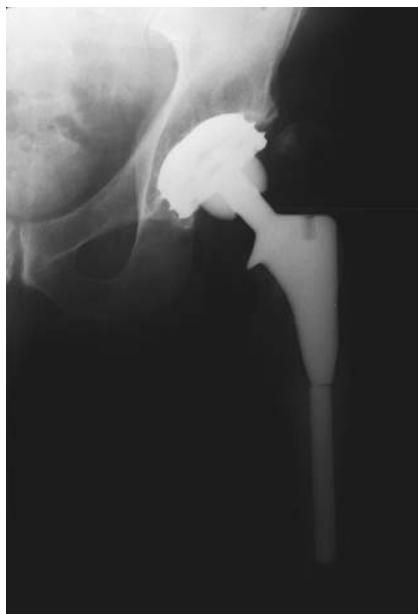
Fig. 5 Stem fracture

This study confirms the encouraging reports already in the literature of the high success rate for the femoral component of the JRI HA total hip replacement and of HA-coated femoral stems in general. The single failure in this series was a fractured femoral stem, which has already been reported in the literature [14] (Figs. 5, 6).

minimising the loss of endosteal bone. Donnelly et al. [4] have proposed that HA generates spot-welding of bone to the prosthesis and that this layer in turn may impede the access of polyethylene debris to the interface. The only case revised in our series was because of metal stem fatigue fracture [14]. This is a rare complication, and if we exclude this case, the survival of femoral stems would be 100%. There was no aseptic loosening or periprosthetic fracture observed in our series, and there was no impending or potential loose stem in the radiographs. Our results are comparable to those reported by McNally et al. [11], which showed a survival rate of 99% for the femoral stem of the same prosthesis.

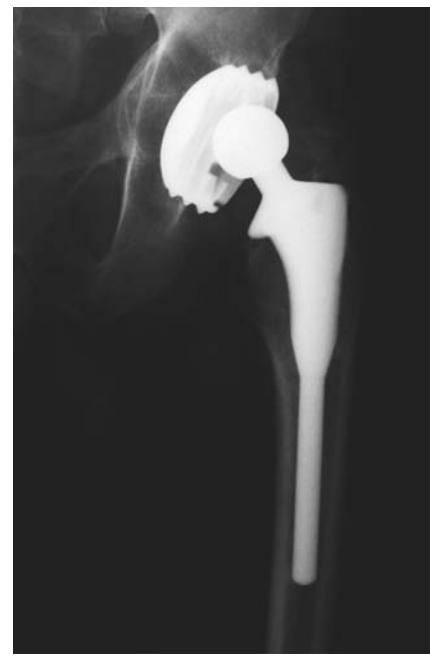
Fig. 7 Cup showing appearance of polyethylene wear

The other question we asked in our study concerned the role of polyethylene wear. Although the radiological appearance was suggestive of polyethylene wear (Fig. 7), the retrieved cups (Figs. 8, 9) did not support this. The typical appearance was complete delamination of the HA coating with a fairly well-preserved polyethylene lining.

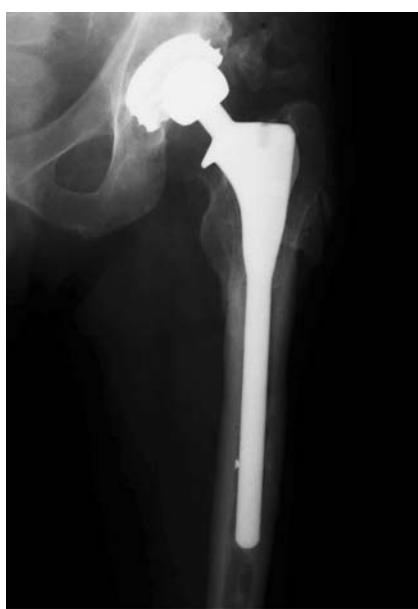
Fig. 6 Stem revision

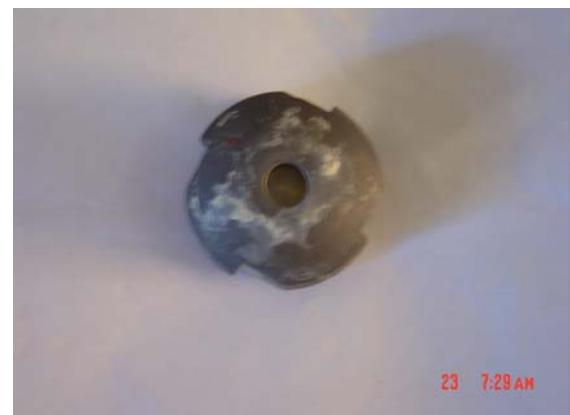
Fig. 8 Cup showing complete delamination
