Spontaneous fracture of indwelling polyurethane ureteral stents: A case series and review of literature

Michael E. Chua, MD; Marcelino L. Morales Jr, MD

St. Luke's Medical Center, Institute of Urology, Quezon City, Philippines

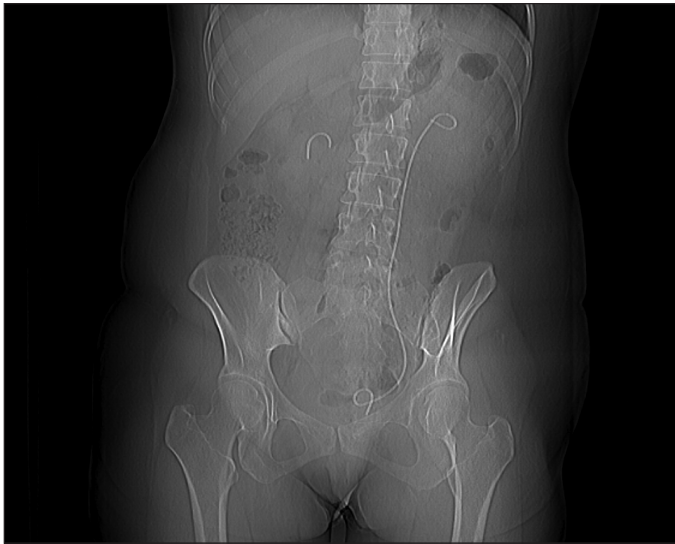
Fig. 1. Computed tomography scout film showing a fragment of stent left at the right renal pelvis and an indwelling left ureteral stent.

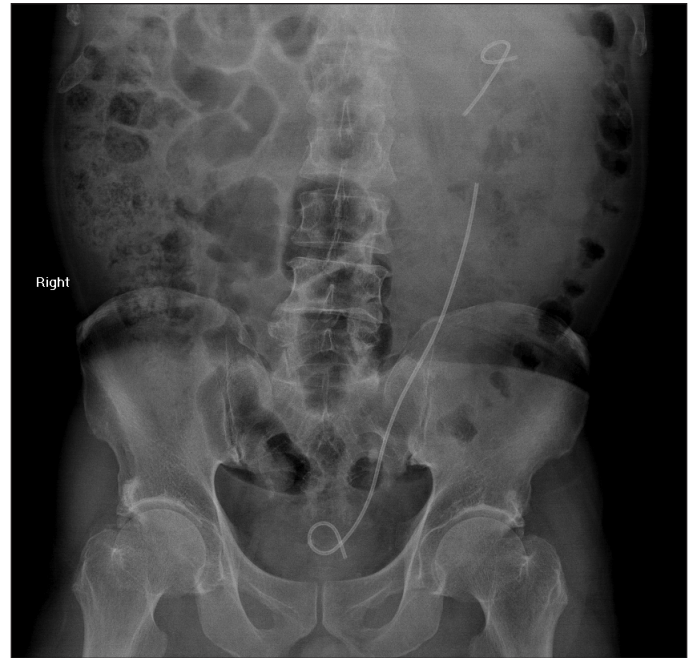
Fig. 3. Kidney, ureter, bladder x-ray showed a fragmented left ureteral stent, with the point of fracture at the proximal renal end.

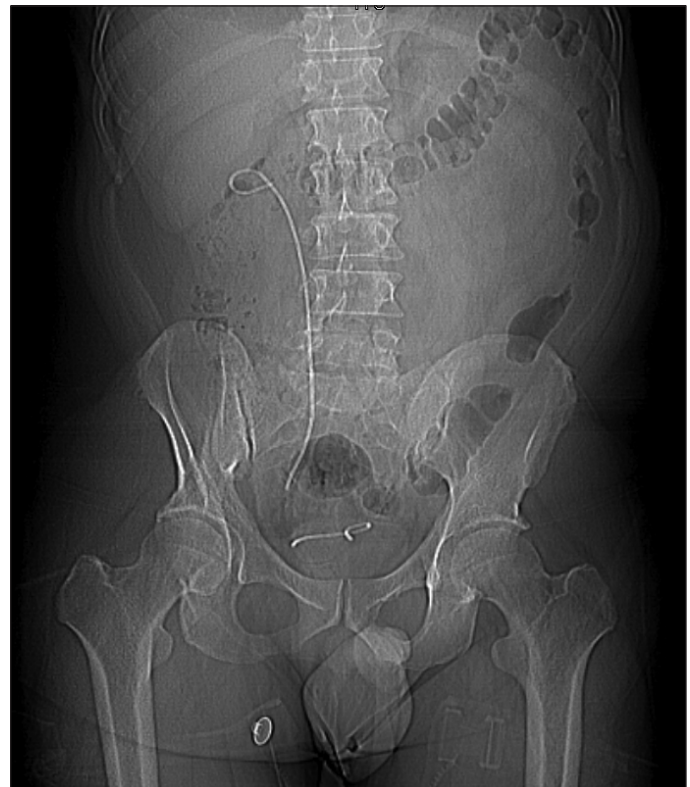
Fig. 4. Computed tomography scout film showing a fragmented ureteral stent point of fracture at the distal bladder end.

On this consult, physical examination revealed mild right costovertebral angle tenderness; other systemic examinations were unremarkable. Routine biochemical parameters were normal: urinalysis revealed proteinuria (30 mg/dL), leukocyte esterase positive (+2); hematuria RBC (60-80/hpf), pyuria WBC (60-80/hpf) and bacteruria (300/hpf). Urine culture revealed *Escherichia Coli* about 50 000 cfu/mL. A CT stonogram revealed a fragmented right ureteral stent, point of fracture at the distal bladder end (Fig. 4, Fig. 5, Fig.

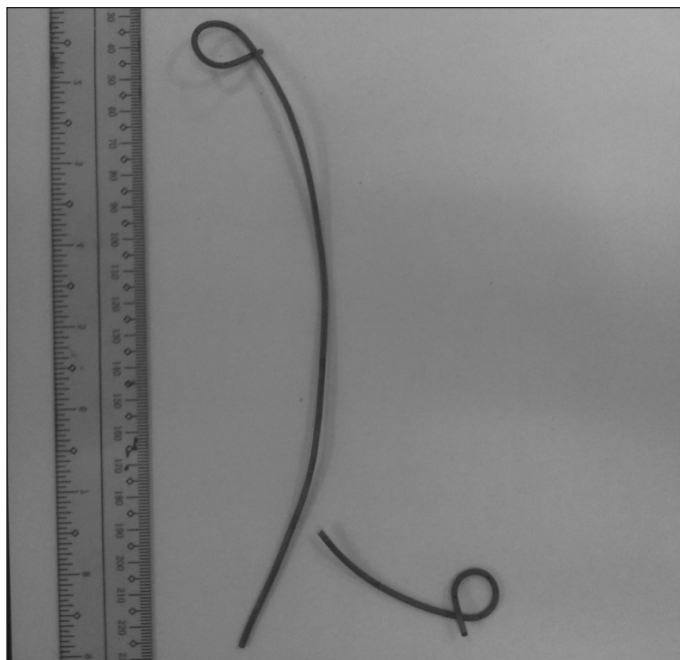
Fig. 5. Actual retrieved fracture stent.

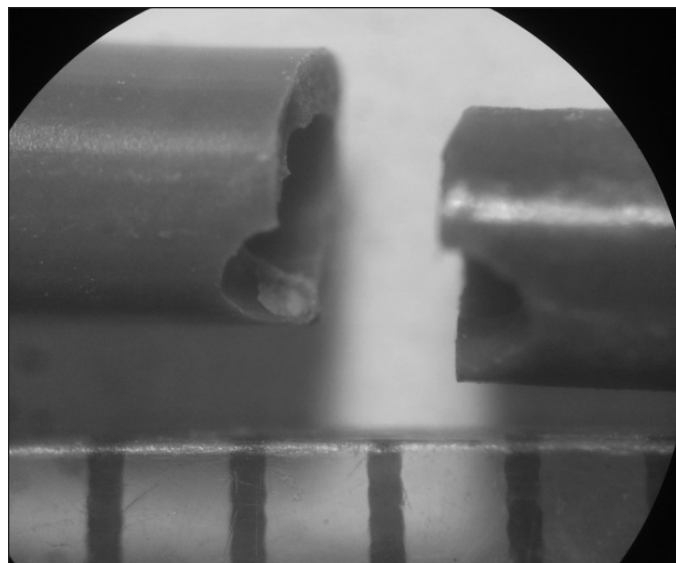
Fig. 6. Microscopic imaging of the stent fragment (magnification ×500) showing line of breakage traversing the polyurethane ureteral stent side hole near the distal bladder end.

frequent as silicone and other biomaterial stents. Fracture of the polyurethane stents may also be caused by repeated mechanical stress, especially along the side holes.²⁴ It has been reported that most fracture points were also along the drainage holes; therefore, the incidence of ureteral stent fracture can be decreased by eliminating these holes.²⁰ In our cases, most fractures were at the proximal renal end and, on the microscopic finding of the retrieved stents, the breakage line traverses the ureteral stent side holes. Upon preoperative radiological workup of our patients, we found that most of the inserted polyurethane ureteral stents lengths were longer than appropriate; this may have led to an increase in mechanical stress to the stent.

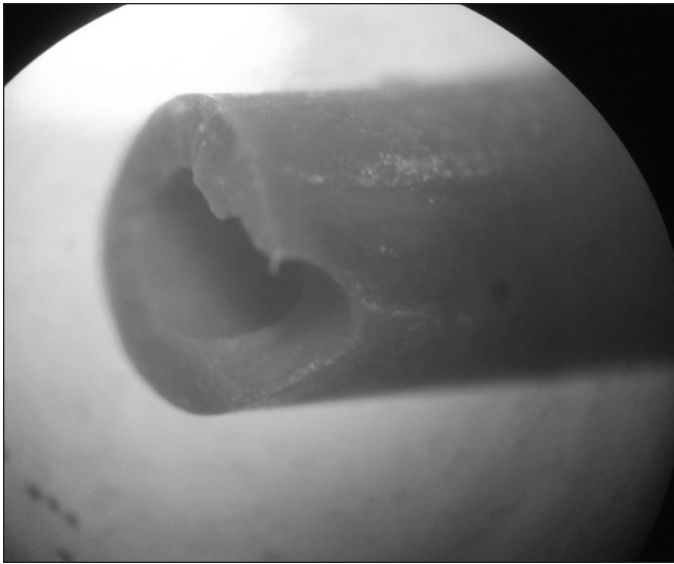
Fig. 7. Second image: microscopic imaging of the stent fragment (magnification $\times 500$) showing line of breakage traversing the polyurethane ureteral stent side hole near the distal bladder end.

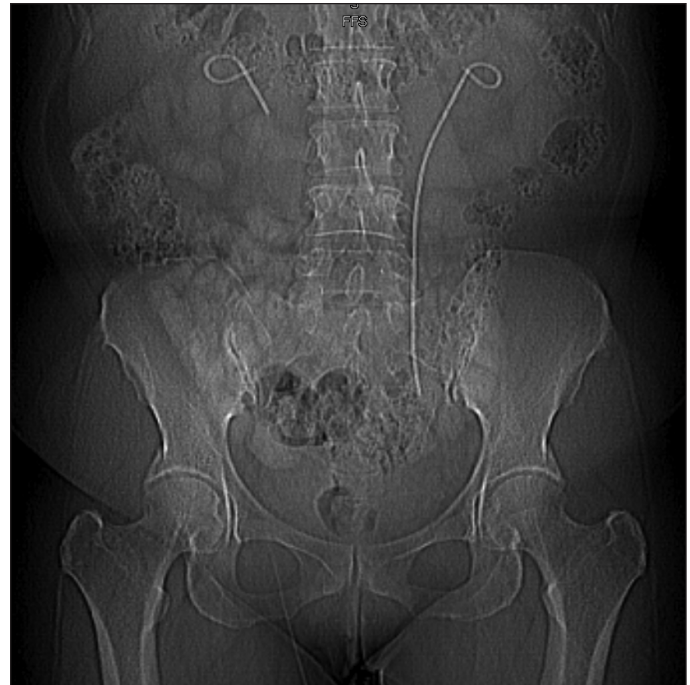
Fig. 8. Computed tomography scout film showing bilateral fractured stent; a piece of retained right ureteral stent on the right pelvis and a retained segment of left ureteral stent with a missing bladder end.

on the right kidney, while dilated pelvocalyceal system on the left. She was admitted and treated with culture-guided IV antibiotics. The left retained J stent was removed using Fr 7 ureteroscope and ureteral foreign body grasper. The ureteroscope was not able to advance through middle segment of the right ureter due to extrinsic compression of the retroperitoneal mass. The patient underwent endonephroscopy percutaneous retrieval of stent fragment. A superior pole renal access was done under fluoroscopy using a 2-stick technique; a Nephromax balloon dilator was used to dilate the fascia prior to placement of the access sheath. Fr 24 nephroscope was inserted and the retained stent fragment was retrieved under direct visualization. She was retained with a draining nephrostomy tube postoperatively (Table 1) (Fig. 8). She recovered well and was discharged on POD 8.

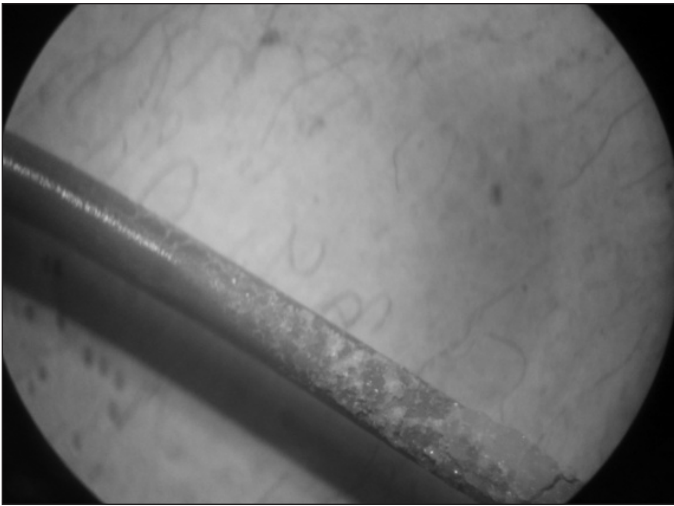
Fig. 9. Removed polyurethane ureteral stent fragments were noted moderately encrusted and breakage lines are noted along the stent side hole.

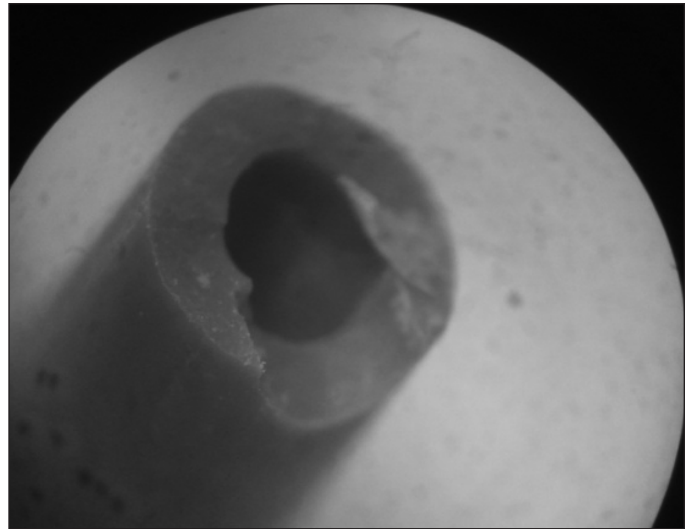
Fig. 10. Second image: Removed polyurethane ureteral stent fragments were noted moderately encrusted and breakage lines are noted along the stent side hole.
