## CASE REPORT

## Catastrophic failure of ceramic-on-ceramic total hip arthroplasty presenting as squeaking hip

David Malem, Mathias Thomas Nagy, Sabyasachi Ghosh, Bhavik Shah

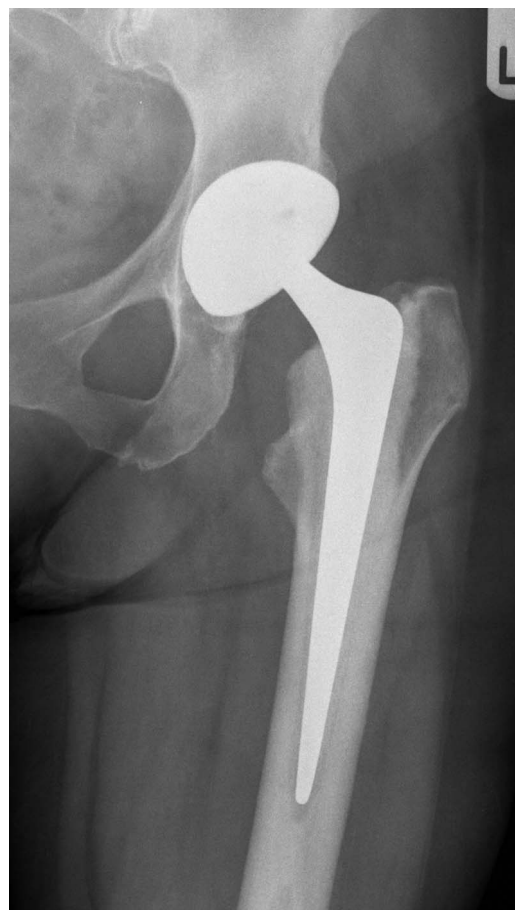
**Figure 1** A 68-year-old woman who had left total hip arthroplasty. Initial postoperative radiograph shows satisfactory position of the femoral stem, head and acetabular shell and liner.

A 68-year-old woman with primary osteoarthritis had a ceramic-on-ceramic left total hip arthroplasty, including ceramic femoral head and acetabular cup liner (Exeter total hip system (femoral component) and ABG (acetabular component), Stryker, Kalamazoo, USA) (figure 1). She had good postoperative recovery with physiotherapy and occupational therapy, and she had no postoperative trauma or dislocation.

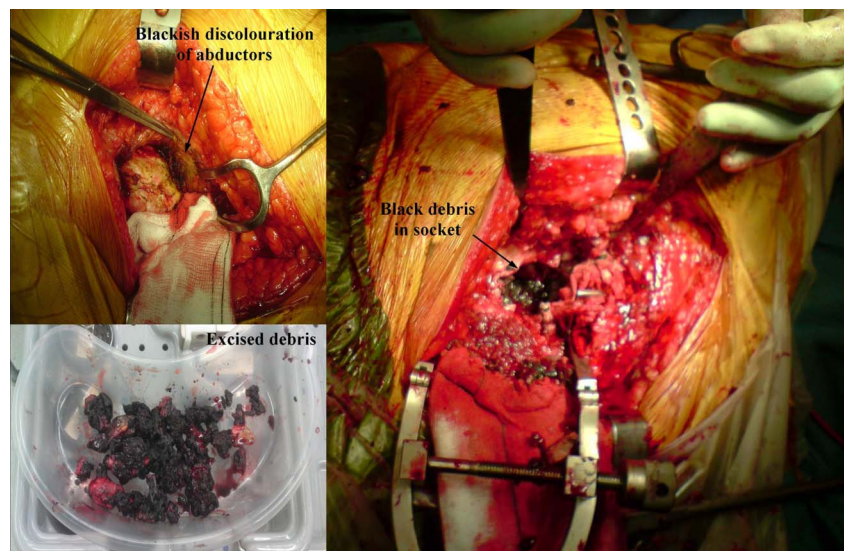
**Figure 3** Intraoperative image showed black discoloration and debris in the adductor muscles and acetabulum (arrows).

At revision surgery using a Hardinge approach, black discoloration and debris were noted in the adductor muscles and acetabulum (figure 3). The femoral prosthetic stem was intact and was not revised. The broken prosthetic ceramic femoral head was replaced with a metal head, and the acetabulum was revised with a metal acetabular component with a polyethylene insert (Orthodynamics, SERF, Bourton, UK). The postoperative radiograph showed satisfactory position of the implant (figure 4). Analysis of the removed acetabular component showed marked wear of the ceramic cup. The mean hole diameter was 29 mm and shell thickness was 5.5 mm, consistent with 3600 mm<sup>3</sup> wear (equivalent to 10 mm<sup>3</sup>/day for 1 year) (figure 5). Retrieval analysis and wear calculations were conducted by Dr Amir Kamali (The Implant Development Centre, Leamington Spa, UK).

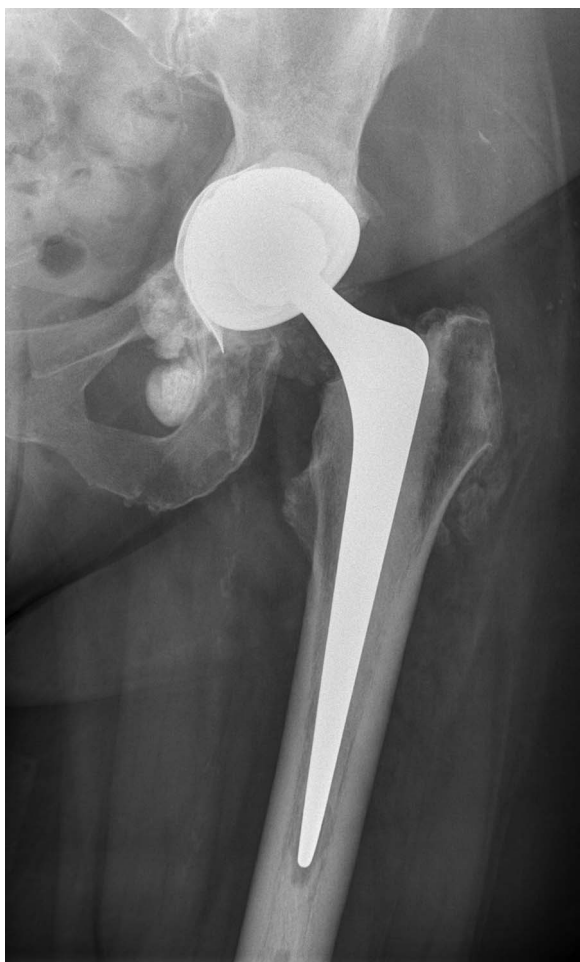
**Figure 4** Postoperative radiograph following revision of the acetabular component showed satisfactory position of the implant.

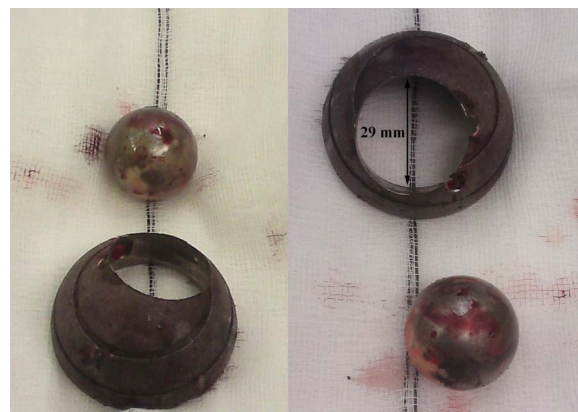
**Figure 5** The ceramic femoral head and acetabular shell removed at revision surgery. The femoral head was broken, and the acetabular cup had complete wear.

This patient had catastrophic failure of a total hip prosthesis from complete wear of the ceramic-on-ceramic components. The average annual wear rate for squeaking hips is 2.9 mm<sup>3</sup> for the femoral head and 3.4 mm<sup>3</sup> for the acetabular liner, and the average annual wear rate for ceramic-on-ceramic bearings is 0.1 mm<sup>3</sup> for the femoral head and 0.04 mm<sup>3</sup> for the acetabular liner.<sup>2</sup> However, the wear in the present patient after 5 years was much greater, equivalent to 720 mm<sup>3</sup> wear per year for the acetabular component.

Squeaking usually begins between 6 and 26 months after surgery, and the present case is unusual because squeaking did not occur until 5 years after surgery.<sup>2</sup> An uncoupled shell may resonate at audible frequencies heard in squeaky prosthetic hips in vivo.<sup>14</sup> Therefore, it is likely that that squeaking began in the present patient after the ceramic liner had fully eroded, causing uncoupling at the liner-shell interface.
