Cementless cup fixation in total hip arthroplasty after 5–8 years

Abstract A series of 199 total hip arthroplasties was performed using a porous-coated, hemispherical press-fit acetabular cup. At a mean follow-up of 91.5 months 158 cups were available for clinical and radiological review. The mean age of the patients at the time of the index arthroplasty was 62.5 years. The mean Harris Hip score at final follow-up was 87.3. No shells were revised although eccentric polyethylene wear prompted liner replacement in two cases. Osteolysis was noted in six cases but predominantly in relation to the femoral stem. Focal pelvic osteolytic lesions were rare. All the cups were classified as stable on radiography.

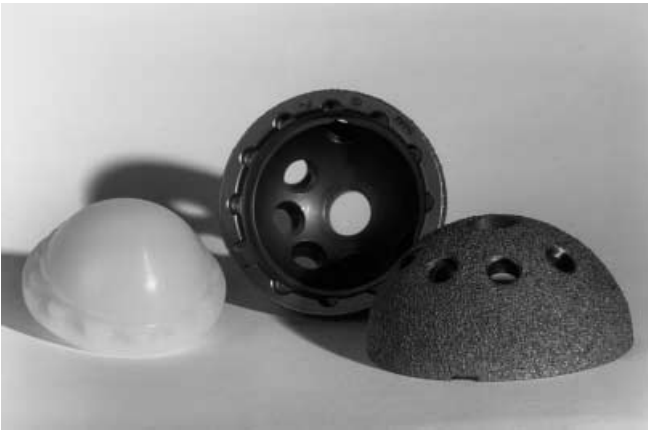
Fig. 1 The Osteolock acetabular cup

The Osteolock acetabular component (Stryker, Howmedica, Osteonics Inc, Rutherford, N.J., USA) was used in all patients (Fig. 1). This is a porous-coated, hemispherical press-fit acetabular shell. The shell and screws are manufactured from titanium-6-aluminium-4-vanadium (Ti6Al4V) alloy. The shell coating is CP titanium plasma spray. The implant's ultra-high molecular weight polyethylene (UHMWPE) liner was produced by a ram extrusion process, machined and sterilised in air (3 Mrad). Stability is achieved by a snap-lock mechanism into the shell.

Any modular connection can generate debris. Recent concern centers on the debris formed at the interface between the liner and shell (backsurface wear). Such wear is a function of the locking mechanism, the amount of micromotion present, and the surface finish of the interface [24]. The design of the Osteolock snap-lock liner into the Ti-alloy shell provides both dome and circumferential rim contact along 12 semi-spherical marginal scallops (Fig. 1). The addition of a peripheral locking mechanism is purported by the manufacturers to mini-

mize such back surface wear by minimizing motion between the surfaces of liner and shell.

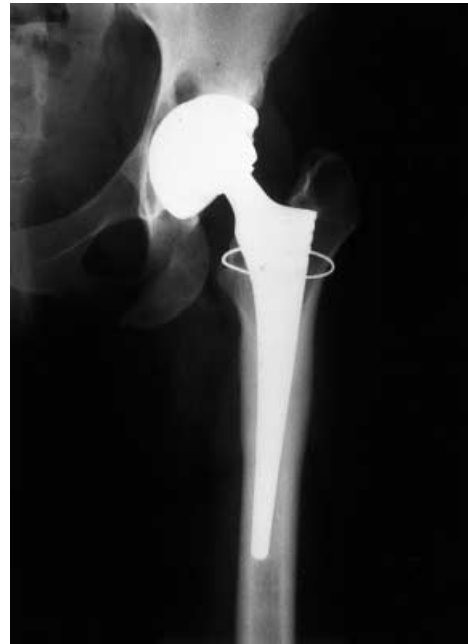
Fig. 2 Focal pelvic osteolysis and polyethylene wear noted at 7 years post-implantation

The mean preoperative HHS was 47.2 (range 3–76). At latest follow-up, the mean HHS reported was 87.3 (range 37–100). No significant difference in scores was noted for variables such as sex, age or preoperative diagnosis. No infections were identified. Although an undisplaced fracture (Fig. 2) occurred during insertion of an HA-coated femoral component (managed with prophylactic cerclage wiring) no other major perioperative complica-

In 2 cases, painful, eccentric wear of the UHMWPE liner prompted liner exchange. In the first revision eccentric liner wear was noted in a 61-year-old male with a 54 mm cup at 7 years. Minor non-progressive focal osteolysis was identified around the femoral component in zones 1 and 7 and in DeLee zone 2 around the acetabular shell. Both the femoral and acetabular components were solidly fixed and therefore not revised. The other case, a 31-year-old female with a 52 mm cup, required liner exchange for wear that was also identified at 7-year follow-up (Fig. 2). Non-progressive focal osteolysis was also evident in DeLee zone 2, but again both components were stable at surgery and therefore not revised. Retrieved liners in both cases showed eccentric wear and cold flow at the bearing surface, but no demonstrable back-surface wear.

Focal pelvic osteolytic lesions were only seen in these two cases showing gross polyethylene wear. No acetabular shells were revised for loosening or migration during the study period.
