Donald R. Gore

Impaction bone grafting for total hip revision

Accepted: 9 January 2002 / Published online: 6 April 2002
© Springer-Verlag 2002

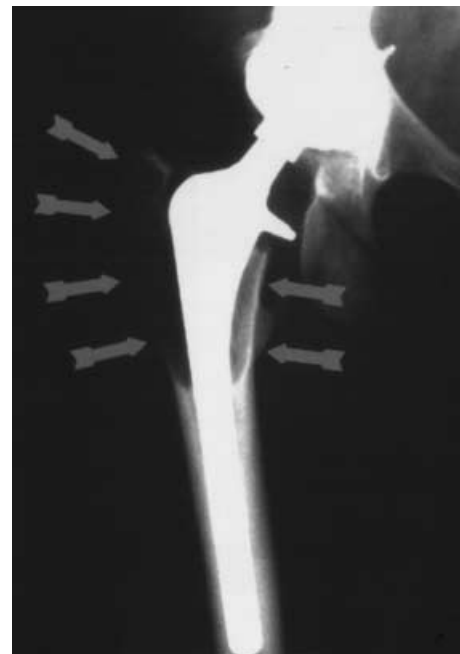
Fig. 1 A 34-year-old woman 7 years after a cementless total hip replacement for avascular necrosis. *Arrows* point to areas of extensive bone loss of the entire proximal femur

Our interest in impaction bone grafting was stimulated by the presentation of a 34-year-old woman who received a cementless total hip replacement 7 years previously for avascular necrosis caused by high doses of immunosuppressive drugs that were required for a kidney transplant. She had done well for 6 years when she began having pain. Her roentgenograms showed good distal fixation of the femoral stem but extensive proximal bone loss (Fig. 1). We did not believe this problem could be satisfactorily managed with a standard cemented or noncemented revision prosthesis. Therefore, impaction bone grafting, along with a collarless, polished, tapered stem

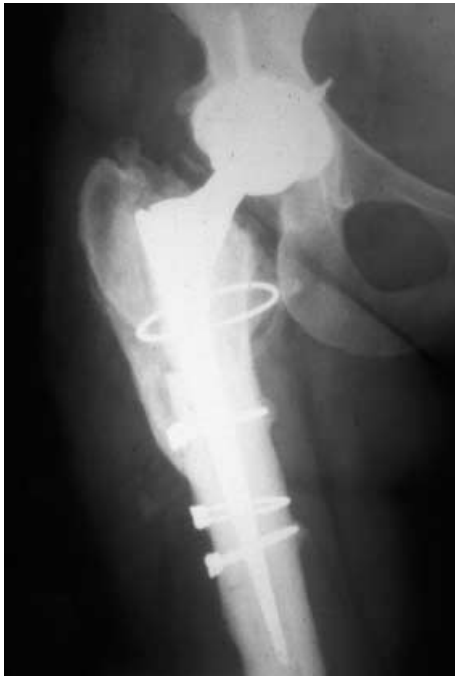
Fig. 2 The same woman 6 years after revision surgery

was used. The successful final result 6 years after surgery is shown in Fig. 2.

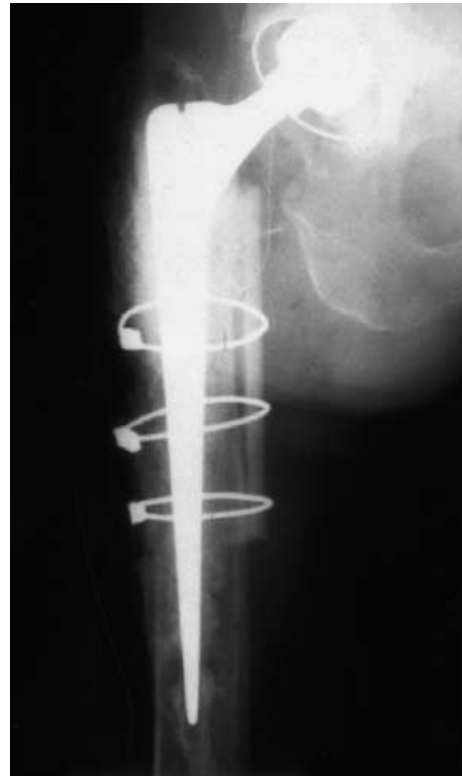
Fig. 4 An immediate postoperative roentgenogram of a patient who had medial bone loss. This was corrected with a strut bone graft held by cerclage cables

Varus placement of the stem is a technical error that can be prevented by proper placement of the distal plug and guidewire. In addition, the trial tamp must be inserted in slight valgus and secured by initially packing the allograft bone on the medial side of the femur. Postoperative development of varus, in our one case, was the result of failure to provide adequate medial support. If this cannot be accomplished with tight packing of morselized bone because of a deficiency of bone in the calcar, then a strut graft should be used for reinforcement (Fig. 4).
