Do Ceramic Femoral Heads Reduce Taper Fretting Corrosion in Hip Arthroplasty? A Retrieval Study

Abstract

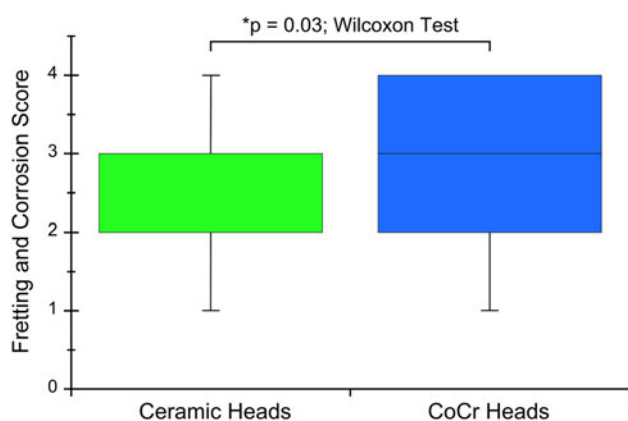
Fig. 1 The femoral stem taper fretting and corrosion damage scores for the matched ceramic and CoCr head cohorts are shown. The damage scores were significantly lower for the ceramic cohort ($p = 0.03$).

Fretting and corrosion scores were lower for the stems in the ceramic-metal when compared with the metal-metal taper cohort ($p = 0.03$; Fig. 1). Evidence of fretting and corrosion, consistent with a score of 2 or greater, was observed in 42 of 50 (84%) stems in the ceramic-metal and 42 of 50 (84%) stems in the metal-metal taper cohort. The median damage score for the stems in the ceramic-metal taper cohort was 2 (Figs. 1, 2), whereas for stems in the metal-metal taper cohort, the median score was 3 (Figs. 1, 3). We observed dark corrosion deposits outside the head-neck taper junctions in three of 50 (6%) of the metal-metal taper cohort and zero of 50 (0%) of the ceramic-metal taper cohort.

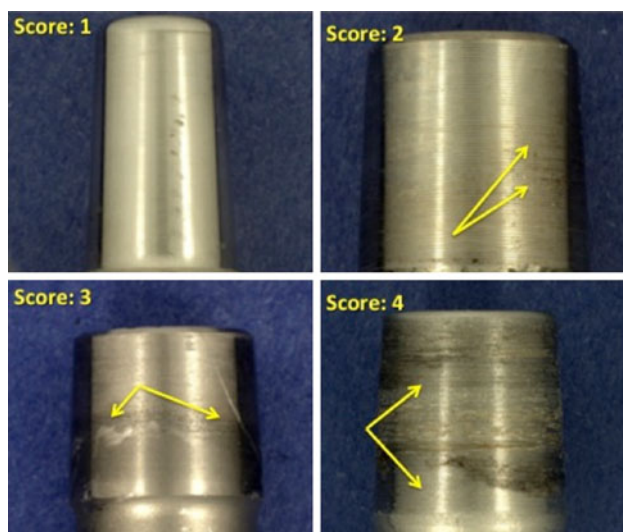
Fig. 2 Some examples of stem taper fretting and corrosion scores for the ceramic head cohort are shown. The median score for this cohort was 2.

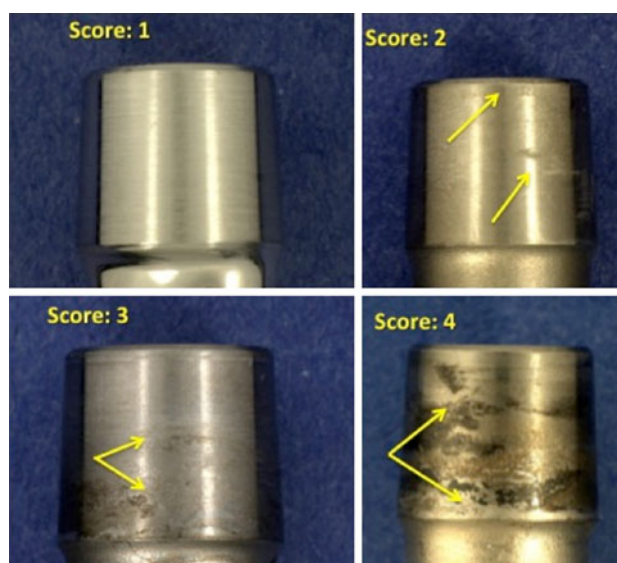
Fig. 3 Examples of stem taper fretting and corrosion scores for the CoCr head cohort are shown. The median score for this cohort was 3.

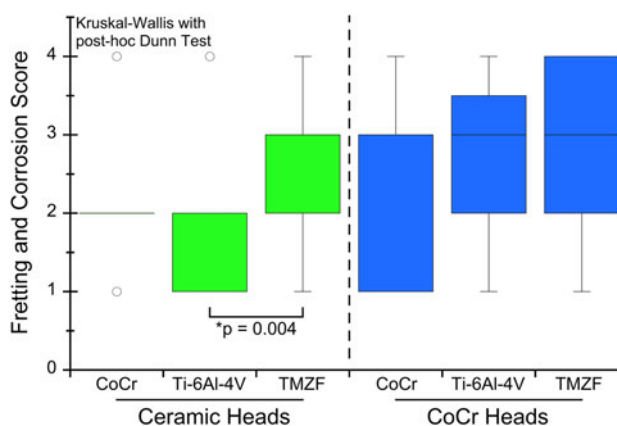
Fig. 4 A boxplot illustrating femoral stem taper fretting and corrosion score versus stem alloy for the ceramic and metal head cohorts is presented.

Both stem alloy ($p = 0.004$; Kruskal-Wallis test with post hoc Dunn Test; Fig. 4) and decreased stem flexural rigidity (Spearman's $\rho = -0.35$, $p = 0.01$) were predictors of stem fretting and corrosion damage for the ceramic-metal

taper cohort however, these variables did not have an effect for the metal-metal taper cohort (Fig. 4). Stem corrosion for the ceramic-metal taper cohort was not significantly affected by implantation time ($p = 0.46$), lateral offset ($p = 0.35$), head size ($p = 0.26$), type of ceramic bearing ($p = 0.82$), or the ceramic material formulation ($p = 0.93$). However, these tests were generally underpowered (power < 25%). The only variable in this study that was a significant predictor of the metal transfer score inside the ceramic heads was decreased flexural rigidity (Spearman's $\rho = -0.35$, $p = 0.01$). For the metal head cohort, none of the patient or device variables in this study was a significant predictor of the stem corrosion for the metal-metal taper cohort. Patient weight was positively correlated with stem fretting and corrosion scores in the

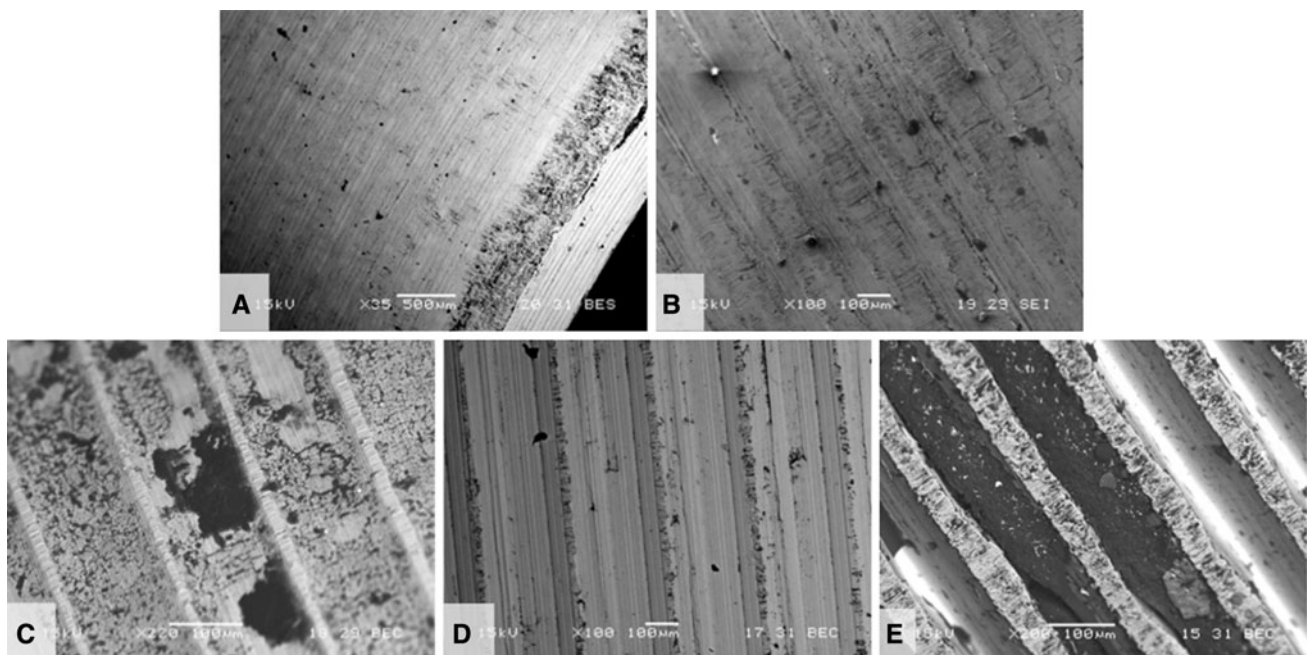
Fig. 5A–E SEMs of five different design and materials for the male taper of ceramic-metal trunnions. (A) TMZF (Stryker Orthopaedics, Mahwah, NJ, USA) \times 35 BEC, (B) Ti-6Al-4V (Zimmer, Inc, Warsaw, IN, USA) \times 100 SEI, (C) Ti-6Al-4V (Wright Medical Technology, Inc, Arlington, TN, USA) \times 220 BEC, (D) Co-Cr-Mo (DePuy Orthopaedics, Inc, Warsaw, IN, USA) \times 100 BEC,

(E) Co-Ni-Cr-Mo (Zimmer) \times 100 BEC. SEI = secondary electron imaging; BEC = backscattered electron contrast image. A is a ground surface, whereas B–E have machining grooves present. Also shown are fretting scars and corrosion and biological debris present. For grooved implants, only the groove tips show evidence of fretting corrosion damage.

showed damage on each implant that was reflective of the type of metallic surface topography present. Interestingly, the surface topography for tapers was highly variable based on alloy (Co-based or Ti-based) and manufacturer. The taper surfaces were either finely machined (TMZF; Fig. 5A) or with machined grooves present (both Ti-6Al-4V, Fig. 5B–C, and CoCr, Fig. 5D–E). The geometry of the grooves varied with design in terms of grooves per length and groove depth. For example, in Figures 5D and 5E, both implants are Co-Cr-Mo based, but Figure 5E shows tightly spaced grooves approximately 150 μm apart and roughly 60 to 100 μm deep, whereas in Figure 5D, the grooves are approximately 500 μm apart and 50 μm deep. The fretting corrosion damage seen in these tapers is intermittently distributed over the tapers and where grooves are present occur only at the top of the groove. With deep grooves, debris can accumulate (Fig. 5E) adjacent to the fretting damage. For the device in Figure 5A, the majority of fretting corrosion damage is seen in the proximal taper region (lower right of micrograph) indicating rim loading. Evidence of fretting damage and corrosion debris (dark regions) was observed on titanium alloy surfaces (Fig. 6A–B). Different types of machining grooves on cobalt alloy surfaces (Fig. 6C–D) exhibited different appearances. In one case (Fig. 6C), the damage seen has a distinct (solely) corrosion-based appearance, whereas another case (Fig. 6D) showed evidence of both fretting and corrosion damage.

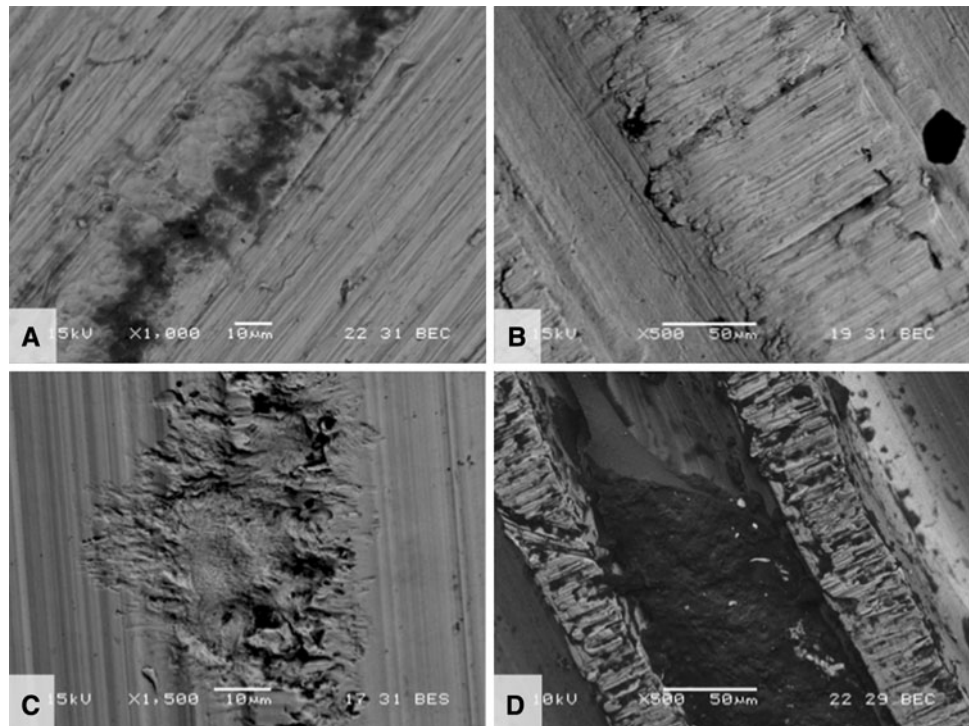
Fig. 6A–D Backscattered electron micrographs of (A) TMZF, (B) Ti-6Al-4V, (C) Co-Cr-Mo, and (D) CoNiCrMo alloy tapers used in conjunction with ceramic femoral heads. Each image shows fretting damage and some corrosion debris present. In C, the damage has a distinctly corrosion-like appearance emanating from a machining ridge.
