International Journal of Surgery Case Reports

Sciatic nerve compression by an extrapelvic cyst secondary to wear debris after a cementless total hip arthroplasty: A case report and literature review[☆]

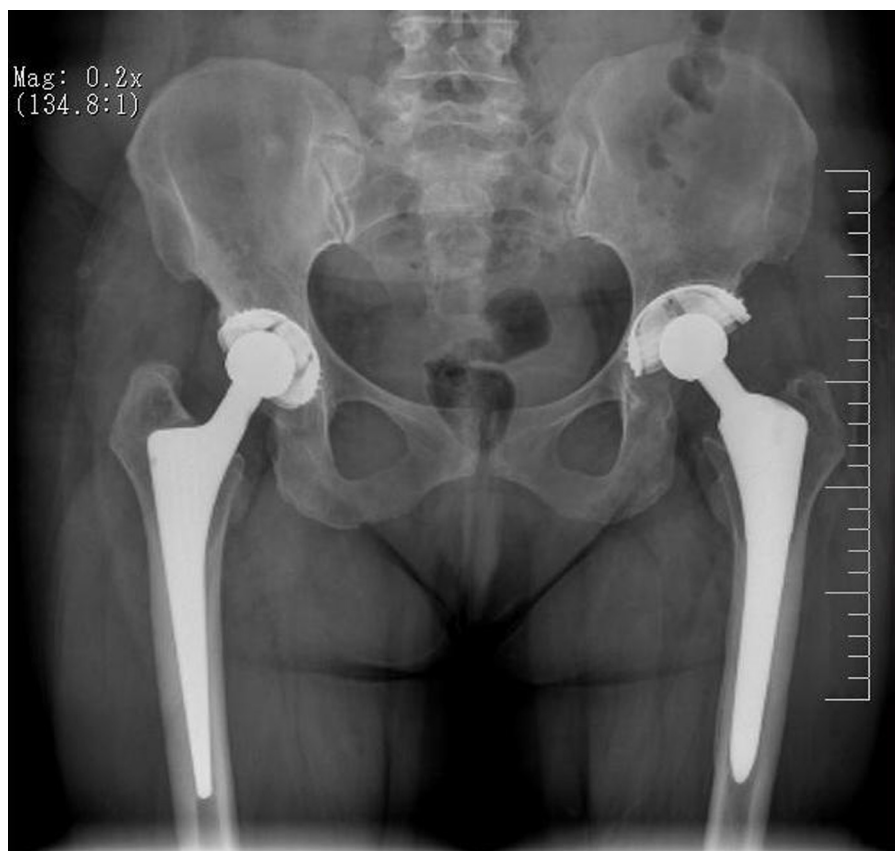
Fig. 1. Anteroposterior radiograph 9 years after the index operation shows no eccentric location of the femoral head or osteolytic lesions of the femur and pelvis.

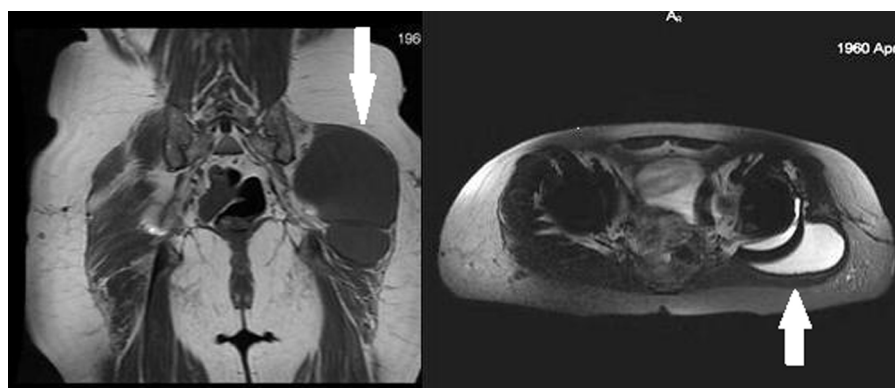
was present in her gluteal region. This lesion extended from the posterior aspect of the left hip joint to the gluteus maximus muscle (Fig. 2). An electromyogram (EMG) of her left lower leg was normal, and a technetium bone scan was negative. The cystic lesion was percutaneously aspirated under ultrasound guidance, with 60 ml of dark yellowish but nonpurulent fluid removed. Pathological examination of the aspirate revealed multiple macrophages and necrotic debris. Cultures of the fluid were negative.

Fig. 2. Axial and coronal pelvic MRI showing a cystic mass located in the extrapelvic region extending to the gluteus maximus muscle (white arrows).

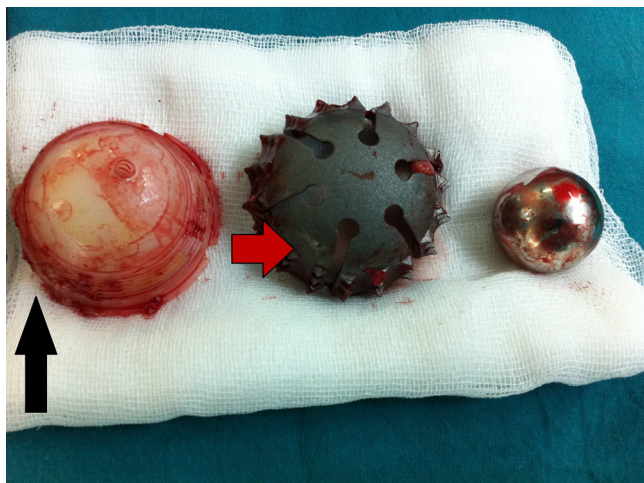
Fig. 3. The picture shows the polyethylene wear at the edge of the liner (black arrow) and the crack pattern in the shell (red arrow).

The design of the titanium alloy expanded acetabular shell would likely affect the degree of PE liner wear.¹⁴ Expanded acetabular shells with multiple holes were reported to be unable to support PE liners sufficiently and could increase the amount of wear debris due to suboptimal locking and micromotion at the nonarticular interface.¹ In addition, our patient underwent the index operation at a young age with higher demands in daily life, which have contributed to PE liner wear. Highly crosslinked PE would be a good option for this patient because highly crosslinked PE liners substantially reduce overall wear and wear rates.¹⁸

Catastrophic acetabular component breakage of the expansion cup secondary to severe liner wear and acetabular osteolysis is well described in the literature.¹⁹⁻²¹ The expansion acetabular component consists of six titanium lobes connected at the pole. Each of these lobes has three rows of antirotation spikes on its convex side. The inner surface is threaded to capture the PE insert. When the insert is screwed in place, the cup expands and mechanical stability is achieved by means of purchase of the sharp antirotation spikes on the bony acetabulum. The metal back is provided with a porous surface to promote bone ingrowth. Since the expansion cup is not rigid, it can match the elasticity of the iliac bone, minimizing the relative movement between the implant and the pelvis.¹⁹ Fatigue fracture is favoured by this typical structure, elasticity, and thinness of the expansion cup.¹⁹ In our case the operation was performed by the senior orthopaedic surgeon and overturning to expand the cup was avoided. No signs of a production or material failure was observed in the revision surgery. The accelerated wear led to complete PE wear-through and direct contact between the metallic head and the titanium lobe of the acetabular shell, which was weakened and which ultimately cracked. We believe that cracking was an indicator of future catastrophic failure.

We were unable to perform a total cystectomy in our patient due to abundant soft tissue adhesions and the close proximity of the cyst to the sciatic nerve. Follow-up radiological examination showed that the remaining portion of the cyst resolved after exchange of the acetabular shell and polyethylene liner. Similar resolutions of remaining cystic portions after subtotal cystectomy and revision of the components have been described.^{2,13}
