# CASE REPORT

# Successful revision of polyethylene only, after delayed presentation of a dislocated bearing in an Oxford unicompartmental knee replacement

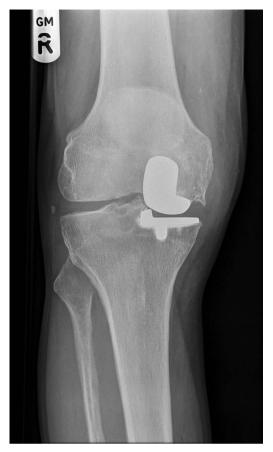
Figure 2 Post replacement check X-ray after 3.5 years.

surface damage. The anterior cruciate ligament and remaining articular surfaces were in good condition. After some debate, it was decided to simply exchange the polyethylene bearing surface and retain the other components. The patient was encouraged to mobilise fully weight-bearing immediately. The patient has been followed up at 6-month intervals for the last 3.5 years. He reports full normal function and has no pain. Examination reveals an intact straight leg raise with no lag and flexion to 115°. Serial X-rays show no evidence of polyethylene wear.

Our patient has been followed up for 3.5 years with no functional limitation and no evidence of excessive polyethylene wear. This case indicates that it is reasonable to retain the metal components and simply exchange the mobile bearing despite a mild degree of damage to the metal component surfaces.
