Journal section: *Biomaterials and Bioengineering in Dentistry*
 Publication Types: *Research*

Fractographic study of the behavior of different ceramic veneers on full coverage crowns in relation to supporting core materials

Farga-Niñoles I, Agustín-Panadero R, Román-Rodríguez JL, Solá-Ruiz MF, Granell-Ruiz M, Fons-Font A. Fractographic study of the behavior of different ceramic veneers on full coverage crowns in relation to supporting core materials. *J Clin Exp Dent.* 2013;5(5):e260-6. <http://www.medicinaoral.com/odo/volumenes/v5i5/jcedv5i5p260.pdf>

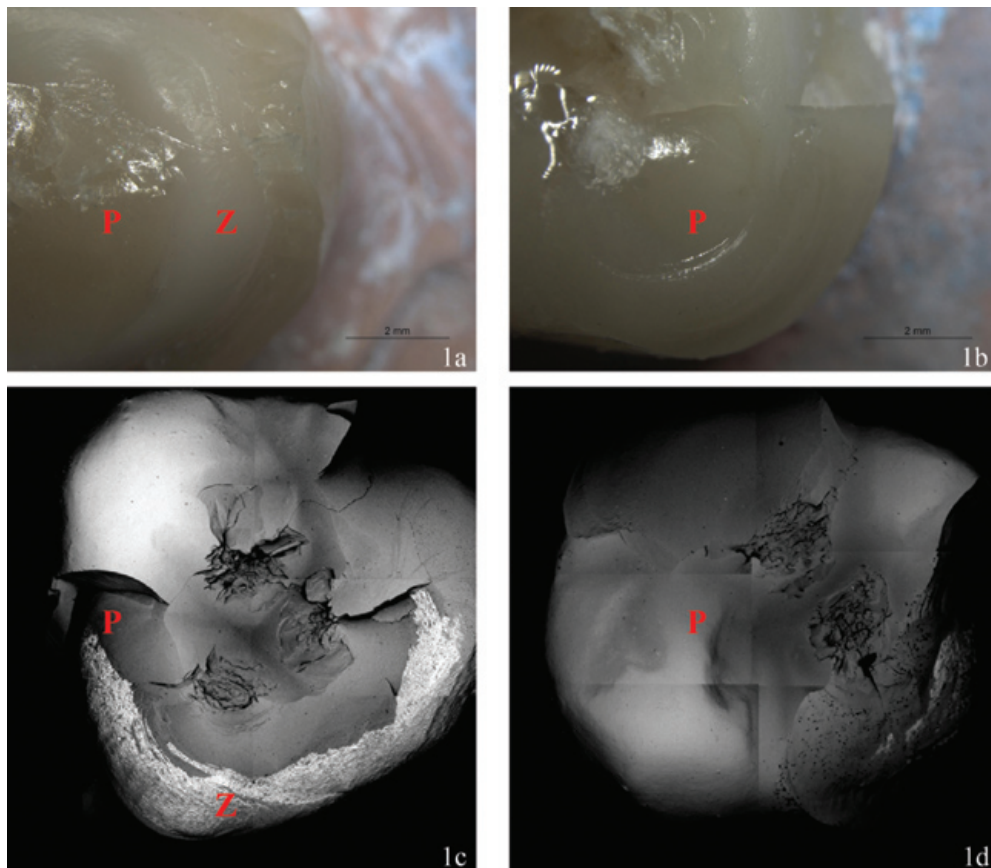
Fig. 1. A.-Adhesive fracture of Specimen 8, Group 1 observed under the Stereo Microscope 8x. B.-Cohesive fracture of Specimen 18, Group 2 observed under the Stereo Microscope 8x. C.-Adhesive fracture of Specimen 8, Group 1 observed using SEM BSE x25. D.- Cohesive fracture of Specimen 18, Group 2 observed using SEM BSE x25. P = Porcelain Veneer. Z = Zirconia.

Of the 120 crowns studied, 58.3% suffered adhesive fracture, 40% cohesive fracture, and 1.7% complete crown fracture. In Group 1, 60% of crowns underwent cohesive fracture, 30% adhesive fracture, and 10% complete crown fracture (Fig. 1). In Group 2, 85% of crowns suffered cohesive fracture while 15% suffered adhesive fracture (Fig. 1). In Group 3, 70% of crowns underwent cohesive fracture, while 30% suffered adhesive fracture. In Group 4, all fractures were adhesive, exposing the metal core. In Group 5, 10% of crowns underwent cohesive fracture, while 90% suffered adhesive fracture. In Group 6, 15% of crowns underwent cohesive fracture, whereas 85% were adhesive fractures. Table 1 shows the fracture types obtained in each group and their relation

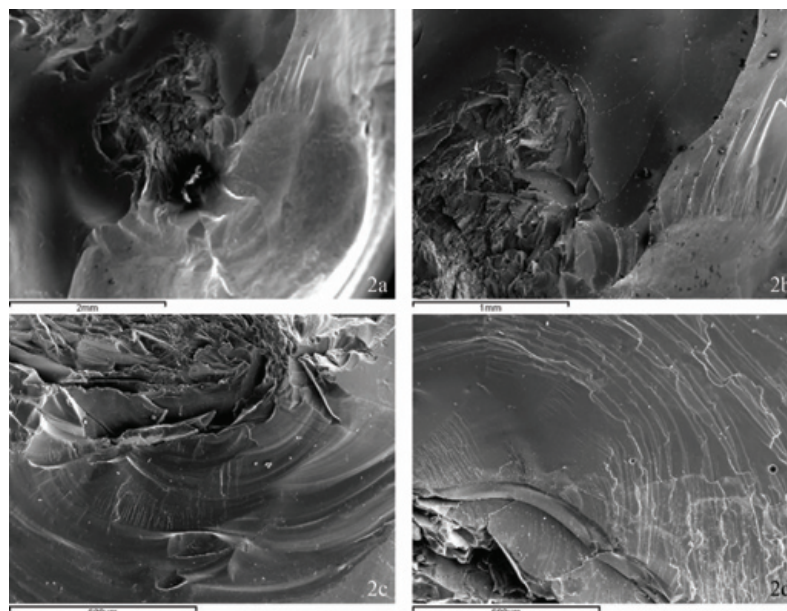
Fig. 2. A.- Peripheral or radial surface fracture propagation adjacent to the area of contact with the antagonist (Specimen number 18, Group 1 SEM SE x25. B.- Same Specimen SEM SE x50. C.-The same fracture propagation pattern is seen in Specimen 8, Group 2, SEM SE x100. D.-The same fracture propagation pattern in Specimen 6, Group 2, SEM SE x100.

dence of adhesive fracture (Table 2). Surface fracture patterns for all the crowns analyzed at the point of occlusion with the antagonist were radial or peripheral, in other words, the deformation of the veneer material was produced in the occlusal zone, with the fracture projected from the central point of load application towards the periphery where porcelain delamination occurred (Fig. 2). Composition analysis of selected specimens by SEM helped make a clear distinction between cohesive fractures and adhesive fractures (those that exposed the internal core) (Fig. 3).

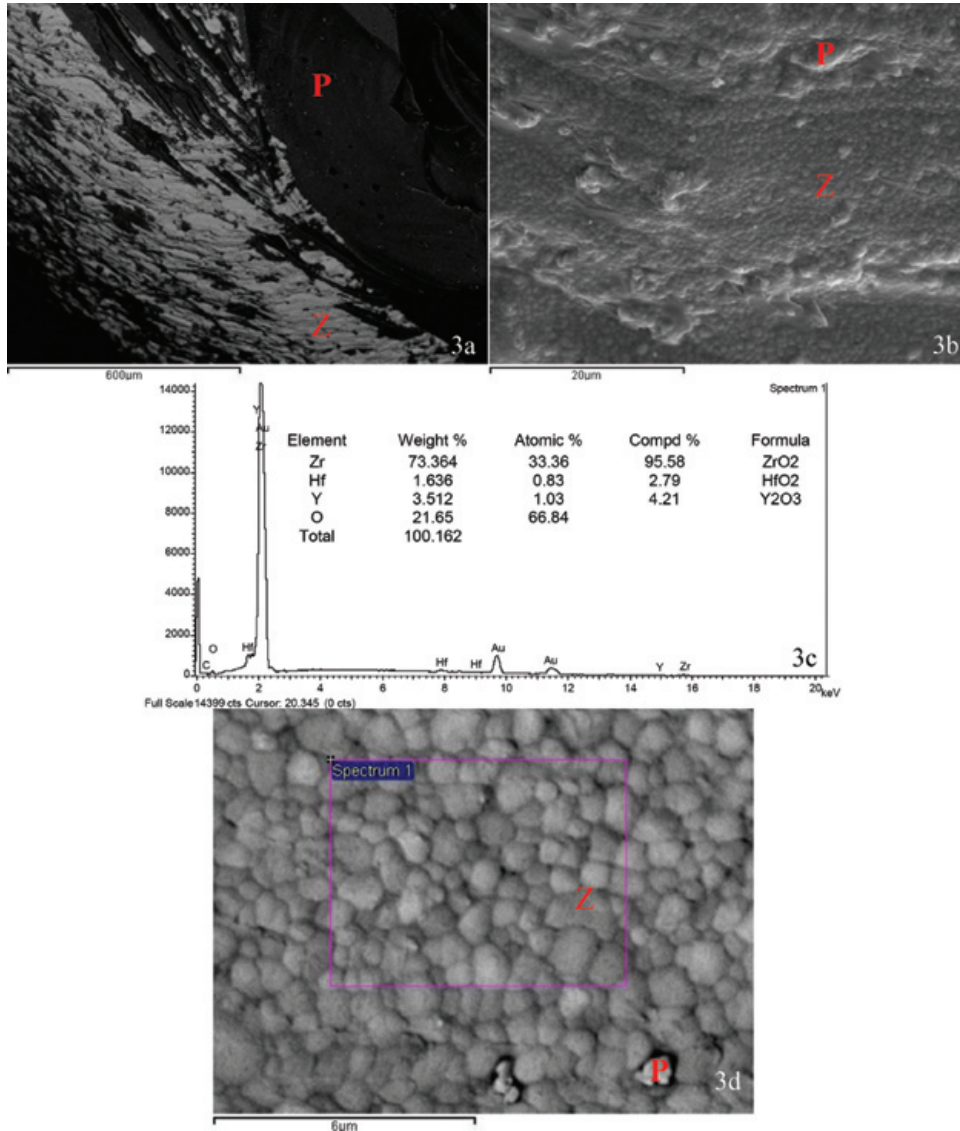
Fig 3. A.-Specimen 1, Group III 100x BSE. B.-Same Specimen x2500 SE. C.-Composition analysis from Spectrum 1 x10000 BSE. D.-Same Specimen x10000 BSE. **P** = Porcelain Veneer. **Z** = Zirconia
