CASE REPORT

Unusual prosthetic femoral head fracture in total hip arthroplasty: ceramic on polyethylene articulation

Damien Tucker, Mehool Acharya

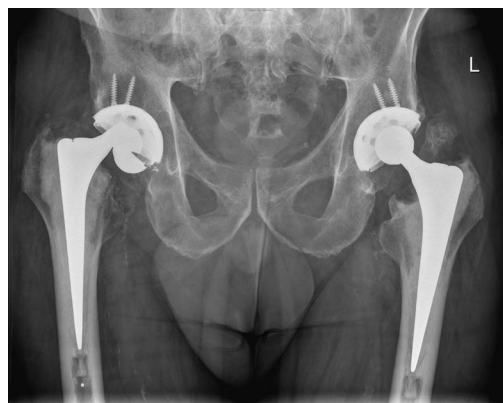
Forty-eight hours prior to the recent admission in 2013, the patient reported acute onset of pain in the right hip on standing first thing in the morning. There was no associated trauma reported with normal daily activities being conducted pain free the previous day. He works as a sheep farmer and uses a stick for walking only on uneven ground. After presenting to his general practitioner, he was referred to the orthopaedic team for management. On arrival to the department, he was comfortable at rest, non-feverish and had no neurovascular compromise but experienced pain on internal and external rotation as well as flexion past 90° of the hip. The radiograph of both hips taken on admission ([figure 1](#)) showed an acute fracture of the ceramic femoral head with osteolysis present behind the acetabular shell; the femoral stem, however, appeared well fixed. The patient was prepared for an urgent revision surgery of the right hip.

Figure 1 Anteroposterior radiograph of the hips showing a fracture of the ceramic femoral head in the right hip.

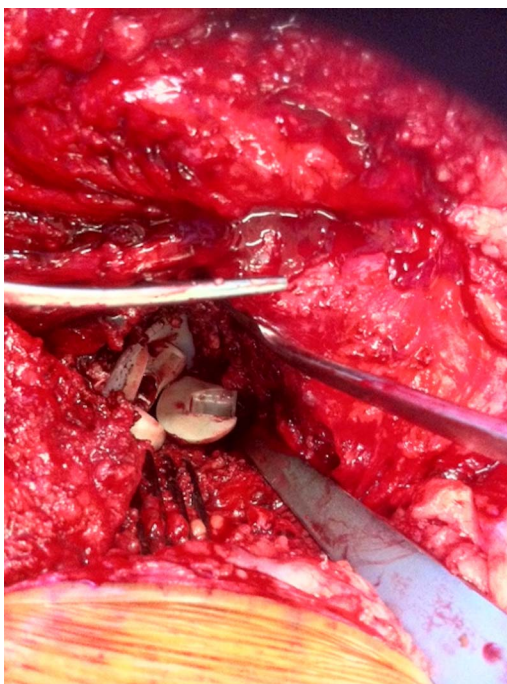
A single-stage revision arthroplasty of the right hip was undertaken. The fractured femoral head (figures 2 and 3) was removed as four main fragments. Copious saline was used to remove all the ceramic particles. The acetabular liner was loose and was easily removed. After the acetabular shell was removed, large areas of osteolysis were noted, requiring bone grafting before a replacement shell could be implanted. The femoral stem was knocked out of the cement mantle, which was intact, showing no signs of loosening. The well-fixed stem was removed due to trunnion damage, which if retained could cause damage to the replacement ceramic femoral head which would be unacceptable. Reimplantation of a Zimmer Continuum 60 mm outer diameter acetabular shell with a Continuum BIOLOX 36 mm inner diameter alumina ceramic liner was performed. A size 1 Zimmer CPT femoral stem was cemented in place using a cement-in-cement technique and a 36 mm alumina ceramic head. The postoperative radiograph showed a well-implanted total hip arthroplasty (figure 4). The patient made an uneventful recovery and was discharged on the third postoperative day.

Figure 2 Intraoperative findings of fractured ceramic bearing in situ.

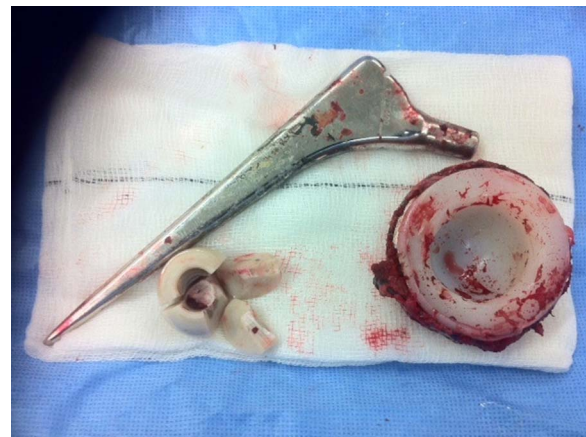
Figure 3 The explanted implants including the femoral stem, polyethylene acetabular liner and fractured ceramic femoral head.

abnormal situation, will result in failure of the prosthesis. Contact with other hard surfaces can occur as a result of wear or loosening of the acetabular liner—which occurs more frequently in a soft UHMWPE liner—exposing the underlying metal shell or if the shell itself loosens from its attachment to the pelvis in a process called osteolysis. Under normal conditions, there is no movement between the tapered trunnion and the head, if for some reason movement can occur, this would cause imperfections and flaws to occur on the inside of the ceramic head providing yet another mode of ceramic damage. Movement between the trunnion and the femoral head is increased in situations where the trunnion itself is damaged, hence the revision of the well-fixed stem following identification of trunnion damage in this case.

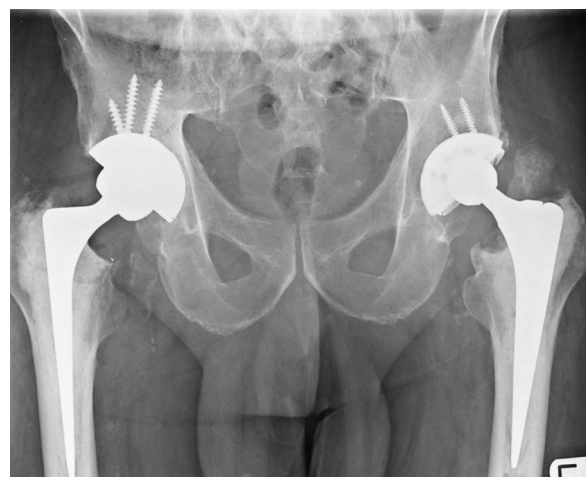
Figure 4 Postoperative radiograph depicting the revised right total hip replacement in situ.
