Fatigue degradation and electric recovery in Silicon solar cells embedded in photovoltaic modules

Marco Paggi¹, Irene Berardone², Andrea Infuso² & Mauro Corrado²Received
31 December 2013Accepted
6 March 2014Published
28 March 2014Correspondence and
requests for materials
should be addressed to
M.P. (marco.paggi@
imtlucca.it)

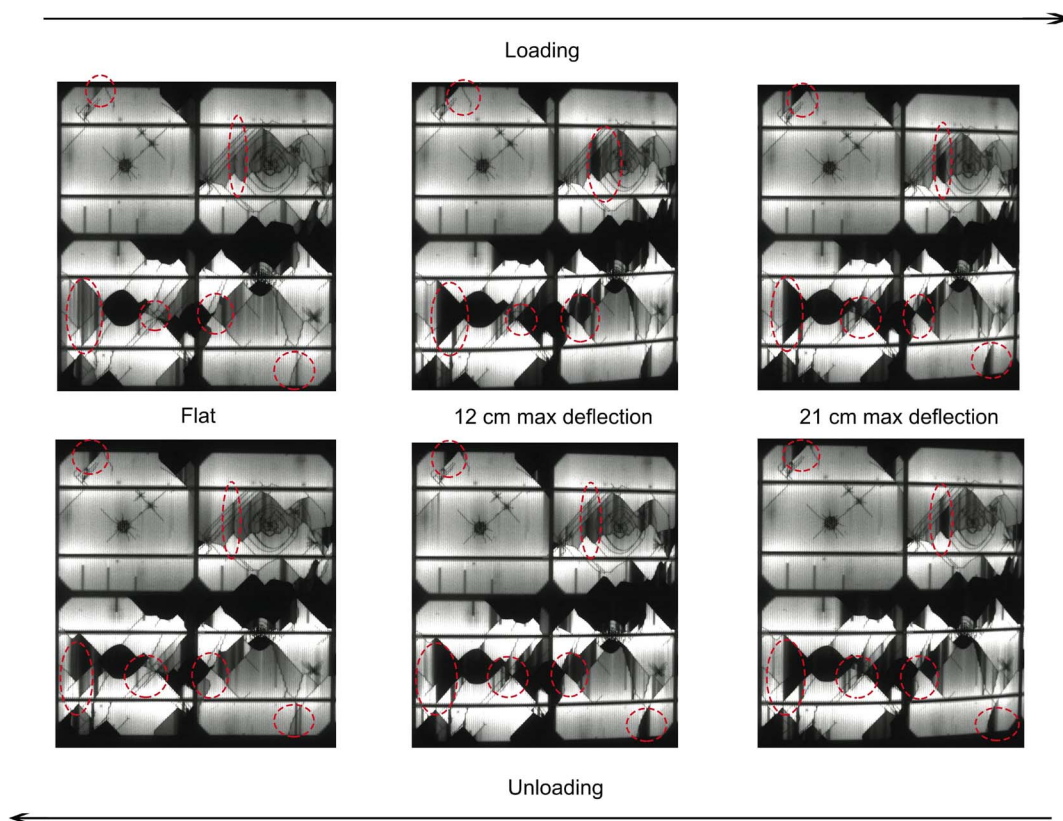
Figure 3 | Evolution of EL signal during bending loading and unloading for different deflections.

To create pre-existing cracks and study their evolution depending on the imposed flexure, moderate impacts have been made with PMMA balls of 4 cm of diameter at a velocity of 6 m/s. In this way, cracks are introduced by an indentation effect. The EL images of four solar cells in the middle of the panel are shown in Fig. 3.

Location of impacts can be clearly distinguished by the circular dark spots from where diagonal cracks, influenced by the crystallographic planes of cubic face centred monocrystalline Silicon, depart. These patterns are completely invisible by naked eye and can only be determined by the EL technique. In some cases, large electrically insulated cell portions, appearing as dark areas, are present. Other portions, circled with dashed lines, show regions isolated by cracks but still partially conducting from the electrical point of view. This can be well explained by the assumption that their crack opening is smaller than a critical value for complete electric insulation and by a compressive stress state inside the cells due to residual thermo-elastic stresses induced by cooling down the module from the lamination temperature at 150°C to the ambient temperature at 20°C .

By increasing the mid-span bending deflection (upper row in Fig. 3, loading direction from left to right), cracks open and additional insulated dark areas appear, thus confirming that the electrical behaviour of cracks does depend on the elastic deformation. Very interesting is the unloading stage (lower row in Fig. 3, unloading direction from right to left), where cracks come into contact and conduct again. Hence, although globally the amount of damage is increased during the cycle since the final EL image is more dark than before, an electric recovery due to crack closure is reported.

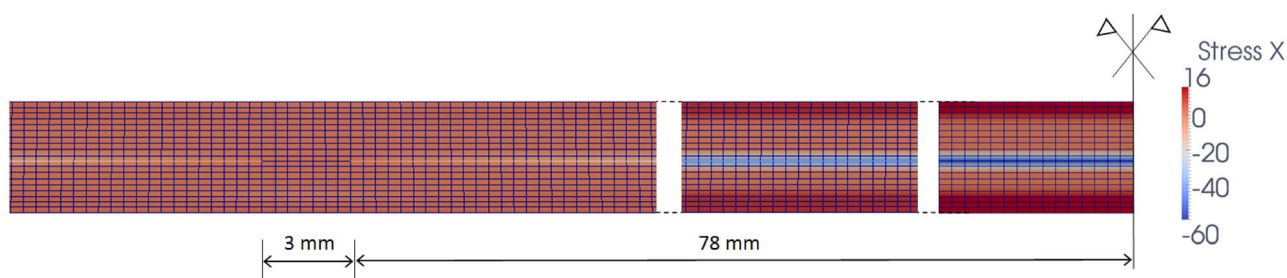
Figure 4 | Contour plot of the horizontal stresses inside the PV laminate in the portion near the symmetry line.

estimate a compressive stress field in the Si cells variable from 0 MPa at their borders up to 60 MPa in their centre (see the contour plot in Fig. 4). Therefore, this residual stress field is beneficial for the module since any initial crack or defect present in Silicon would be closed by compression.

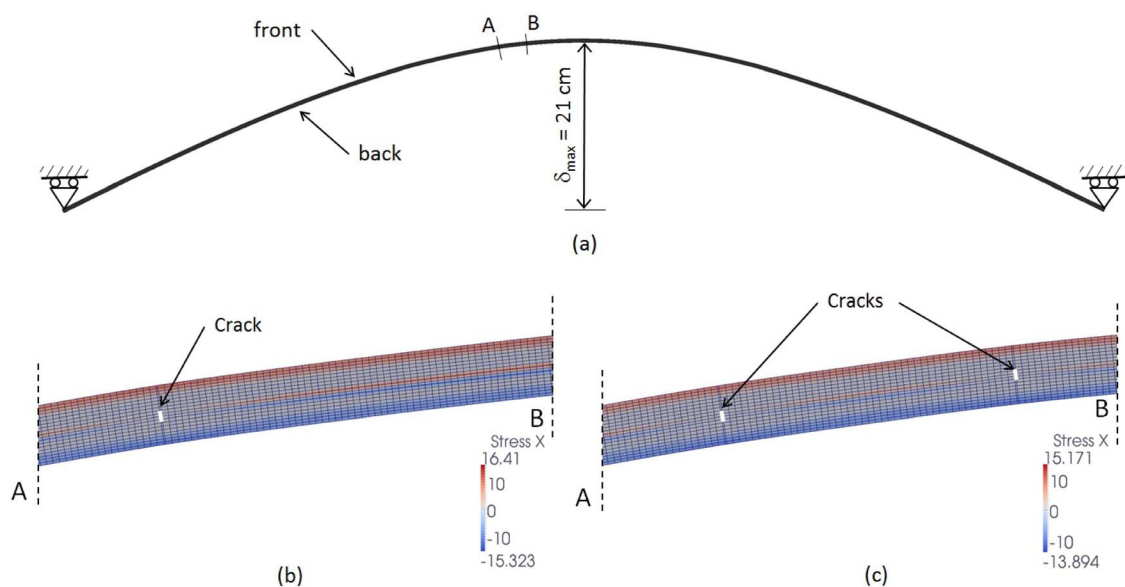
Figure 6 | Structural scheme (a); contour plot of the horizontal stress field in case of one single crack (b); contour plot of the horizontal stress field in case of two cracks (c).

To confirm the effect of a new crack on the crack opening of a pre-existing crack in case of a brittle material embedded in the laminate, a FE study based on nonlinear fracture mechanics is proposed. For more details about the CZM, see Ref. 9. In the 2D approximation of the PV module shown in Fig. 6(a), one or two cohesive cracks (distant 0.9 cm from each other) are introduced in the Si cell placed near the symmetry line (see Figs. 6(b) and 6(c)). In the numerical simulations, the PV module is loaded by imposing a displacement to

the middle cross-section up to $\delta_{\max} = 21$ cm as shown in Fig. 6(a). Residual thermo-elastic stresses are not considered here for the sake of simplicity. If the stress relief takes place, then it would happen also in the presence of residual thermo-elastic stresses. A very low cohesive peak stress of $\sigma_{\max} = 0.2$ MPa is considered to simulate a very low cohesion due to a severe state of damage. The contour plots of the horizontal stress field superimposed to the deformed meshes of the portion of the module where cracks are placed are shown in Figs. 6(b) and 6(c). Stresses are slightly reduced by the simultaneous presence of two cracks and the crack opening of the pre-existing crack reduces from 11 μm to 9 μm . Therefore, the effect of strain localization induced by the propagation of new cracks supports the hypothesis of unloading effects at pre-existing cracks that might come into contact, thus leading to a recovery of their electric conductivity.
