Aortic Perforation by Active-Fixation Atrial Pacing Lead:

An Unusual but Serious Complication

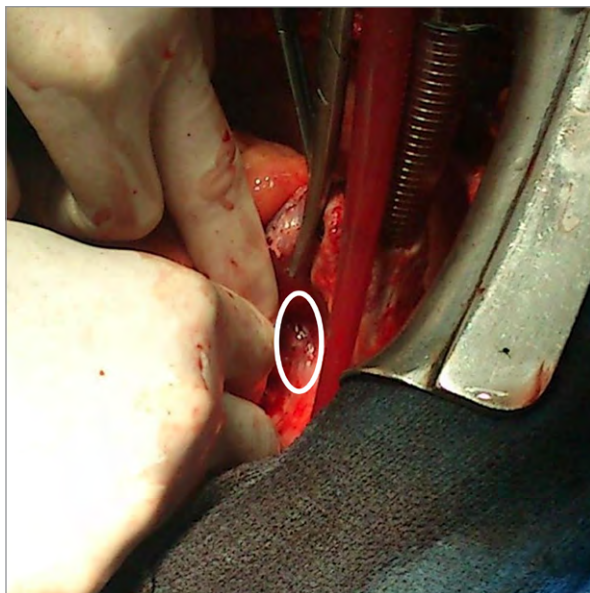
was caused by mechanical friction from the atrial lead. We also observed a small erosion of the atrial wall, without active bleeding from the right atrium, and we could palpate the helix of the right atrial lead that protruded from the right atrium (Fig. 1). Thorough inspection of the pericardium and the 2 ventricular leads revealed no other bleeding sites. After extracorporeal circulation was established, both the aortic and atrial punctures were repaired with Prolene sutures reinforced by Teflon pledgets (Fig. 2). Together with suturing the atrial puncture, we plicated the atrial wall above the atrial lead in order to cover the tip of the lead and prevent further damage to the atrial or aortic wall. There was no need to reposition the atrial lead, because it functioned correctly.

Fig. 1 Intraoperative photograph shows the small puncture of the atrial wall caused by the helix of the atrial active-fixation lead (within the circle). Right atrial cannulation for extracorporeal circulation is also shown.

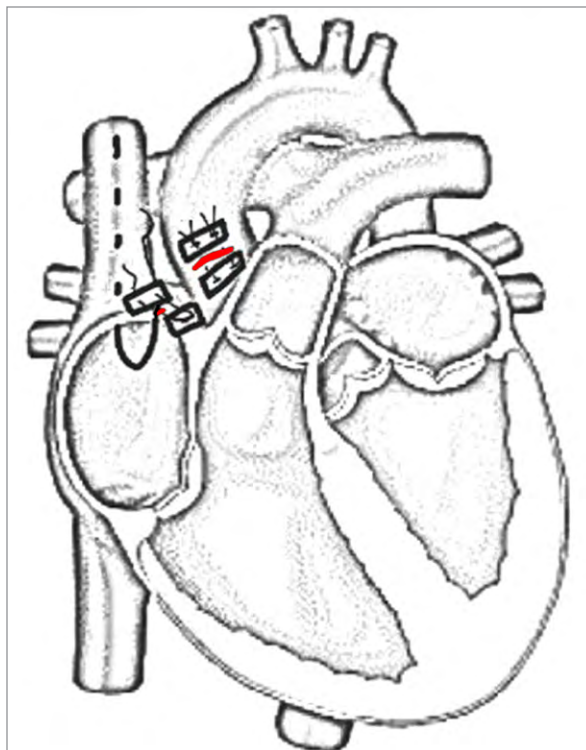
Fig. 2 Anatomic sketch shows the close relationship between the atrial lead and the aorta. Note also the lesions (red) of the atrial and aortic walls and the Prolene sutures reinforced by Teflon pledgets, which were used to repair both wounds.

Aortic perforation by a pacemaker lead is a very rare and life-threatening event. In the reports published up to the present time, its clinical presentation always took the form of cardiac tamponade. Immediate surgery is mandatory to diagnose and treat this severe sequela. In our patient, aortic perforation was undoubtedly due to the pacing lead's puncturing the right atrial wall and injuring the adjacent ascending aorta by mechanical friction. Moreover, this result was probably abetted by the severe dilation of the right atrium and by the increased right atrial pressure associated with the patient's advanced stage of heart failure.
