# Geomorphic and Ecological Disturbance and Recovery from Two Small Dams and Their Removal

## Abstract

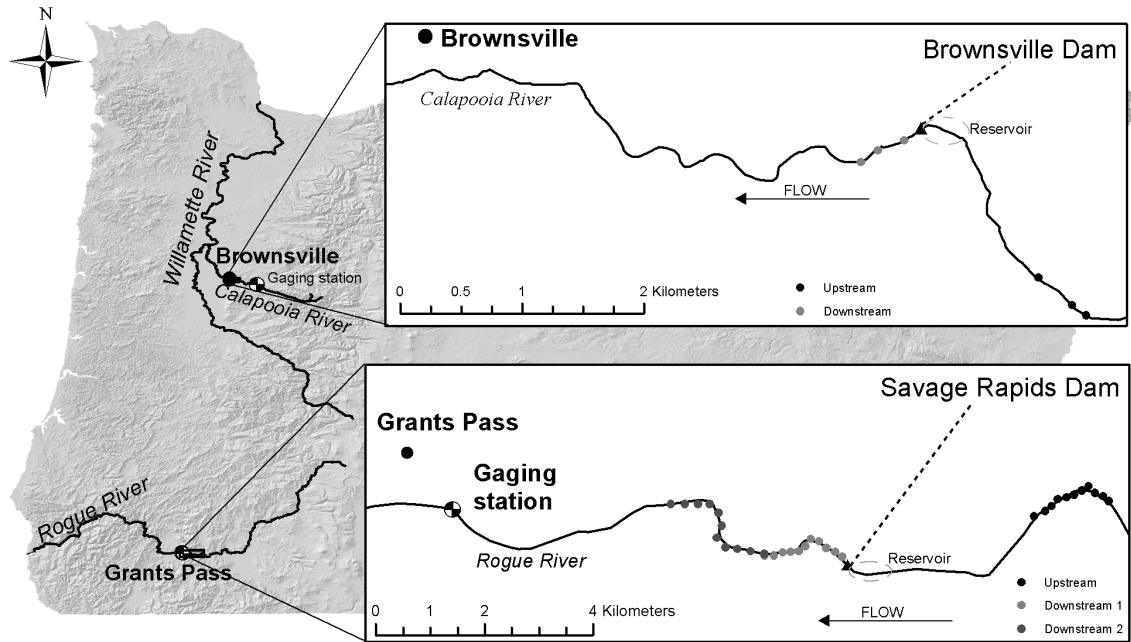
**Figure 1. Site locations.** Each dot represents a macroinvertebrate sampling location: 3 riffles per reach on the Calapooia River, and 11 transects per reach on the Rogue River.  
doi:10.1371/journal.pone.0108091.g001

The Calapooia River runs 121 km west from Tidbits Mountain in the Western Cascade Range to Albany, Oregon where it joins the Willamette River (Figure 1). Brownsville Dam (122°56′0.05″W 44°23′15.67″N) was a run of river, low-head dam (Table 1). The dam was originally built as a log crib dam in the late 1800s as a diversion and was rebuilt after failure in the 1964 flood [45–46]. The study area includes two reaches: 1) a 0.67 km control reach (C-US), a length equal to twenty times active channel width, that was located 2 km upstream from the dam; and 2) a 0.67 km (C-DS) impact reach starting immediately downstream of the dam (Figure 1). Permission for access was not necessary since work was conducted within the high-water elevation of the river.

The Rogue River flows 346 km west from springs on Mount McLoughlin in the Cascade Range near Crater Lake to the Pacific Ocean at Gold Beach, Oregon (Figure 1). Savage Rapids Dam (123°13′46.85″W 42°25′14.30″N) was built in 1921 as an irrigation diversion (Table 1) [47] during the summer, passing peaks flows during winter rainfall and spring snowmelt runoff [48] unregulated. Decommissioning of Savage Rapids Dam began with the removal of the right bays of the dam in April–June 2009 during which time there was a small release of sediment associated with drawdown and the partial failure of the coffer dam [49]. The coffer dam remained in place and flow was forced through the left bays and fish ladder until October–November 2009, when the coffer dam and remaining infrastructure was removed, a pilot channel was constructed, and the river was returned to a free flowing river [50]. The study area consisted of three reaches (Figure 1): 1) a 1.5 km control reach (R-US), approximately 40 times summer wetted width, located 4 km upstream from the dam; 2) one 1.8 km impact reach, starting immediately downstream of the dam (R-DS1); and 3) a second 2.4 km impact reach (R-DS2), starting immediately below R-DS1. Permission for access was not necessary since work was conducted within the high-water elevation of the river.

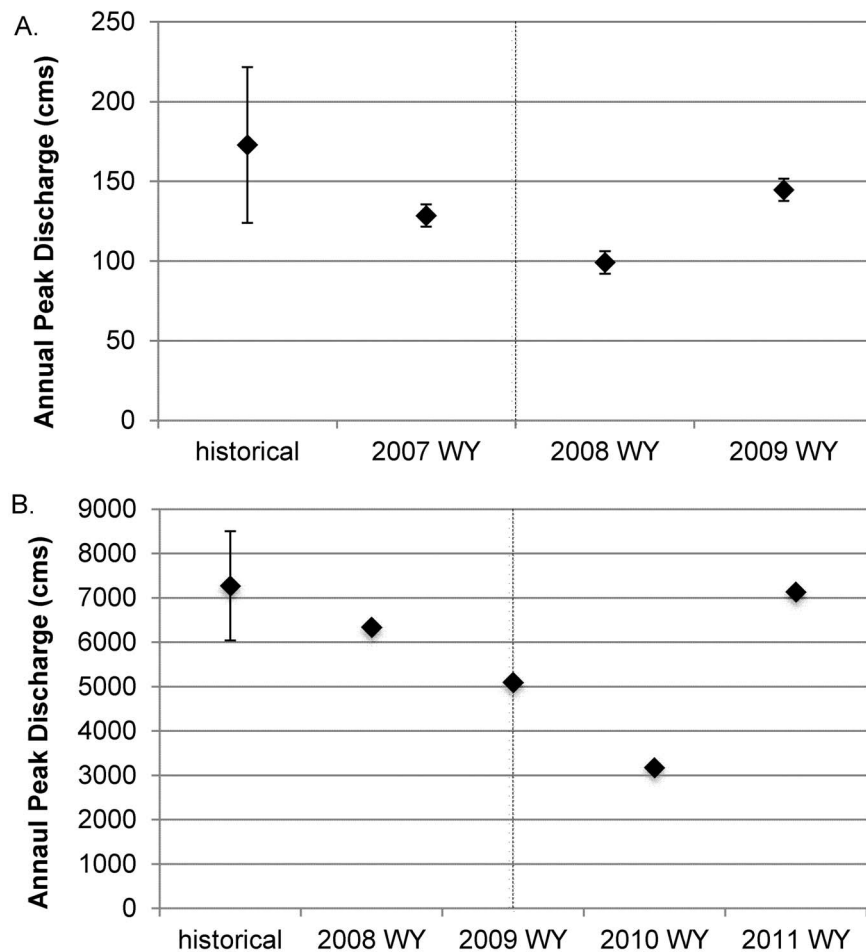
**Figure 2. Annual peak discharge for the historical period of record and over the study period for the a) Calapooia at Holley, located 16 km upstream of Brownsville Dam, and b) Rogue River at Grants Pass located 8.6 km downstream of Savage Rapids Dam.** Error bars on historical annual peaks represent 2 standard errors. Error bars for the Calapooia River for study years reflect estimation error associated with multiple regression estimate of peak discharge. Vertical dashed lined indicates approximate date of dam removal. doi:10.1371/journal.pone.0108091.g002

flow at both study sites for context. Hydrologic records were summarized as the annual peak discharge for the historical and study time periods (Figure 2). For the Calapooia River, there has not been a published record of discharge since the U.S. Geological Survey (USGS) stopped gaging the Calapooia River at Holley (#14172000), 16 km upstream of Brownsville Dam, in 1990. Therefore, we used two nearby USGS gages, South Santiam below Cascadia (#14185000) and Mohawk River at Springfield (#14165000), in basins of similar hydrogeology and land uses, to create a log-transformed regression model for annual peak flow for the Calapooia at Holley based upon 35 years of concurrent historical annual peaks [51]. The Rogue River is gauged by the USGS at Grants Pass (#14361500), 8.6 km downstream from the Savage Rapids Dam.

On the Calapooia River, all three years of the study period experienced peak flows that were lower than the historical mean (Figure 2A). The first year post-removal was exceptionally low as it was less than two standard errors below the mean, whereas the pre-removal and second year post-removal experienced an annual peak flow that, while still low, were more typical of the historical peaks. The Rogue River experienced nearly the average annual peak flow in 2008, prior to dam removal, and an average annual peak flow in 2011, two years post-removal. Water year 2009, the year of the removal, experienced a peak flow of average magnitude whereas the lowest annual peak flow occurred in the water year following the dam removal.

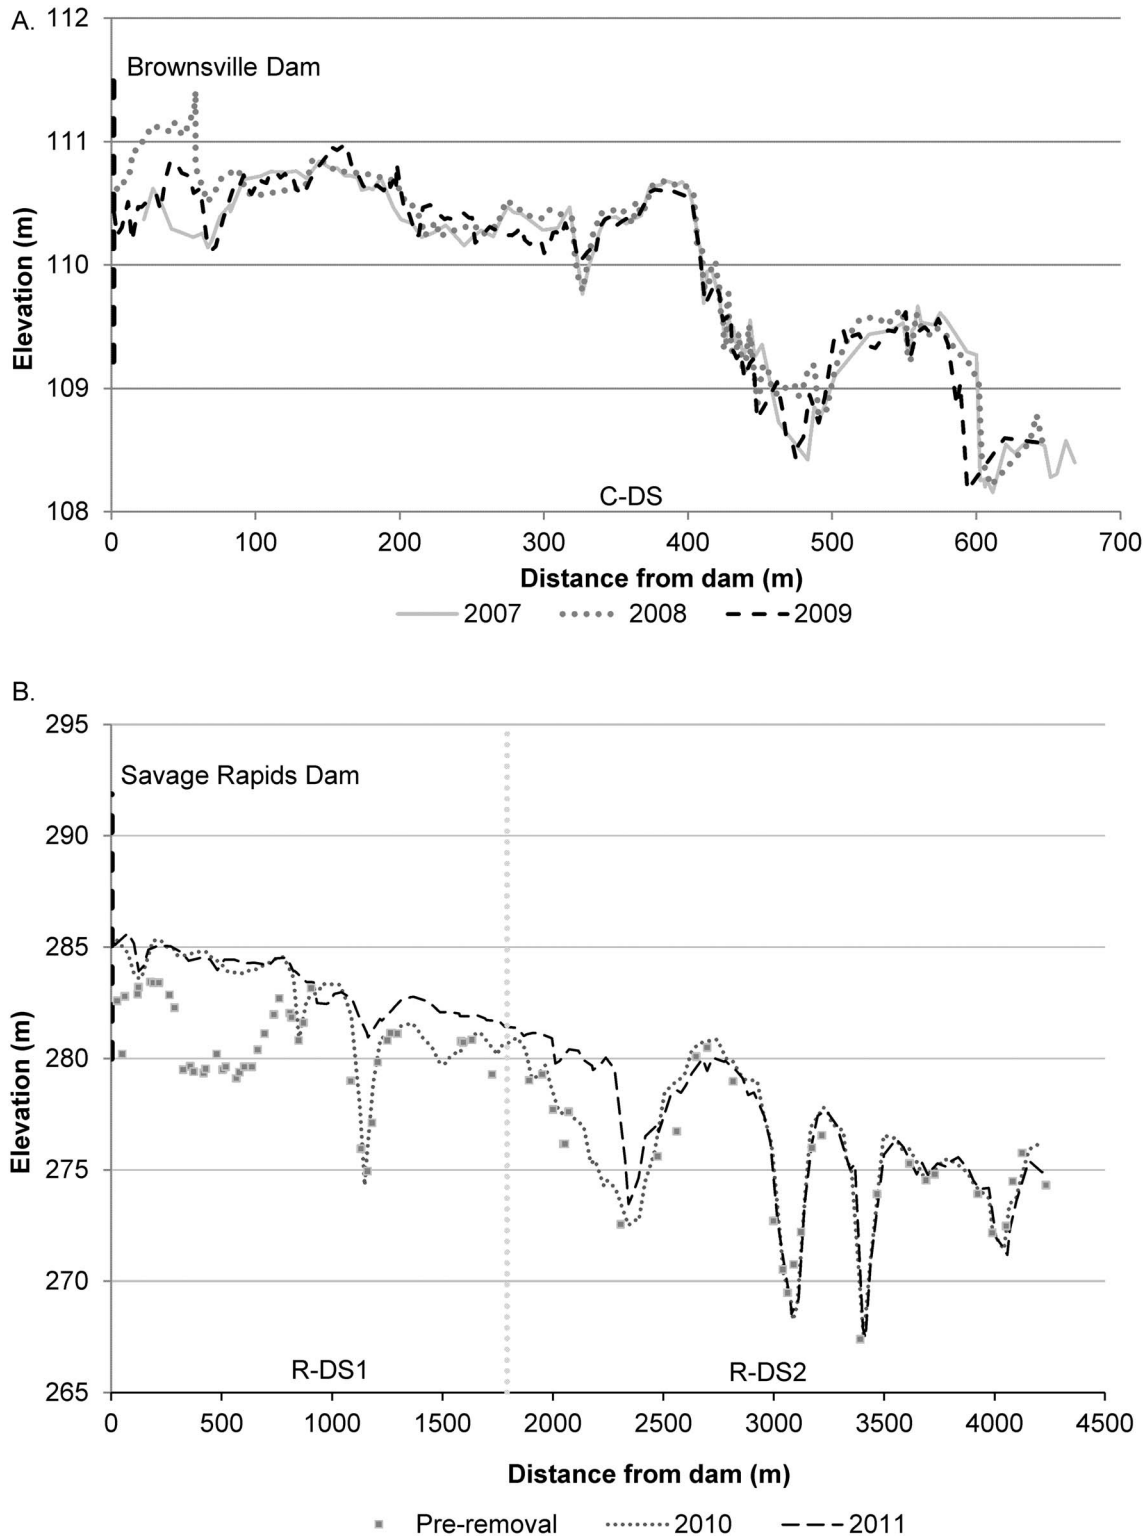
**Figure 3. Longitudinal profiles downstream from the dams over time at a) Calapooia River and b) Rogue River.** On the Rogue River, no longitudinal profile was collected during 2009, and the pre-removal profile is a compilation of surveys from 1999 in the farthest US and DS reaches and from 2002 for the main reservoir, both conducted by the US Bureau of Reclamation.  
 doi:10.1371/journal.pone.0108091.g003

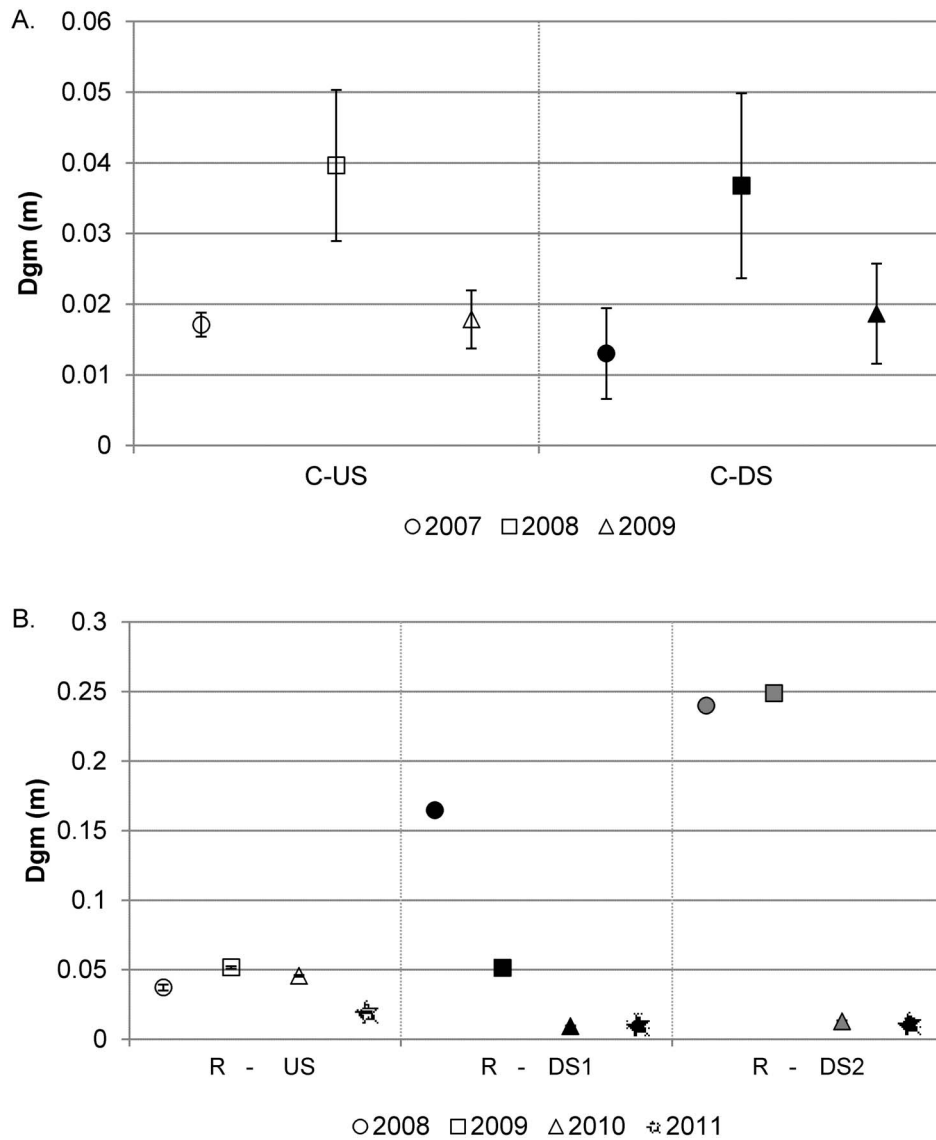
**Figure 4. Plot of geometric mean grain size by reach over time at a) Calapooia River and b) Rogue River.** Symbols represent the mean value, and lines represent two standard errors from the mean.  
doi:10.1371/journal.pone.0108091.g004

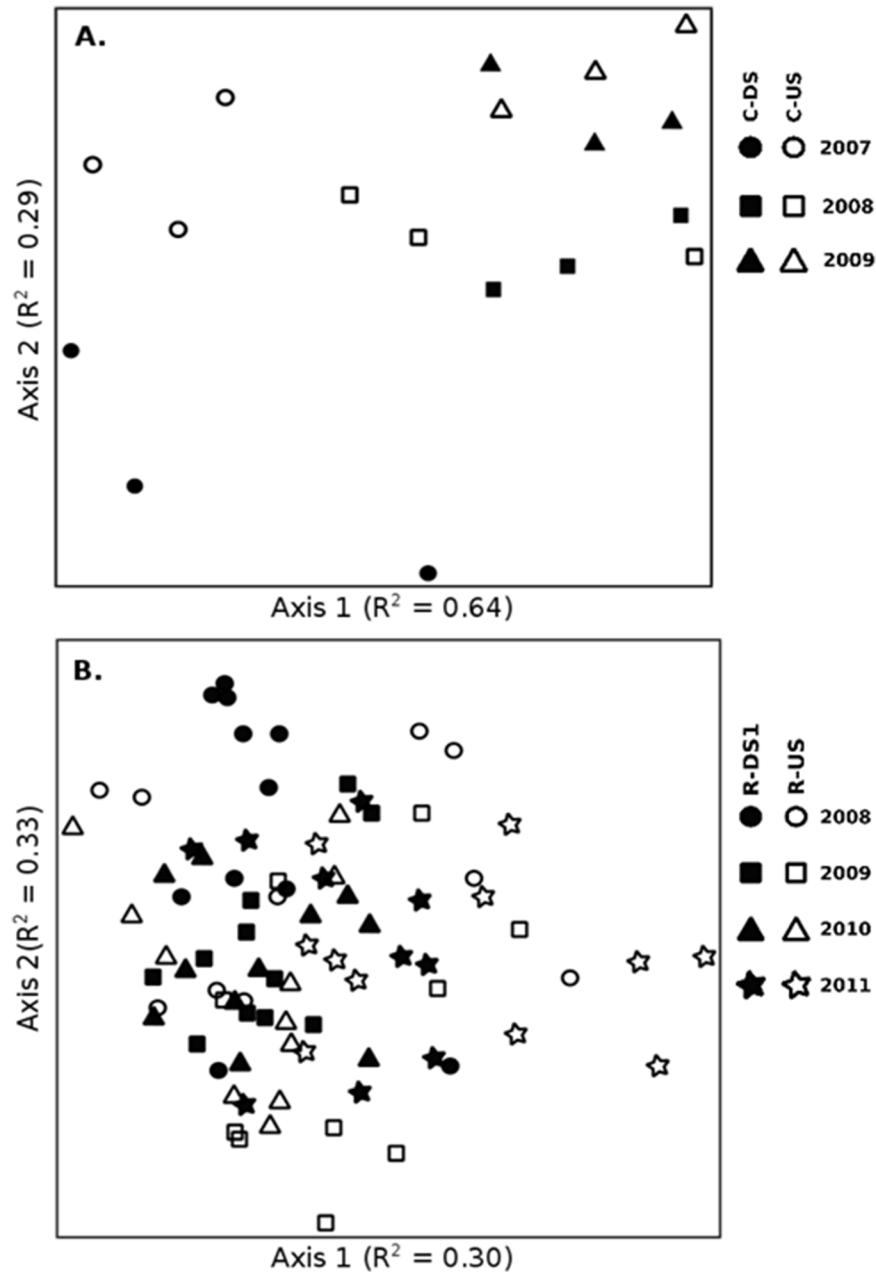
**Figure 5. NMS ordination plot according to the taxonomic structure of A) 3 upstream and 3 downstream riffles associated with the Brownsville Dam removal on the Calapooia River over three collection years, and B) 11 upstream and 11 downstream transects associated with the Savage Rapids Dam removal on the Rogue River over four collection years.** Note that the 11 transects from reach “DS2” have been removed from the figure to reduce clutter (see Table 3 for MRPP analysis of these data, including the DS2 reach). A) Final stress for the two-dimensional solution = 10.1. B) Final stress for a three-dimensional solution was 15.2, and the unpictured third axis had  $R^2 = 0.21$ . doi:10.1371/journal.pone.0108091.g005

To some extent, the differences observed in the pre- and post-removal assemblages were illustrated in the NMS plots. Taxonomic structure clearly delineated C-US and C-DS on the Calapooia River prior to dam removal along Axis 2, whereas the post-removal sites were not separated in ordination space (Figure 5A). Similar results are observed with ordinations of the functionally defined assemblages, with upstream and downstream sites on the Calapooia River clearly separated in ordination space prior to dam removal but not following dam removal (Figure 6A). In contrast, the pre-removal taxonomic distinction between R-US and R-DS1 is not evident on the Rogue River (Figure 5B), although upstream and downstream sites were separated to some extent along Axis 1 for the functionally defined assemblages (Figure 6B) prior to, but not following, dam removal.

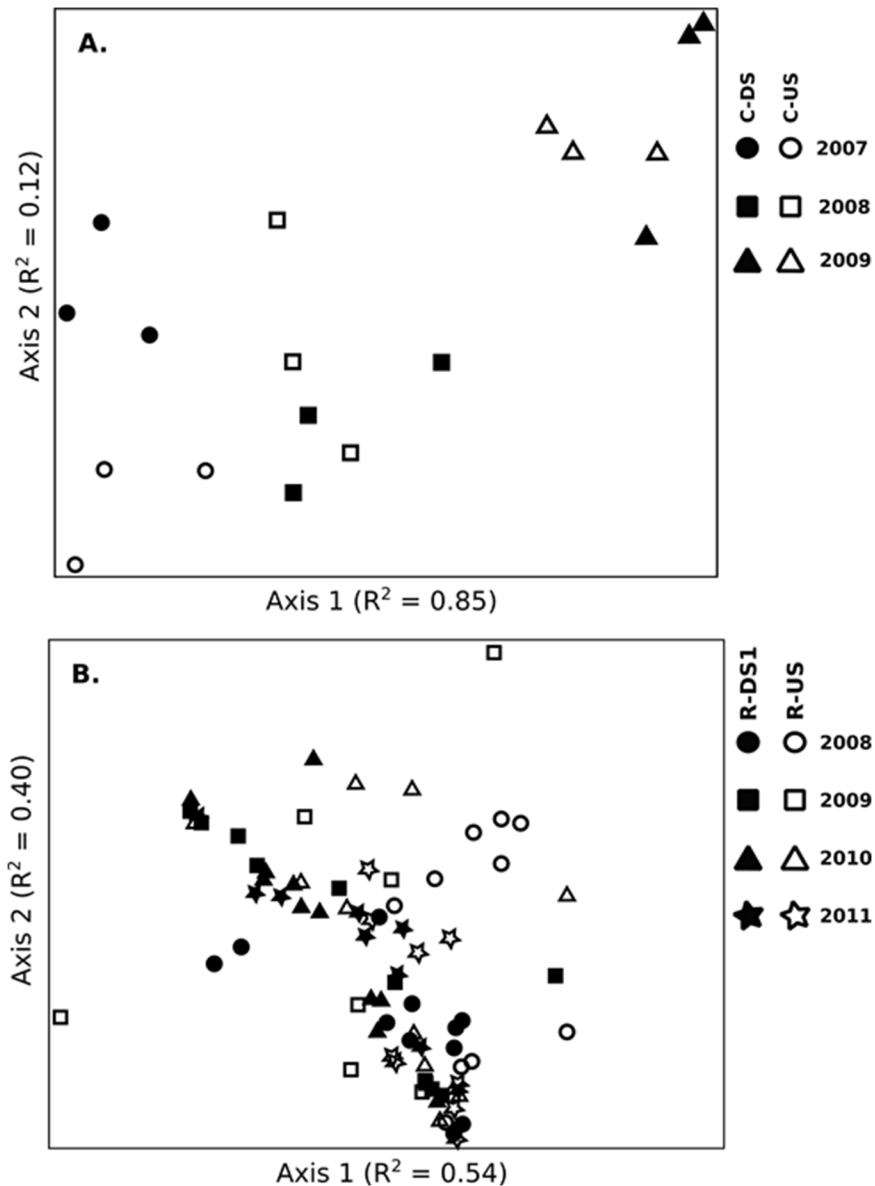
**Figure 6. NMS ordination plot according to the functional community structure (based on 20 benthic insect traits) of A) 3 upstream and 3 downstream riffles associated with the Brownsville Dam removal on the Calapooia River over three collection years, and B) 11 upstream and 11 downstream transects associated with the Savage Rapids Dam removal on the Rogue River over four collection years.** Note that the 11 transects from reach R-DS2 have been removed from the figure to reduce clutter (see Table 4 for MRPP analysis of these data, including the R-DS2 reach). The symbols follow the same explanation as in Figure 2. A) Final stress for the two-dimensional solution = 6.4. B) Final stress for the two-dimensional solution was 13.2. doi:10.1371/journal.pone.0108091.g006

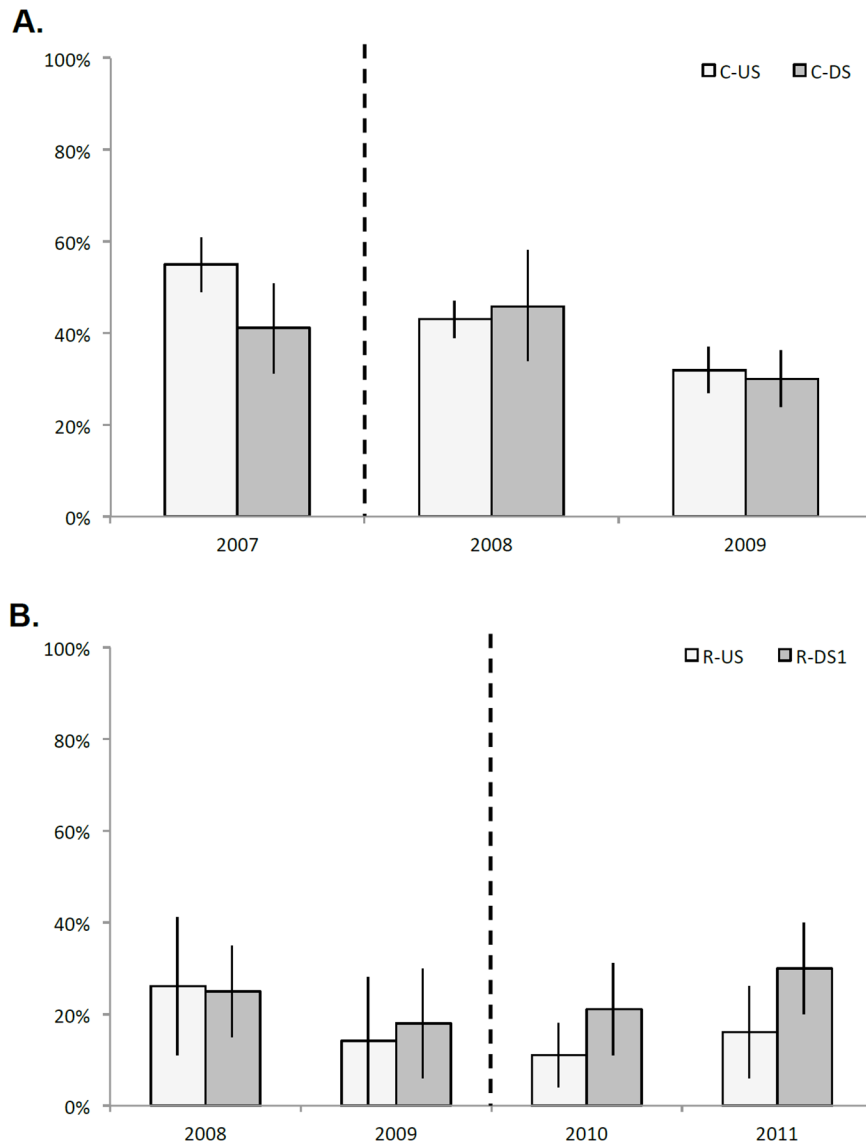
**Figure 7. Mean %clingers (expressed as relative abundance,  $\pm 2$  standard errors) per reach across A) riffle sample units on the Calapooia, and B) transects sampled on the Rogue.** In both panels, year is on the x-axis, and lighter-colored bars represent the upstream reaches. Vertical dashed line shows timing of dam removal. Note that, in the interest of space, the second downstream reach is not plotted for the Rogue due to the lack of change over time.  
doi:10.1371/journal.pone.0108091.g007

The univariate indicators %clingers (Figure 7) and %EPT (Figure 8) illustrate upstream-downstream trends across years, particularly in the Calapooia River, although only one of the within-year *t*-tests produced significant differences. With no statistical difference in % EPT across the years on the Calapooia River (Figure 8A), the only statistically significant difference on the Calapooia River was greater %clingers in C-DS than C-US in 2007, the year prior to dam removal (Figure 7A). In the two years following dam removal, the two reaches on the Calapooia River became statistically indistinguishable for %clingers. Values of %EPT were greater, though nonsignificant (*p* = 0.11), in C-US relative to C-DS for the Calapooia River prior to dam removal,

followed by convergence of these reaches in the two years following dam removal. Year-to-year trends were difficult to assess and were nonsignificant on the Rogue River due to high reach-scale variability for both %EPT and %clingers (Figures 7B, 8B).

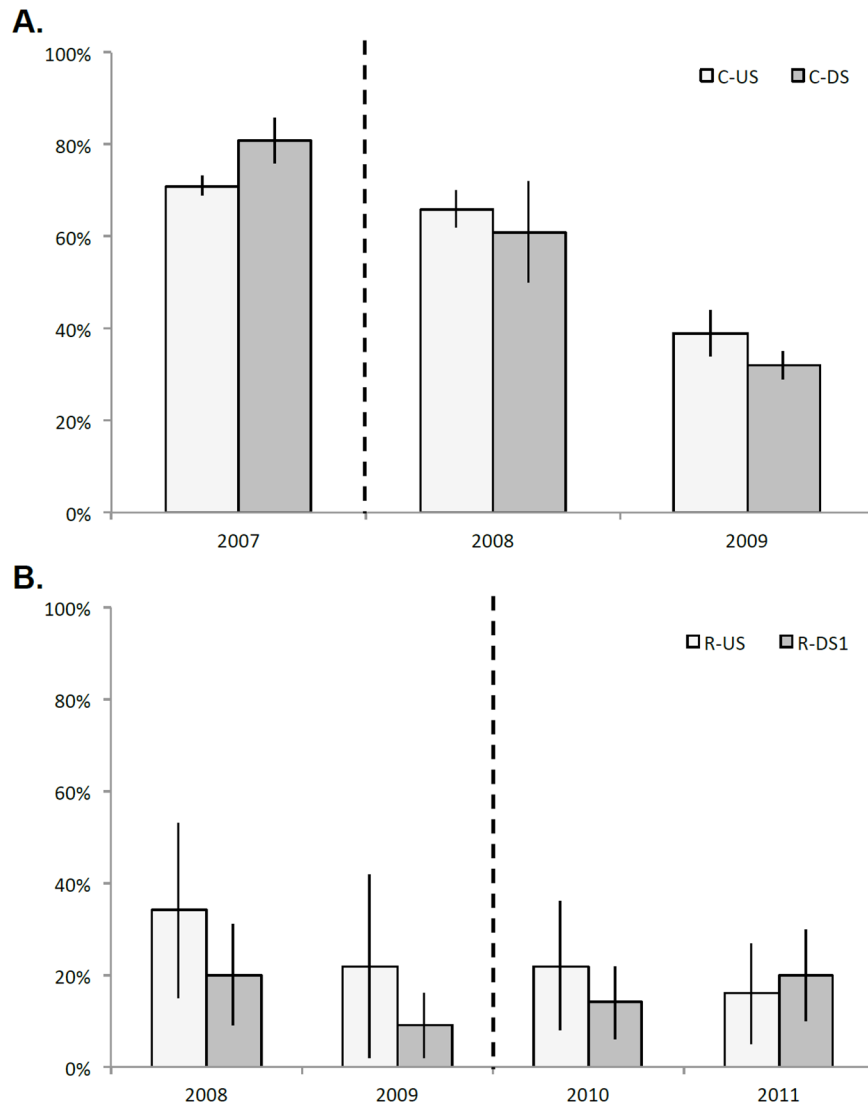
**Figure 8. Mean %EPT (expressed as a proportion,  $\pm 2$  standard errors) per reach across A) riffle sample units on the Calapooia, and B) transects sampled on the Rogue.** In both panels, year is on the x-axis, and lighter-colored bars represent the upstream reaches. Vertical dashed line shows timing of dam removal. Note that the second downstream reach is not plotted for the Rogue River due to the lack of change over time.
