Remedy for Repeated Implant Retained Denture Fracture-A Challenging Case Report

ABSTRACT

CASE REPORT

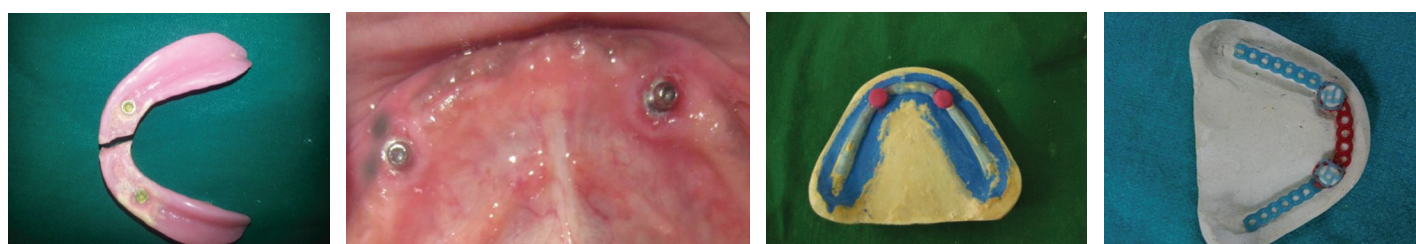
[Table/Fig-1]: Fractured denture **[Table/Fig-2]:** Ball abutments **[Table/Fig-3]:** Block out of the master cast and ball abutments **[Table/Fig-4]:** Wax pattern fabrication on the refractory cast

A 65-year-old male patient reported to the Department of Prosthodontics, with the chief complaint of fractured mandibular implant supported over denture [Table/Fig-1] due to which he was unable to wear his denture since one week. Patient was systemically healthy with no medical compromise. History revealed placement of two endosseous dental implants with ball attachments [Table/Fig-2] three years back and history of previous denture fracture one year back and new denture made, subsequently fracture of second set of denture occurred within the gap of six months. Intra oral examination revealed natural teeth in relation to 15,17,23,24,25. The radiographic investigation revealed well osseointegrated implants in relation to the lower arch. The main treatment objective was to overcome this repeated fracture of the lower denture. So it was planned to reinforce mandibular implant supported over denture with metal. As the patient is socially active, the fracture denture was temporarily repaired and given to the patient in order to provide minimum function.

In this case report the most probable cause for the implant supported lower denture to fracture could be natural dentition opposed by the artificial denture, decreased/inadequate thickness of acrylic resin in the anterior portion of the denture where the final attachments were positioned. Hence it was planned to reinforce metallic frame work into the implant supported over denture which reduce the problems of repeated denture fracture. Past reports suggests that the incorporation of metal frameworks may reinforce or strengthen removable prosthesis [8]. Incorporation of a metal frame work, metal reinforcing mesh, or woven or fiberglass-impregnated mesh have been recommended to improve resistance to denture fracture during function [9]. This would facilitate longer durability of the dentures.

Alginate impression of edentulous ridge along with the ball abutments were made with perforated edentulous tray and special tray fabricated with auto polymerizing acrylic resin. Border molding was done with the help of green stick compound and final impression was made with additional silicone. Metal housings were not removed from the existing denture as patient did not want to be edentulous. Definitive casts poured with type II dental stone. Relief wax was placed along the crest of the residual alveolar ridge and tissue stops were positioned. Since the metal housings were placed in the repaired denture, shaped block out was made over

the ball abutments of the definitive cast with the similar dimensions [Table/Fig-3]. Further, definitive cast was duplicated with agar. Refractory cast was achieved, on which wax pattern was adapted corresponding to the planned metallic frame work design [Table/Fig-4]. The pattern along with the refractory cast was invested, burned out, casted, divested, finished and polished.
