Bus Stops and Pedestrian-Motor Vehicle Collisions in Lima, Peru: A Matched Case-Control Study

Objective—To evaluate the relationship between bus stop characteristics and pedestrian-motor vehicle collisions.

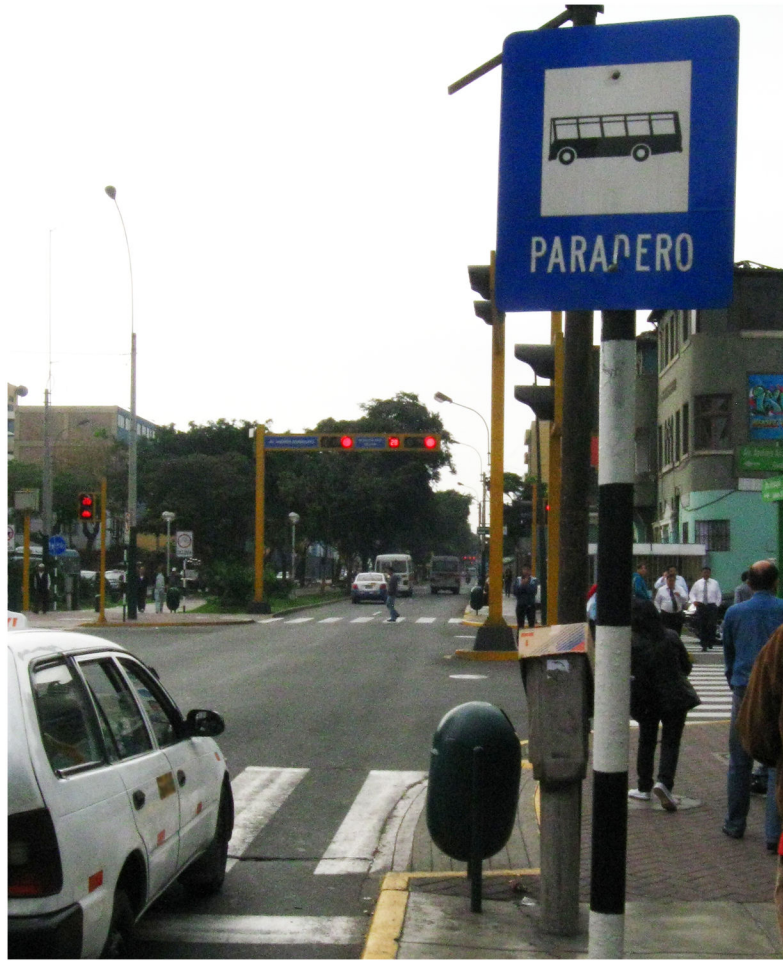
Figure 2.

The primary outcome was the presence of a pedestrian-motor vehicle collision reported to the police. The primary exposures were the presence of a bus stop, the type of bus stop (authorized or unauthorized, Figure 2), whether there were any bus-dedicated traffic lanes (Figures 3a and 3b), the presence of a painted stop area for buses (Figure 3c) and the presence of a bus bay area for boarding and alighting passengers (Figure 3d). Unauthorized stops were identified as any location where an observed bus picked up or dropped off passengers where no municipal bus stop sign was present. Some of the bus-dedicated traffic lanes were part of a bus rapid transit system in Lima (*El Metropolitano*).
