CASE REPORT

Failure of a Knee Joint Load Absorber: Pain, Metallosis and Soft Tissue Damage

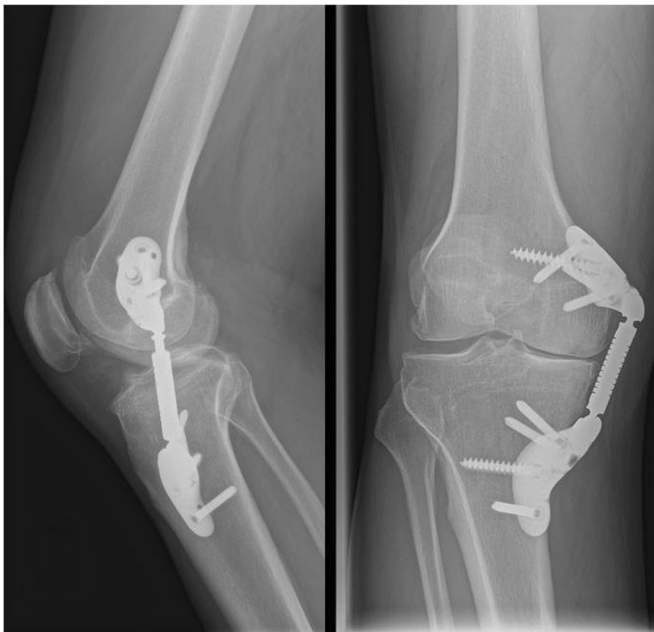
Fig. 1. The lateral and anterior-posterior radiographs of the right knee with the intact device prior to surgery.

Radiographic evaluation by means of radiographs in two plains of the knee joint (Fig. 1) as well as a long leg anterior-posterior radiograph (Fig. 2) showed an intact device and no signs of fracture or other bone lesions.

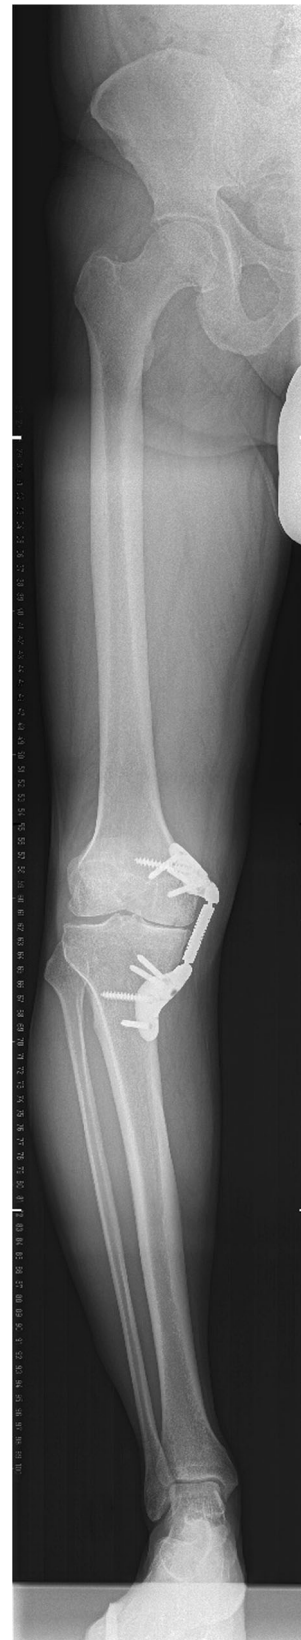
Fig. 2. The long leg anterior-posterior radiograph of the right leg with the implanted device in place prior to revision surgery.

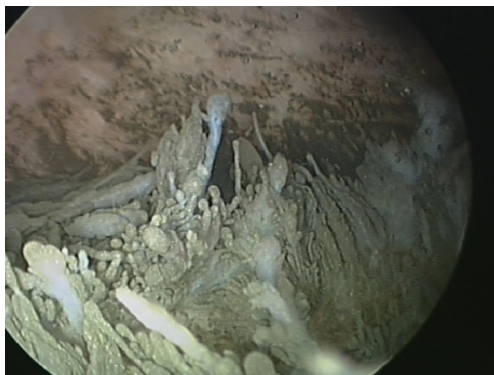
Fig. 3. An arthroscopic view of the superior articular recessus of the patients affected the right knee with extensive synovitis and metallosis.

Arthroscopy of the knee joint was performed via standard antero-medial and antero-lateral portals. Extensive synovitis and metallosis were noted (Fig. 3). There was full thickness cartilage erosion on the medial femoral condyle and the tibia. The medial joint capsule showed disruption with free visualization of the implant spring underneath the pars intermedia of the medial meniscus due to penetration of the device into the joint (Fig. 4). Arthroscopic partial synovectomy was performed, and biopsies were obtained for analysis followed by open hardware removal of the implant. Figure 5 shows the intra-operative site with the implant still in place (Fig. 5a) and after removal (Fig. 5b).

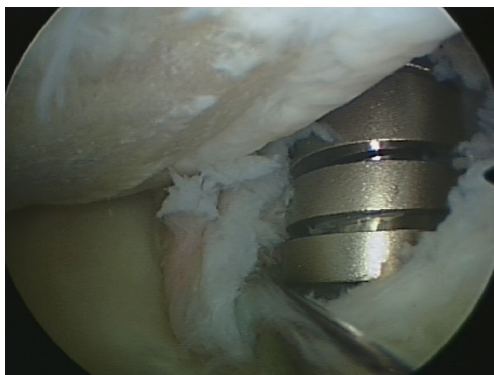
Fig. 4. An arthroscopic view of the medial joint compartment with disruption of the joint capsule and penetration of the implant into the joint space.

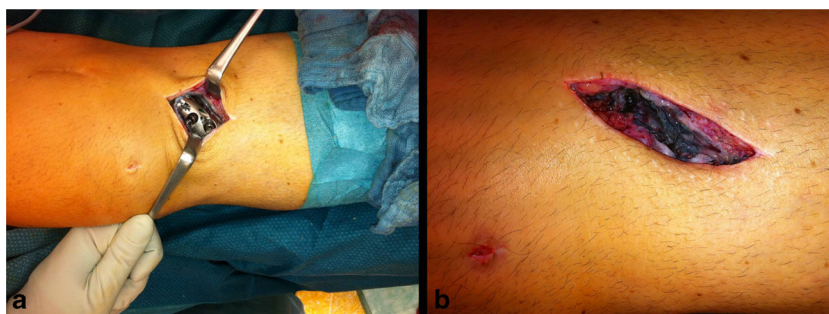
After removal of the implant, the full extent of metallosis could be perceived. Histopathological examination of a synovial biopsy showed synovial hyperplasia combined with an extensive burden of metal wear particles (Fig. 6).

Fig. 5. **a** This intra-operative image documents the exposure of the tibial component of the KineSpring device. **b** This intra-operative photograph documents the extensive metallosis remaining after removal of the implant.

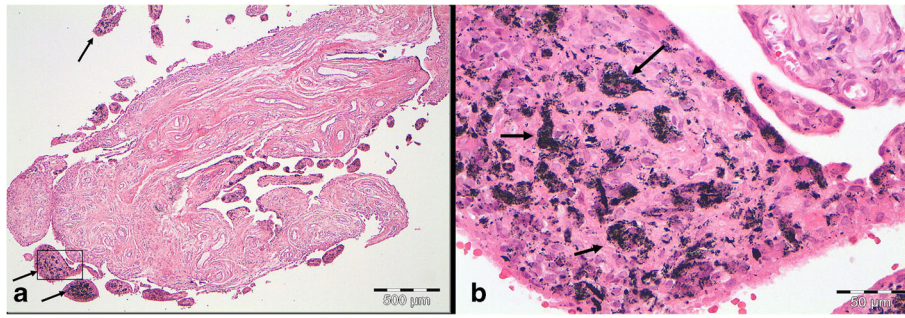
Fig. 6. **a** This histology specimen prepared with hematoxylin and eosin staining of a synovial biopsy shows extensive amounts of metal wear particles indicated by the *black arrows* ($\times 40$ magnification). **b** This part of the figure shows a higher power photograph of the area indicated by the *black box* of **a**. Black metal wear particles are indicated by the *black arrows* ($\times 400$ magnification).
