MR Imaging of Knee Arthroplasty Implants¹

Jan Fritz, MD²
Brett Lurie, MBBS
Hollis G. Potter, MD

RadioGraphics 2015; 35:1483–1501

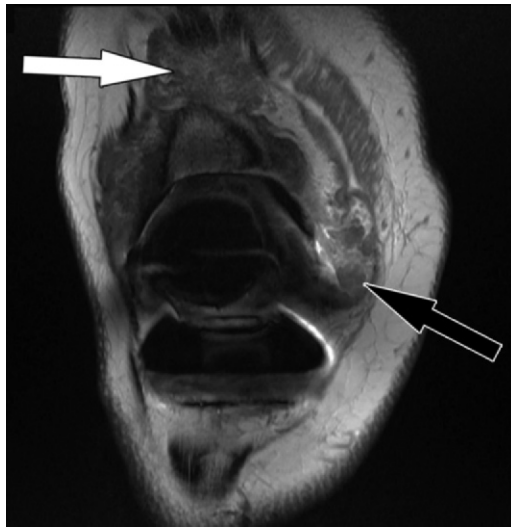
Figure 7. Polyethylene wear-induced synovitis after total knee arthroplasty in a 79-year-old man. Coronal intermediate-weighted fast SE image shows dense synovial proliferations (white arrow) and low-to-intermediate-signal-intensity debris (black arrow), similar to the signal intensity of skeletal muscle.

At MR imaging, polyethylene wear-induced synovitis is typically characterized by synovial thickening with dense synovial proliferation and debris with low-to-intermediate signal intensity (similar to the intensity of skeletal muscle), with variable amounts of interspersed fluid and joint distention (Fig 7). With an increasing burden of intracapsular synovial proliferation and debris, bone erosions can occur (Fig 8). The formation of polyethylene granulomas or focal expansion of the capsule can cause regional neurovascular compression. Polyethylene wear-induced osteolysis is typically geographic and contains particulate debris of intermediate signal intensity that replaces the normal periprosthetic trabecular bone and high-signal-intensity fat of the marrow (Figs 2, 9). This sharp contrast resolution allows for segmentational quantitative volumetry of osteolysis for longitudinal monitoring (34).

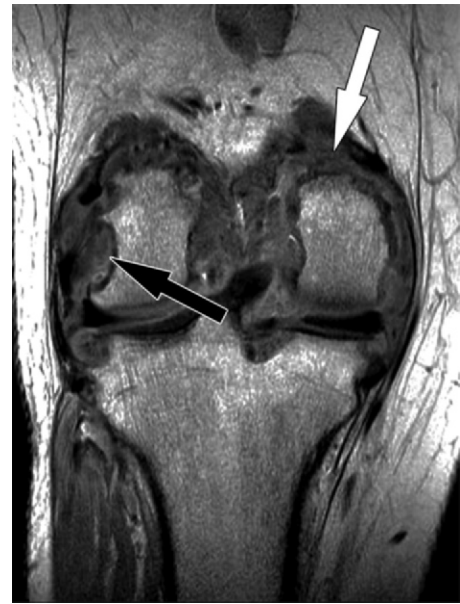
Figure 8. Polyethylene wear-induced synovitis with erosion after total knee arthroplasty in an 88-year-old woman. Coronal intermediate-weighted fast SE image shows dense synovial proliferations, low-to-intermediate-signal-intensity debris (white arrow), and a dominant erosion at the lateral femoral condyle (black arrow) and tibial plateau.

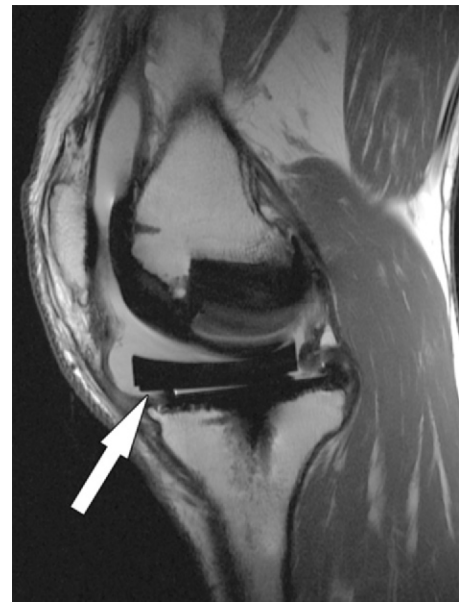
Figure 14. Displacement of the liner after total knee arthroplasty in a 52-year-old man. Sagittal intermediate-weighted fast SE image shows an anteriorly displaced polyethylene insert (arrow).

suited for the detection of fractured polyethylene arthroplasty components (Figs 13, 14).

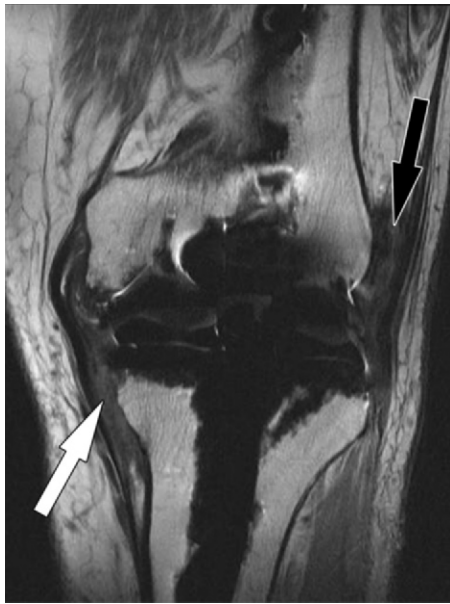
Figure 18. Arthrofibrosis after total knee arthroplasty in an 82-year-old man. Coronal intermediate-weighted fast SE image shows low-to-intermediate-signal-intensity fibrotic tissue proliferation obliterating the medial (white arrow) and the lateral (black arrow) gutters.

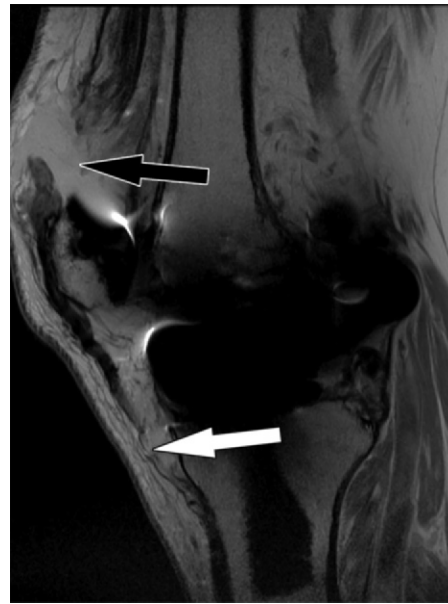
Figure 23. Quadriceps tendon rupture after total knee arthroplasty in a 72-year-old man. Sagittal intermediate-weighted fast SE image shows a full-thickness quadriceps tendon tear (black arrow) and patella baja. Additionally, there is a partial-thickness patellar tendon tear (white arrow).
