Postoperative radiograph of the hip arthroplasty: what the radiologist should know

Abstract This pictorial review aims to provide the radiologist with simple and systematic guidelines for the radiographic evaluation of a hip prosthesis. Currently, there is a plethora of commercially available arthroplasties, making postoperative analysis not always straightforward. Knowledge of the different types of hip arthroplasty and fixating techniques is a prerequisite for correct imaging interpretation. After identification of the type of arthroplasty, meticulous and systematic analysis of the following parameters on an anteroposterior standing pelvic radiograph should be undertaken: leg length, vertical and horizontal centre of rotation, lateral acetabular inclination, and femoral stem positioning. Additional orthogonal views may be useful to evaluate acetabular anteversion. Complications can be classified in three major groups: periprosthetic lucencies, sclerosis or bone proliferation, and component failure or fracture.

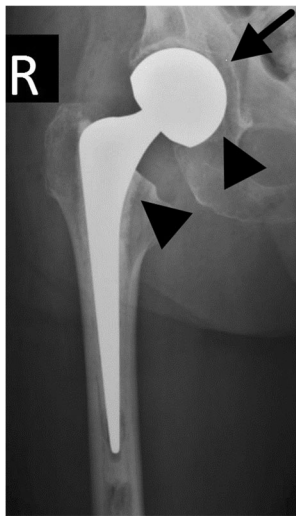
Fig. 1 Anteroposterior (AP) radiograph. Cemented unipolar hemiarthroplasty. The femoral stem with the fixed head (*arrowheads*) articulates with the native acetabulum (*arrow*)

In a hemiarthroplasty, the acetabulum is spared whereas the femoral head and neck are replaced. This type of prosthesis is indicated when the native acetabulum is unaffected. A unipolar hemiarthroplasty consists of a femoral stem with a fixed head, which articulates with the native acetabulum (Fig. 1). A bipolar

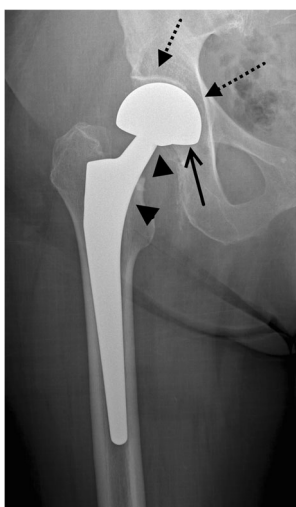
Fig. 2 AP radiograph. Cementless bipolar hemiarthroplasty. The femoral stem with a fixed head (*arrowheads*) articulates with a polyethylene lined metal cup (*arrow* indicates position of the radiolucent polyethylene), which articulates with the native acetabulum (*dotted arrow*)

hemiarthroplasty consists of a femoral stem with a fixed head and a polyethylene lined metal cup, accommodating motion between the cup and the prosthetic head as well as between the cup and the native acetabulum (Fig. 2). In a resurfacing hemiarthroplasty, only the femoral head is replaced (Fig. 3).

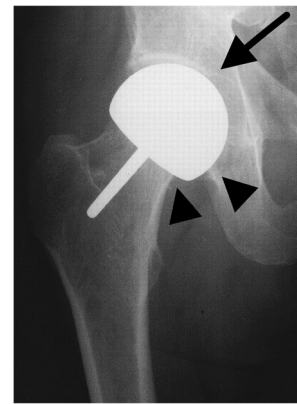
Fig. 3 AP radiograph. Cementless resurfacing hemiarthroplasty. Only the femoral head is replaced (*arrowheads*), which articulates with the native acetabulum (*arrow*)

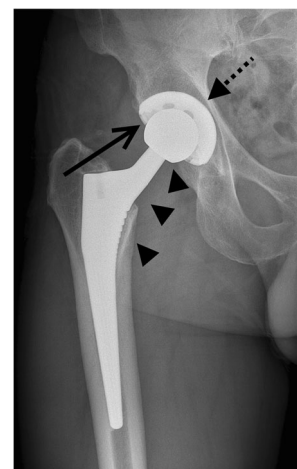
Fig. 4 AP radiograph. Cementless total hip arthroplasty. In a total hip arthroplasty, both femoral head and neck (*arrowheads*) as well as the acetabulum (*dotted arrow*) are replaced. The *open arrow* indicates the position of the radiolucent polyethylene cup at the articulation of the prosthetic femoral head and the acetabulum

In a total hip arthroplasty both the femoral head and neck as well as the acetabulum are replaced (Fig. 4). In a resurfacing total hip arthroplasty, the femoral head and acetabulum are replaced, whereas the femoral neck is spared (Fig. 5).

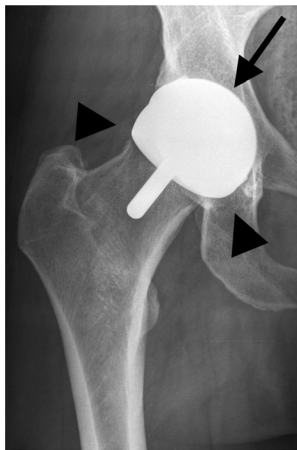
Fig. 5 AP radiograph. Cementless resurfacing total hip arthroplasty. In a resurfacing total hip arthroplasty, the femoral head (*arrowheads*) and acetabulum (*arrow*) are replaced. No radiolucent area at the femoral head—acetabulum is noted (metal—on—metal bearing surface)

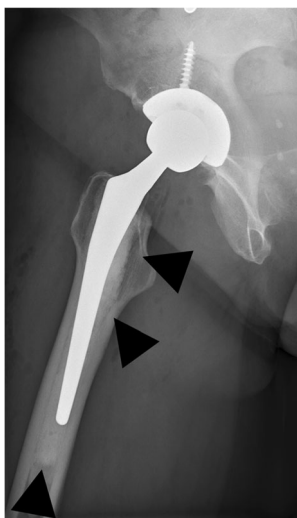
Fig. 6 AP radiograph. Cemented total hip arthroplasty, single acetabular screw fixation. In a hybrid cemented arthroplasty, the femoral stem is fixed with cement (*arrowheads*)

Bone cement consists of a mixture of an acrylic cement and additives, including Barium (or Zirconium) to render it radio-opaque. Hybrid arthroplasty is a combination of a cemented femoral stem and a cementless acetabular cup, whereas in a reverse hybrid arthroplasty a cementless femoral stem and a cemented acetabular cup are used (Figs. 6 and 7) [5].

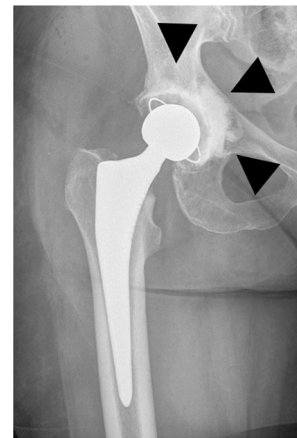
Fig. 7 AP radiograph. Cemented total hip arthroplasty. In a reverse hybrid cemented arthroplasty, the acetabular cup is fixed with cement (*arrowheads*)

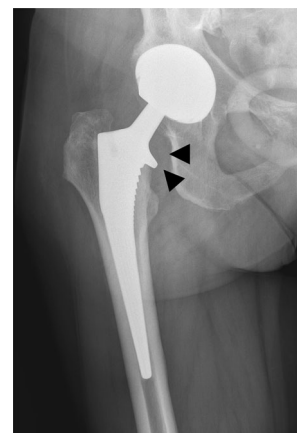
Fig. 8 AP radiograph. Cementless total hip arthroplasty. *Arrowheads* indicating the collar of this collared femoral stem

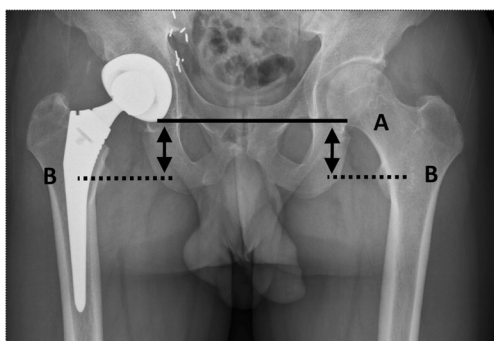
Fig. 9 The leg length is measured as the distance between line *A* (connecting the undersurface of the acetabular teardrop shadows) and line *B* (through the middle of the lesser trochanter)

The leg length (Fig. 9) is measured by drawing a line transversely connecting the inferior borders of the acetabular teardrop shadows, the pelvic reference line. The lesser trochanters are used as the femoral reference lines. Perpendicular lines are drawn from the pelvic reference line to the femoral reference lines, the difference between the distances being the leg length discrepancy [8]. Leg length inequality is common after hip arthroplasty; a discrepancy of up to 1 cm is well tolerated. Moderate inequalities are usually corrected with a shoe orthosis.

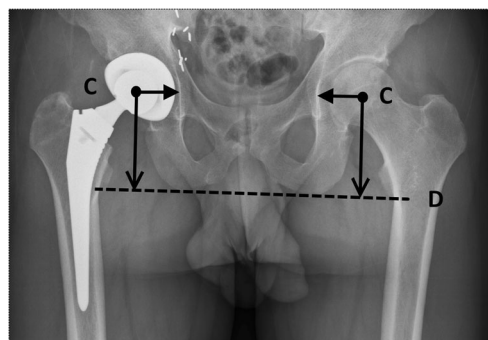
Fig. 10 The horizontal centre of rotation is defined as the distance between the centre of the femoral head (point *C*) and the lateral outline of the teardrop shadow. The vertical centre of rotation is defined as the distance between the centre of the femoral head (point *C*) and the transischial tuberosity line (line *D*)

The horizontal centre of rotation (Fig. 10) is defined by the distance between the centre of the femoral head and

the teardrop shadow. Ideally, this distance should be equal to that of the contralateral hip; excessive lateral positioning of the acetabular component increases the risk for dislocation and may cause limping.

The vertical centre of rotation (Fig. 10) is defined by the distance between the centre of the femoral head and the transischial tuberosity line. Ideally, this distance should be equal to that of the contralateral hip, mimicking normal anatomy.

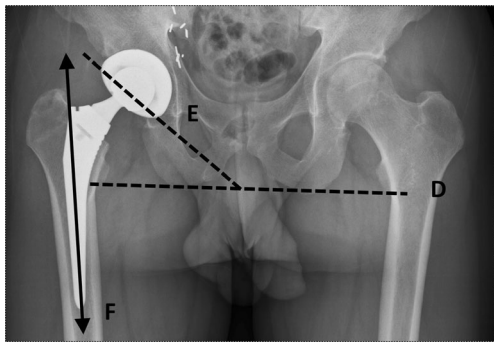
Fig. 11 The acetabular inclination is measured by drawing a line through the medial and lateral margins of the cup (line *E*) and measuring the angle with the transverse pelvic axis (line *D*). The femoral stem positioning should be aligned with the longitudinal axis of the shaft (line *F* = normal, longitudinal axis of the shaft)

The acetabular inclination (Fig. 11) is the angle between the articular side of the acetabular cup and the transverse axis. Measurement of this angle can be done by drawing a line through the medial and lateral margins of the cup and measuring the angle with the transischial tuberosity line. The normal range of inclination is between 30 and 50° [9]. Smaller angles provide a stable

Ideally, the position of the femoral stem (Fig. 11) on an AP view should be seen in neutral alignment with the longitudinal axis of the femoral shaft, and the tip situated in the centre of the shaft. Many studies have shown that failure of the femoral stem is associated with varus malpositioning [10–12]. The femoral

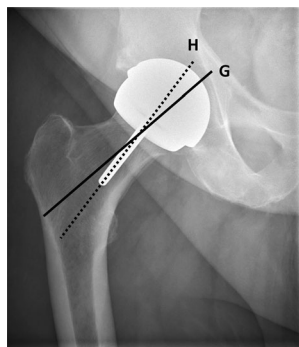
Fig. 12 Normal valgus positioning of the femoral stem in a resurfacing arthroplasty (line *H*) compared with the longitudinal axis of the femoral neck (line *G*)

component of a resurfacing arthroplasty should be placed in a relative valgus position of 5° – 10° (Fig. 12).

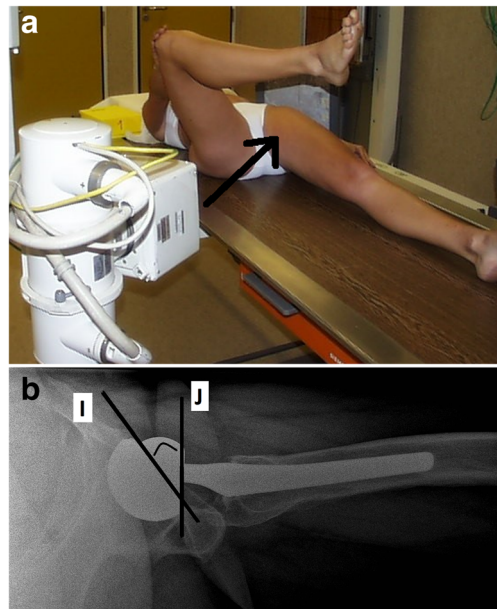
Fig. 13 a Photograph of the patient positioning for a lateral view of the hip, the *arrow* indicating the direction of the x-rays. **b** Lateral radiograph. The acetabular anteversion is defined by the angle between the acetabular axis (line *I*) and the coronal plane (line *J*). In this patient, the angle measures approximately 25° (normal range between 5°–25°)

coronal plane (Fig. 13). Normal value ranges from 5° to 25° anteversion as this allows adequate flexion of the hip [13]. Acetabular retroversion predisposes to hip dislocation.

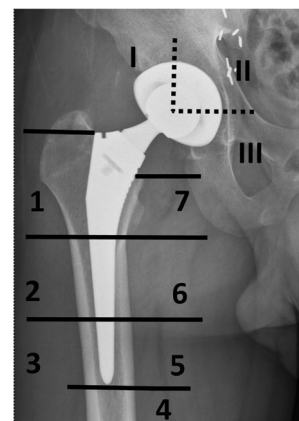
Fig. 14 Standardized template for radiographic assessment of periprosthetic lucency, with three acetabular zones (*I–III*) and seven femoral zones (*I–7*)

For localization of cement-related or periprosthetic abnormalities at the acetabular and femoral components, standardized templates have been described by Charnley-Delee [16] and Gruen [17], respectively (Fig. 14).

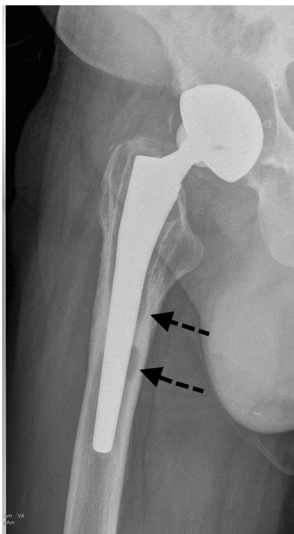
Fig. 15 AP radiograph, 3 years postoperatively. Cementless bipolar hemiarthroplasty. Aseptic loosening, radiographically seen as periprosthetic lucencies in a Gruen zone 5/6 (arrows)

Aseptic loosening or osteolysis (Fig. 15) is a biological process that is initiated by macrophage phagocytosis of particulate debris, causing an aseptic foreign body granulomatosis [18]. The implant becomes separated from the host bone, resulting in mechanical (aseptic) loosening. On a radiograph, this manifests as a periprosthetic zone of radiolucency around the bone-cement or the bone-prosthesis interface.

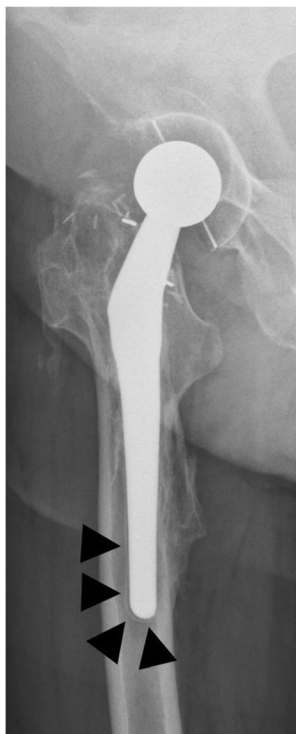
Fig. 16 AP radiograph. Cementless total hip arthroplasty. A < 2 mm lucency, outlined by a discrete sclerotic margin, in Gruen zone 3/4 (arrowheads): this indicates a fibrous rather than bony ingrowth, thought to provide sufficient stability

Aseptic loosening and osteolysis should be differentiated from other, nonpathological causes of periprosthetic lucencies. In a cemented arthroplasty, a < 2 mm lucency at the bone-cement interface indicates the formation of a fibrous membrane (representing the lucency), outlined by a thin, sclerotic demarcation line [19]. This is thought to represent a stable fibrous reaction to cement. In a cementless arthroplasty, a similar < 2 mm lucency also outlined by a thin sclerotic line, along a polished segment where no bony ingrowth is expected, indicates fibrous bony ingrowth and is thought to provide sufficient stability (Fig. 16) [20].

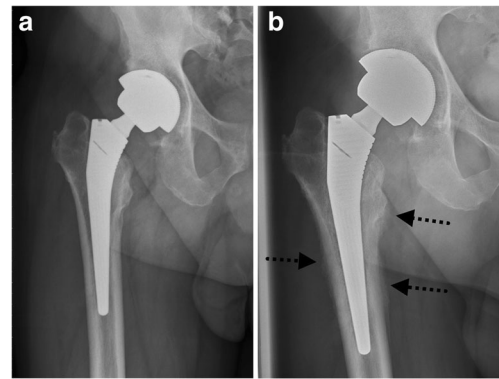
Fig. 17 **a** AP radiograph, 1 month postoperatively. Cementless total hip arthroplasty. Normal postoperative findings. **b** AP radiograph of the same patient, 3 months postoperatively. Periprosthetic reaction in Gruen zone 2/5/6/7 (arrows): proven case of infection

aseptic loosening can be very challenging, especially when no previous radiographs are available. However, the presence of a femoral periosteal reaction [22] (Fig. 17) or rapid progressive disease [23] (Fig. 18) are indicative of septic rather than aseptic loosening.

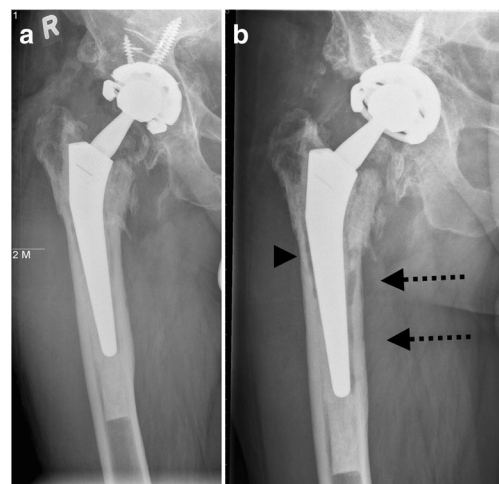
Fig. 18 **a** AP radiograph, 4 months postoperatively. Cemented (hybrid) total hip arthroplasty after revision with acetabular fixation screws. Normal postoperative findings. **b** AP radiograph of the same patient, 5 months postoperatively. Periprosthetic lucencies in Gruen zone 5/6 (arrows) and more discrete in Gruen zone 2 (arrowhead): proven case of infection

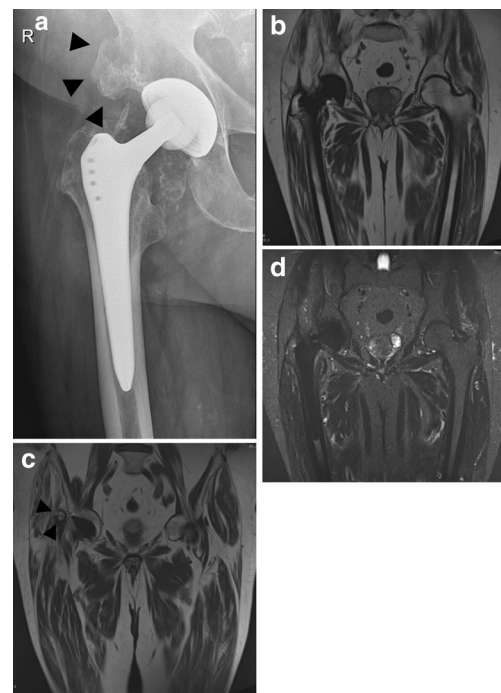
Fig. 20 Although current state-of-the art MRI with Metal Artefact Reduction Sequences allows assessment of correct position of the hip prosthesis as well as periarticular abnormalities, mature heterotopic bone formation (arrowheads in A and C) is often more readily visible on plain radiographs than on MRI due to similar signal of mature bone marrow and fatty infiltration within the gluteus musculature at the site of the hip prosthesis. **a** AP radiograph. Cementless total hip arthroplasty. Heterotopic bone formation (arrowheads), 7 years postoperatively. **b** T1-weighted, coronal image (WI) of the pelvis in the same patient. **c** T1-weighted, coronal image (WI) of the pelvis at a more anterior location barely showing heterotopic bone formation (arrowheads). **d** STIR, coronal image of the pelvis in the same patient

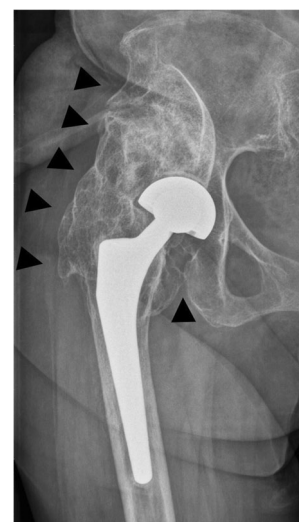
Fig. 21 AP radiograph. Cementless bipolar hemiarthroplasty. Extensive heterotopic bone formation (arrowheads), bridging from femur to pelvis, restricting abduction

Development of bone outside its normal location in the skeleton is termed *heterotopic bone* formation, occurring in up to half of patients; this rarely results in significant limitation of movement (Figs. 20 and 21) [28].

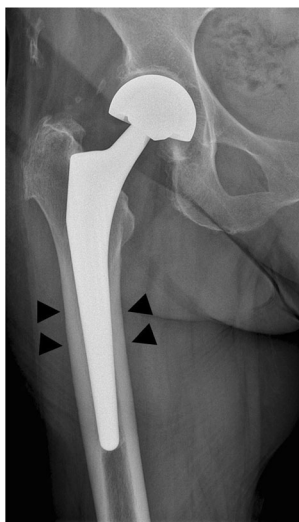
Fig. 22 AP radiograph. Cementless bipolar hemiarthroplasty. Spot welding (new bone formation originating from the endosteal surface and reaching the prosthesis) in Gruen zone 2/6 (arrowheads)

Spot welding consists of new bone formation originating from the endosteal surface and reaching the prosthesis. This is mostly seen in cementless femoral stems and is a strong indicator of stability (Fig. 22) [29].

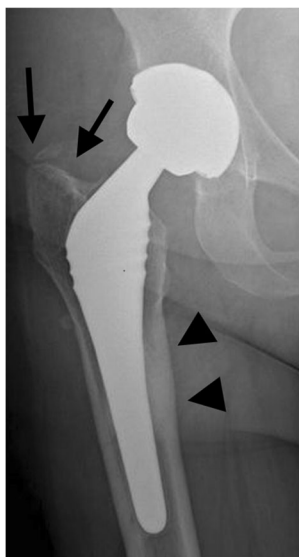
Fig. 23 AP radiograph. Cementless total hip arthroplasty. Stress shielding. Cortical hypertrophy in Gruen zone 1 (arrowheads) and adaptive atrophy in Gruen zone 6 (arrows) as different parts of reactive bone remodelling

Stress shielding refers to the transfer of the normal load from the femoral neck and intertrochanteric region to the proximal femoral diaphysis (the hip implant causes altered mechanical forces), causing bone resorption on the lateral side of the proximal femur, most commonly seen in Gruen zone 1, as well as bone hypertrophy at the medial side of the proximal femur (Fig. 23). This process implies stability and should not be misinterpreted as a complication [30].

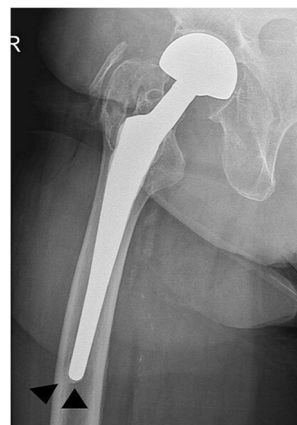
Fig. 24 AP radiograph. Cementless bipolar hemiarthroplasty. Bone pedestal in zone 4 (arrowheads). The association with loosening remains unclear

Sclerosis at the tip of a cementless femoral component, bridging the medullary canal, is a *bone pedestal* (Fig. 24). The association of this often incidentally found entity with loosening remains unclear [31].

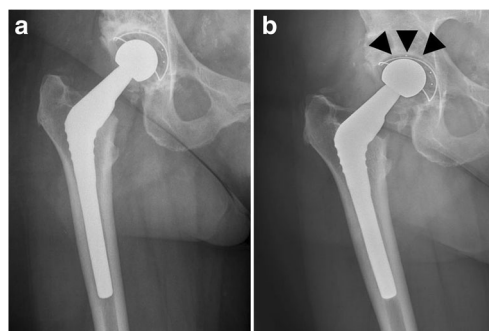
Fig. 25 **a** AP radiograph, 6 months postoperatively. Cementless total hip arthroplasty. Normal postoperative findings. **b** AP radiograph of the same patient, 4 years postoperatively. Cranial displacement of the femoral head in the acetabular cup (arrowheads), indicating linear wear

Linear wear occurs typically in hip arthroplasty with a polyethylene component (hard-on-soft or soft-on-soft bearing surface combination). An asymmetric position of the femoral head within the acetabular cup on radiographs is a definite sign of polyethylene wear (Fig. 25).

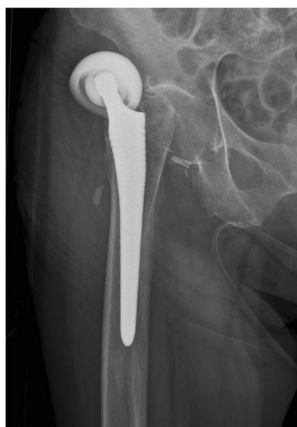
Fig. 26 AP radiograph. Cementless bipolar hemiarthroplasty. Lateral dislocation of head and acetabular cup

The reported rate of *dislocation* varies from 0.5 to 10 % after primary total hip arthroplasty [32]. Most dislocations occur in the early postoperative period, during the initial weight bearing (Fig. 26) [33]. Abnormal acetabular inclination, acetabular retroversion or an incorrect center of rotation, among others, increase the likelihood of dislocation.

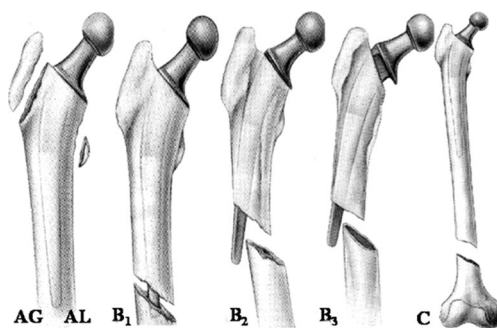
Fig. 27 Vancouver classification of periprosthetic fractures. *Type A* fractures are peritrochanteric fractures (subtypes *AG*: greater trochanter and *AL*: lesser trochanter). *Type B* fractures occur around or just below the tip of the femoral stem (subtypes *B1*: stable stem, *B2*: loose stem, *B3*: loose implant with substantial bone loss). *Type C* fractures occur well below the implant (image courtesy of Hwang KT, Kim YH (2011) Treatment of periprosthetic femoral fractures after hip arthroplasty. J Korean Fract Soc 24:121–130)

Periprosthetic fractures occur more often around the femoral than the acetabular component, be it intra- or postoperative. The Vancouver classification divides the periprosthetic, postoperative fractures of the femur into three major types (Fig. 27) [34]. Postoperative femoral fractures occur typically, but not exclusively, at the level of the tip of the femoral stem (Fig. 28).

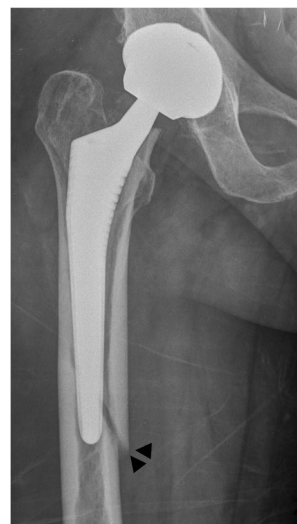
Fig. 28 AP radiograph. Cementless total hip arthroplasty. Periprosthetic fracture in Gruen zone 5 (arrowheads), Vancouver type B1 fracture

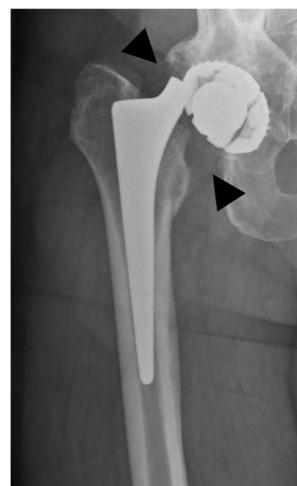
Fig. 29 AP radiograph. Cementless total hip arthroplasty. Proximal prosthetic/metallic fracture through the neck of the femoral implant (arrowheads)

Prosthetic fractures occur mostly in the femoral stem of the implant, representing a metal-fatigue stress fracture; this typically occurs in prostheses that are well fixed distally but are mobile proximally and result in fractures through the middle or proximal third of the stem (Fig. 29) [35]. Patients with increased body mass index (BMI) are at greater risk of reaching an implant failure point due to fatigue loading [36]. Varus malpositioning predisposes to fractures of the femoral stem.
