Male Pectoral Implants: Radiographic Appearance of Complications

Radiology Case. 2016 Mar; 10(3):11-19 :: DOI: 10.3941/jrcr.v10i3.2549

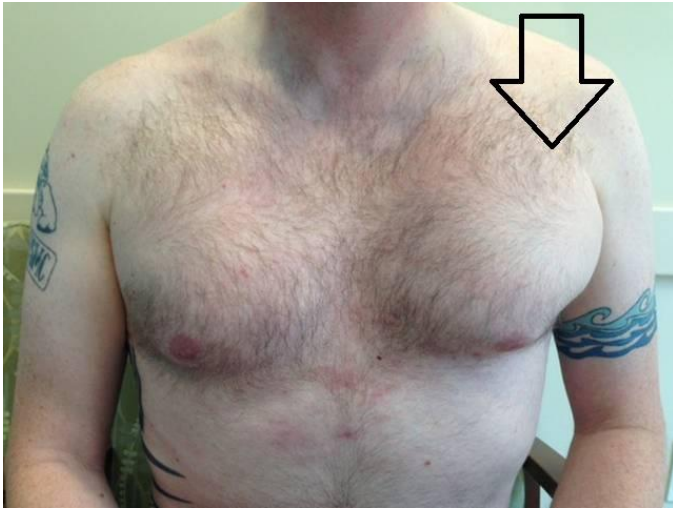
Figure 1: 44-year-old male with left pectoral implant displacement.

FINDINGS: Photograph demonstrates gross asymmetry and increase in size of the left side of the patient's chest (open arrow) secondary to implant displacement and soft tissue swelling.

On physical exam, the patient had bilateral pectoral implants with gross asymmetry of the left side of his chest (Figure 1). The left side of the chest was about two times the size of the right. There was lateral displacement with overlying soft tissue swelling and near extrusion, a forcing out of a normal position, of left pectoral implant. There was a 4 cm x 3 cm area of inflamed and thinned skin laterally to the nipple level at the site of the impending extrusion (Figure 2). Since the soft tissue swelling of the chest was concerning for a mass in this HIV+ patient, the patient was sent for bilateral diagnostic mammography and ultrasound to exclude carcinoma or infection.

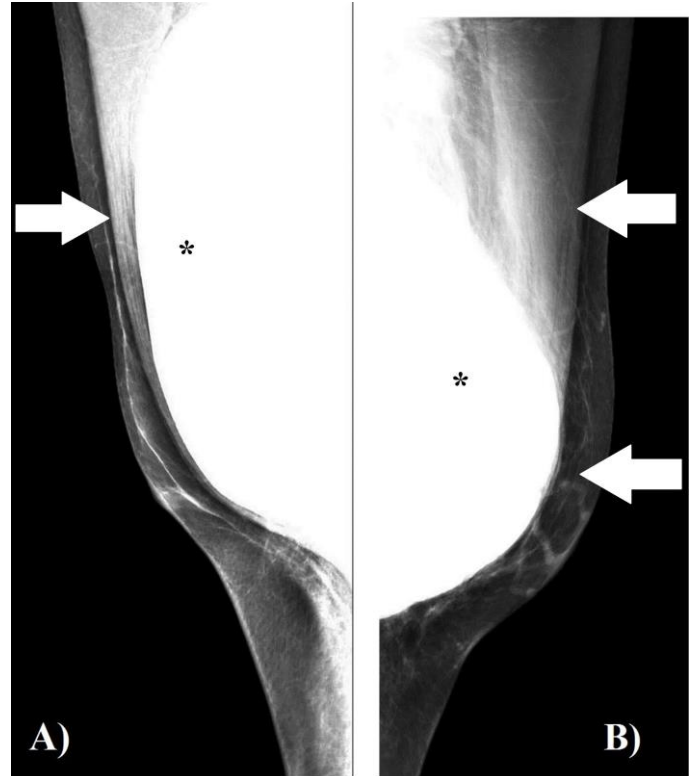
Figure 3: 44-year-old male with left pectoral implant displacement.

FINDINGS: Mammographic mediolateral oblique "implant in-view" of both breasts. The implants (*) are composed of silicone and appear white on the mammogram due to attenuation of the x-ray beam.

A) Correct positioning of the right silicone implant posterior to the pectoralis muscle (arrow). B) Abnormal position of the left silicone implant. It is displaced anteriorly and inferiorly (arrows) compared to the right implant in A.

TECHNIQUE: Digital mammogram, mediolateral oblique "implant in-view" of both breasts.

A) Right mammogram - 110 milliamperage second (mAs), 29 kilovolts (kV), target/filter combination: molybdenum/rhodium, 10.5 cm compression thickness.

B) Left mammogram - 130 mAs, 28 kV, target/filter combination: molybdenum/rhodium, 10.4 cm compression thickness.

Mammography showed bilaterally fatty replaced breasts without mass, distortion or calcifications. Bilateral subpectoral silicone implants were present. There was asymmetric orientation of the left implant, displaced anterolateral and inferiorly, relative to the normally positioned right pectoral implant (Figure 3). Additionally, on the craniocaudal view of the left breast, the overlying left pectoralis muscle was thinned significantly and was compatible with loss of integrity (Figure 4).

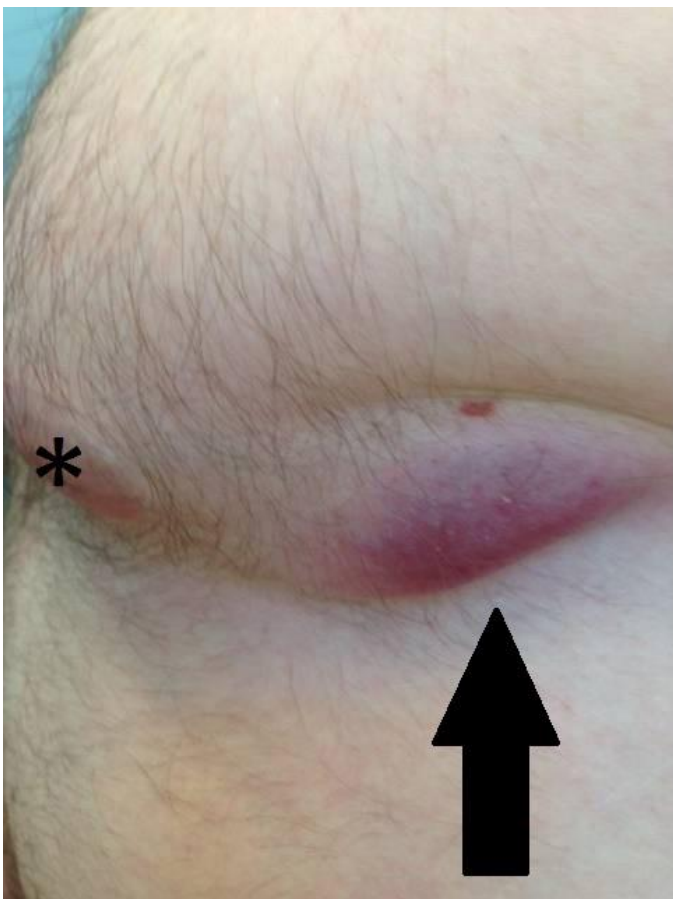
Figure 2 (left): 44-year-old male with left pectoral implant displacement with near extrusion of the implant through the skin.

FINDINGS: 4 cm x 3 cm area of inflamed and thinned skin (arrow) lateral to the nipple (*) at the site of the impending extrusion of the implant.

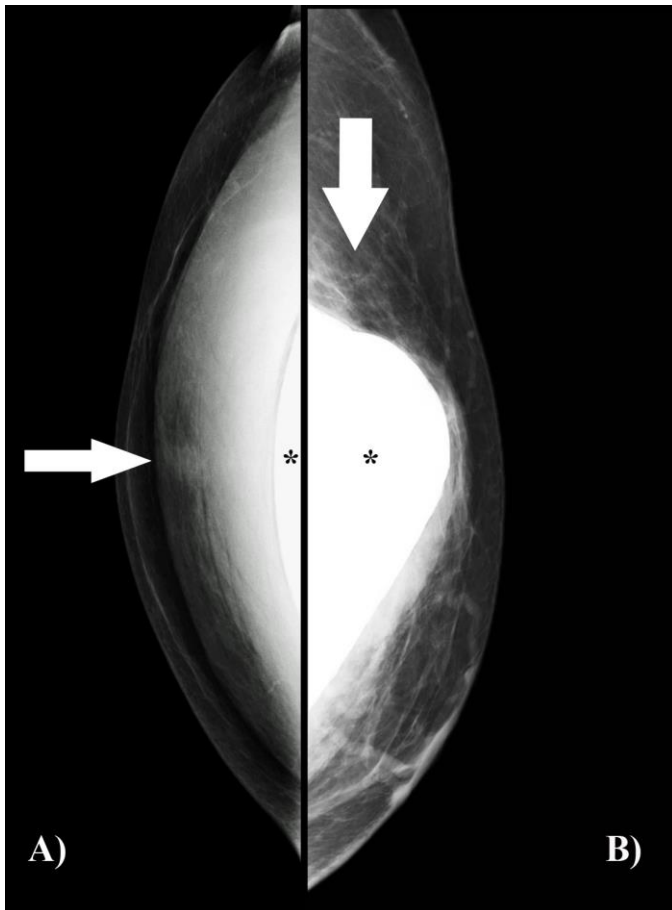
Figure 4: 44-year-old male with left pectoral implant displacement.

FINDINGS: Mammographic craniocaudal "implant in-view" of both breasts. The implants (*) are composed of silicone and appear white on the mammogram due to attenuation of the x-ray beam.

A) Correct positioning of the right silicone implant (*) posterior to the intact pectoralis muscle (arrow).

B) Abnormal position of the left silicone implant (*). The implant is displaced anteriorly and laterally. The overlying pectoralis muscle is thinned significantly (arrow) laterally. This is compatible with loss of pectoralis muscle integrity. The rest of the pectoral silicone implant is located posterior to the visualized pectoralis muscle.

TECHNIQUE: Digital mammogram craniocaudal "implant in-view" of both breasts.

A) Right mammogram -115 mAs, 28KV, target filter combination: molybdenum/rhodium, 5.5 cm compression thickness.

B) Left mammogram - 110 mAs, 28 kV, target filter combination: molybdenum/rhodium, 5 cm compression thickness.

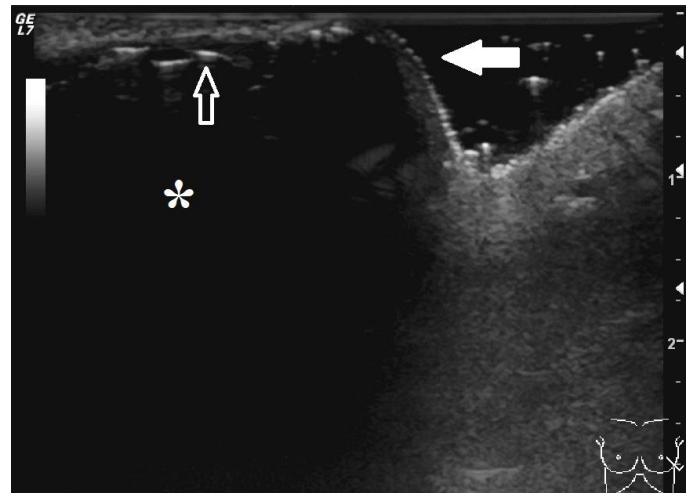
Figure 5: 44-year-old male with left pectoral implant displacement.

FINDINGS: Sonographic image of the displaced implant at site of impending extrusion. The implant (*) is anechoic. The thin echogenic line (open arrow) that is present between the anechoic implant and skin represents the anterior margin of the implant. The posterior margin of the implant is not visualized due to attenuation of the ultrasound beam by the silicone. The overlying pectoralis muscle is not readily appreciated and the implant is directly subjacent to the skin (closed arrow).

TECHNIQUE: Ultrasound, radial plane, 14 megahertz transducer.

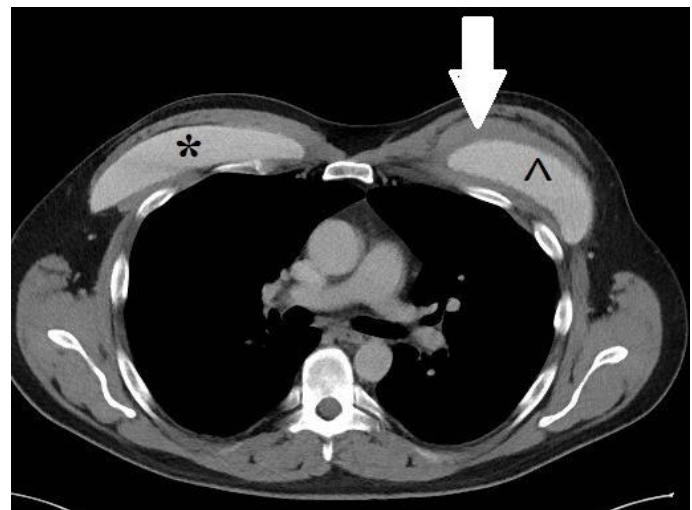
Figure 6: 44-year-old male with left pectoral implant displacement.

FINDINGS: Axial contrast CT, with too early of a scan time by the technologist, of the chest at the level of the great vessels demonstrates the normally placed right silicone pectoral implant (*). The right implant is located between the right pectoralis major and minor muscles. The left silicone pectoral implant (^) is displaced inferiorly and laterally. The silicone implants are high in density compared to muscle on CT imaging. In addition, there is a soft tissue density that is equal in density to slightly less dense than muscle that surrounds the displaced left implant (arrow) on this image. The soft-tissue density is thicker medially. The soft tissue density histologically was dense fibrotic tissue with acute and chronic

inflammation, histiocytic infiltrate, and granulation tissue consistent with inflamed implant capsule.

TECHNIQUE: Axial CT, 88 mAs, 140 kV, 5 mm slice thickness, contrast -with too early of a scan time by the technologist.

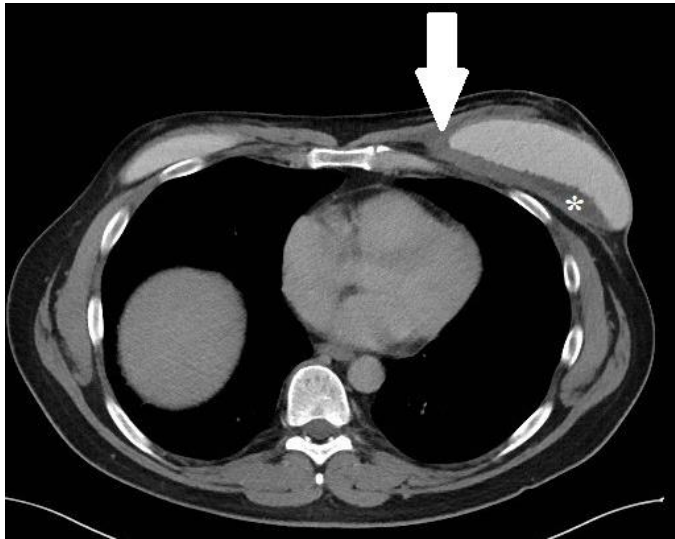
Figure 7: 44-year-old male with bilateral pectoral silicone implants with near extrusion of the left implant.

FINDINGS: Axial contrast CT, with too early of a scan time by the technologist, of the chest near the level of the diaphragm shows near extrusion of the left pectoral implant through the skin laterally at the level of the nipple with an associated soft tissue density (arrow). The soft tissue density is equal in density to slightly less dense than muscle and surrounds the displaced left implant. The soft-tissue density is thicker medially. Histologically it represented dense fibrotic tissue with acute and chronic inflammation, histiocytic infiltrate, and granulation tissue consistent with inflamed implant capsule. In addition, a 6 cm, low density, lenticular-shaped fluid collection (*) is located between the soft tissue density and the posterior aspect of the displaced left implant. On cytological examination, the peri-implant fluid represented fibrin, macrophages and acute inflammation.

TECHNIQUE: Axial CT, 88 mAs, 140 kV, 5 mm slice thickness, contrast -with too early of a scan time by the technologist.

Due to clinical concerns, a computed tomography (CT) study of the chest with contrast was ordered and performed on another day to further evaluate this patient. On the day of the CT study, the patient received an appropriate bolus of intravenous contrast; however, there was too early of a scan time by the technologist. Consequently, it was a limited study and the images appear as though there is no contrast in the vascular and soft tissue structures. Regardless of the contrast scanning time, the CT study demonstrated bilateral subpectoral silicone implants. The normally positioned right pectoral implant was located between the right pectoralis major and minor muscles. No associated findings were seen involving the right implant. The left pectoral silicone implant was displaced inferiorly and laterally with pending extrusion, Figure 6. There was a soft tissue density that was equal to slightly lower in density to muscle located circumferentially around the left implant. The soft tissue density was thicker along its medial aspect (Figure 6). Also detected was a 6 cm x 2 cm x 6 cm, low density, lenticular-shaped fluid collection located between the soft tissue density surrounding the implant and the posterior aspect of the displaced left implant (Figure 7). The underlying ribs appeared normal and no adenopathy was seen.

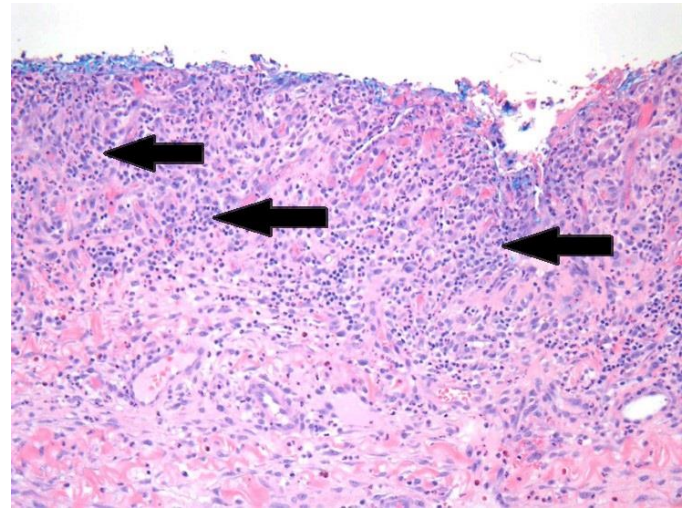
Figure 8: 44-year-old male with left lateral chest wall inflamed and thinned skin.

FINDINGS: Histology demonstrates marked mixed, predominantly acute, inflammation (arrows) involving the dermis and epidermis.

TECHNIQUE: Hematoxylin and eosin stain, 20x magnification.

Pathology of the thinned, inflamed skin showed a marked mixed, predominantly acute, inflammation involving the dermis and epidermis with prominent dermal eosinophils (Figure 8). All the pathologic tissue samples of muscle, chest wall and breast confirmed dense fibrotic tissue with acute and chronic inflammation and histiocytic infiltrate, consistent with inflamed implant capsule (Figure 9). Cytology of the peri-implant fluid showed fibrin, macrophages and acute inflammation. No carcinoma was identified in any of the tissue specimens or peri-implant fluid samples. In addition, microbiology of the fluid obtained during surgery demonstrated no anaerobic, aerobic or fungal growth.

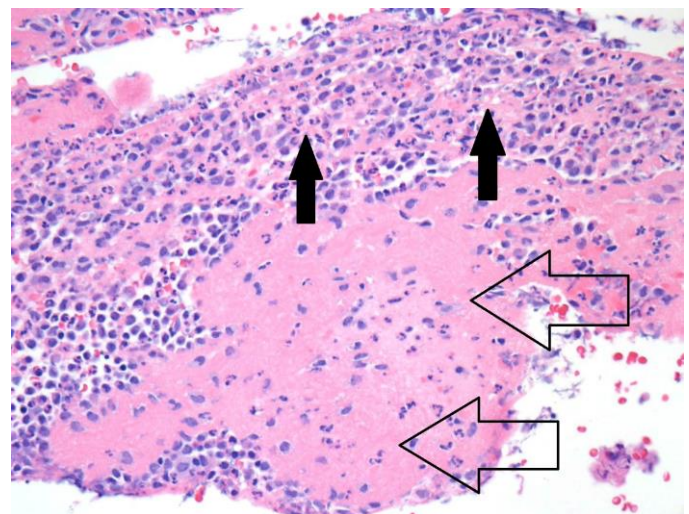
Figure 9: Histology, 44-year-old male with left peri-implant soft-tissue density.

FINDINGS: Histology demonstrates dense fibrotic tissue (open arrows) with acute and chronic inflammation and histiocytic infiltrate (closed arrows), consistent with inflamed implant capsule.

TECHNIQUE: Hematoxylin and eosin stain, 40x magnification.

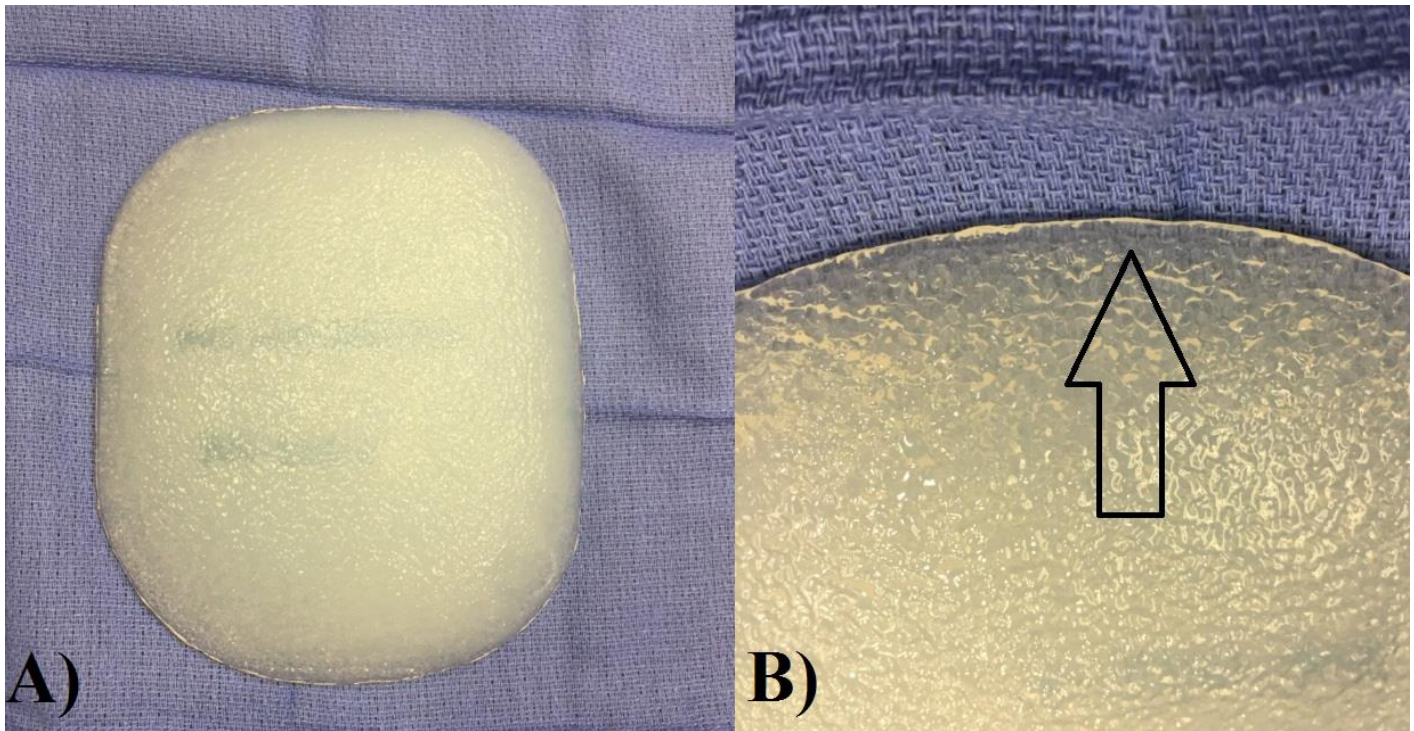
Figure 10: Example of a Pectoral Implant (AART, INC, pectoral implant, style 2, Carson City, NV, USA)

- A) Photograph demonstrates an example of a rectangular-shaped pectoral implant.
- B) Photograph demonstrates the taped, smooth edge of the pectoral implant (open arrow) and the textured exterior surface.

- A) Color photograph, Nikon Coolpix A, digital camera, 16.0 Megapixel.
- B) Color photograph, Nikon Coolpix A, digital camera, 16.0 Megapixel.
