# Scapular Spine Stress Fracture as a Complication of Reverse Shoulder Arthroplasty

Kimberly J. Burkholz, Catherine C. Roberts, and Steven J. Hattrup

## Scapular Spine Stress Fracture

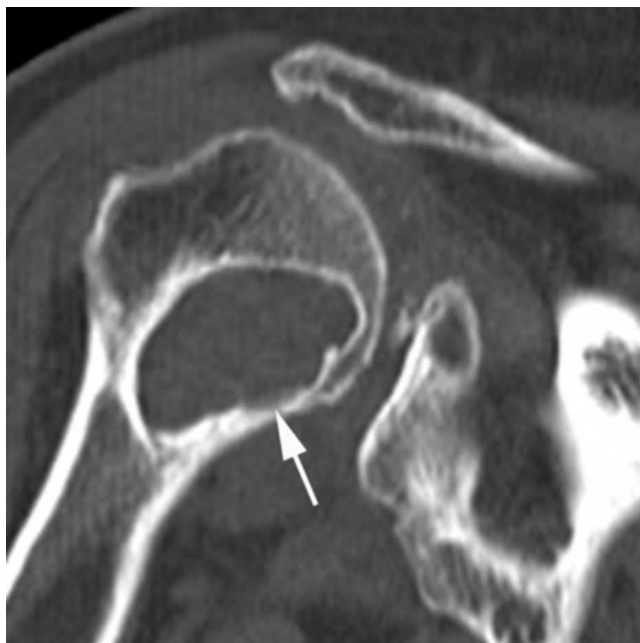
**Figure 1.** Coronal reconstructed CT of the right shoulder demonstrating a lytic lesion with a sclerotic border (arrow) involving the humeral head.

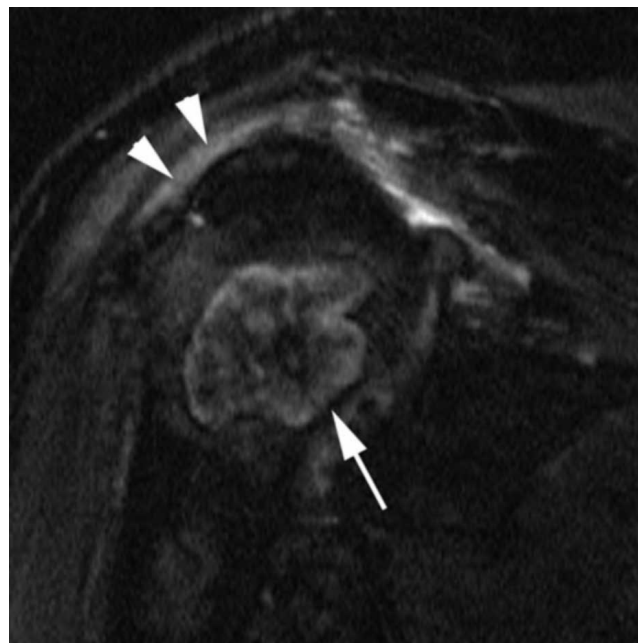
**Figure 2.** Coronal T2-weighted, fat suppressed MR image of the right shoulder also demonstrating the humeral head lesion (arrow). Abnormal signal involving the rotator cuff (arrowheads) was confirmed to represent full thickness tearing on additional images. Study was degraded by patient motion.

opsy revealed a giant cell tumor. In addition to the tumor, a preoperative MRI (Figure 2) also showed a recurrent full thickness tear of the supraspinatus and infraspinatus tendons with significant medial retraction of the torn tendons and severe muscle atrophy. Physical exam revealed a man with a well-healed anterior right shoulder incision, who was otherwise fairly healthy. The right shoulder had limited range of motion with approximately 30 degrees of elevation, 40 degrees of abduction, and 50 degrees of external rotation. There was marked weakness in abduction and external rotation. He had significant subacromial crepitus.

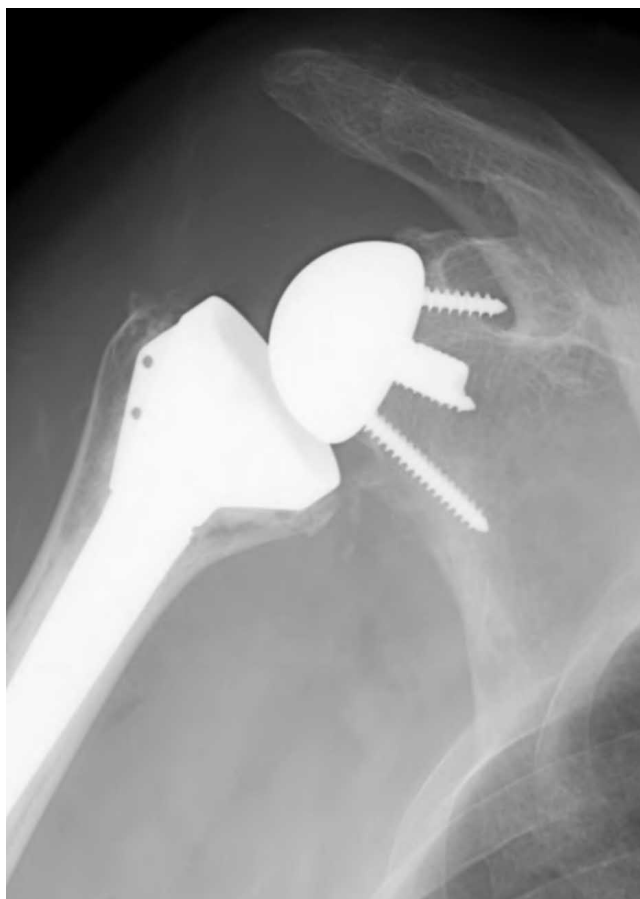
Because of his irreparable rotator cuff tear, a reverse shoulder arthroplasty was performed (Figure 3) rather than a conventional total shoulder arthroplasty at the time of the giant cell tumor resection. The patient did well postoperatively, and at three months was essentially pain free, with markedly improved shoulder mobility. Physical exam revealed 150 degrees of elevation, 140 degrees of abduction, and 30 degrees external rotation. The patient returned at four months post surgery with recurrent pain, which began after a day of heavy yard work and digging. He reported swelling, which had subsequently resolved, with persistent pain and decreased range of motion. Physical exam at that time revealed only 20 degrees of active elevation and abduction. Radiographs demonstrated a mildly displaced scapular spine fracture (Figure 4). He was treated with rest, analgesics and physical therapy. Repeat radiographs at six months post op showed mild progressive inferior displacement of the fracture (Figure 5). The patient was treated

**Figure 3.** Initial radiographs of the reverse shoulder prosthesis were normal.

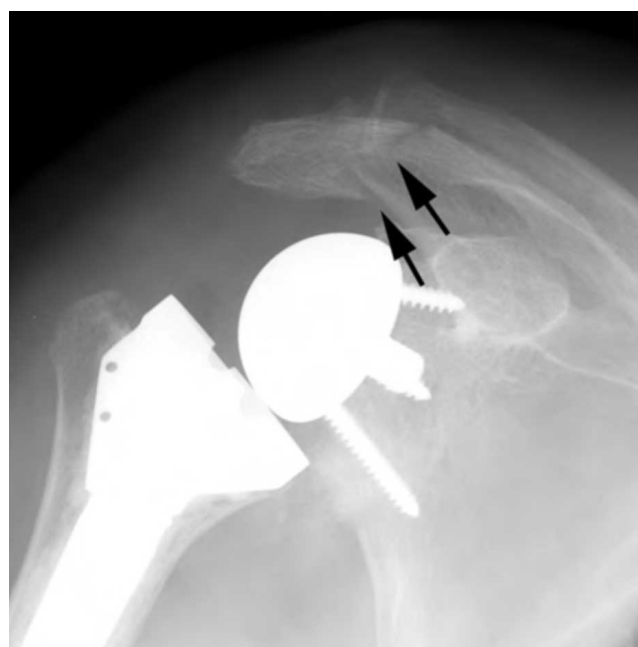
The etiology of scapular spine/acromial fractures in the setting of reverse shoulder arthroplasty has been postulated to be related to added stress on the scapular spine at the attachment of the deltoid muscle. The deltoid muscle confers a greater load to the acromion as it assumes a greater role for shoulder abduction and flexion in patients with the reverse shoulder arthroplasty. Patients with rotator cuff arthropathy also often have osteoporosis and eroded acromial bone, additionally predisposing them to a scapular spine fracture, which would be more accurately termed an insufficiency fracture. Over tensioning of the deltoid muscle at surgery may also predispose to acromial fracture, and may result in a slight and permanent abduction of the arm with inability for the patient to adduct the arm at the side.

**Figure 4.** Mildly displaced scapular spine fracture (arrows) at four months post op, becoming clinically evident after heavy yard work.

Treatment of scapular spine/acromial fractures in patients with reverse shoulder arthroplasty has not yet been established due to the relative lack of experience with this procedure and its complications. Treatment options include conservative treatment with shoulder immobilization to allow fracture healing. In patients with distal acromial fractures, thus conservative management is typically employed. Open reduction and internal fixation may be indicated in some patients with scapular spine fractures [12]. Untreated inferior displacement of the acromion may decrease the resting length of the deltoid and further decrease shoulder elevation and abduction. Asymptomatic patients may not require any treatment.

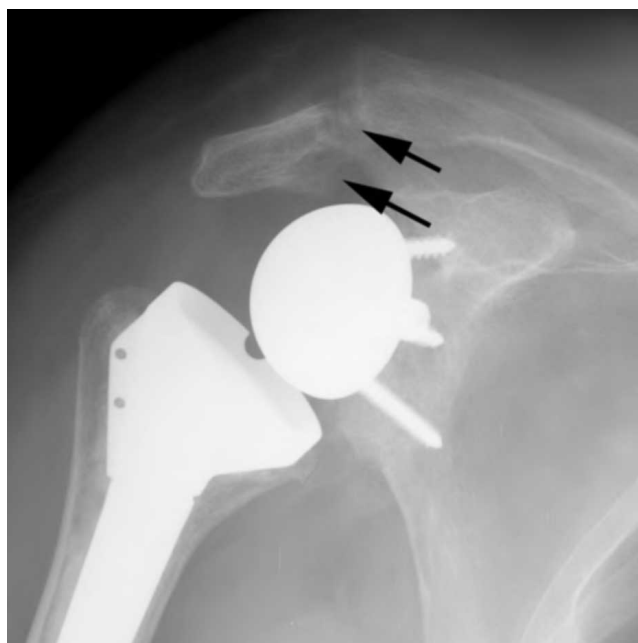
**Figure 5.** Progressively displaced scapular spine fracture (arrows) at six months post op.

detect on standard shoulder radiographs unless they are displaced or there is periosteal reaction/ callus formation. Significant inferior displacement of the fractured scapular spine may occur due to the inferior pull of the deltoid muscle. An interpretation checklist for radiologic evaluation of reverse shoulder arthroplasty can be helpful for those not

nonoperatively and regained function with physical therapy, but reported persistent pain with use of the shoulder at three-year follow up.
