Imaging of common breast implants and implant-related complications: A pictorial essay

Amisha T Shah, Bijal B Jankharia

Department of Breast Imaging, Dr. Jankharia's Imaging Centre, Mumbai, Maharashtra, India

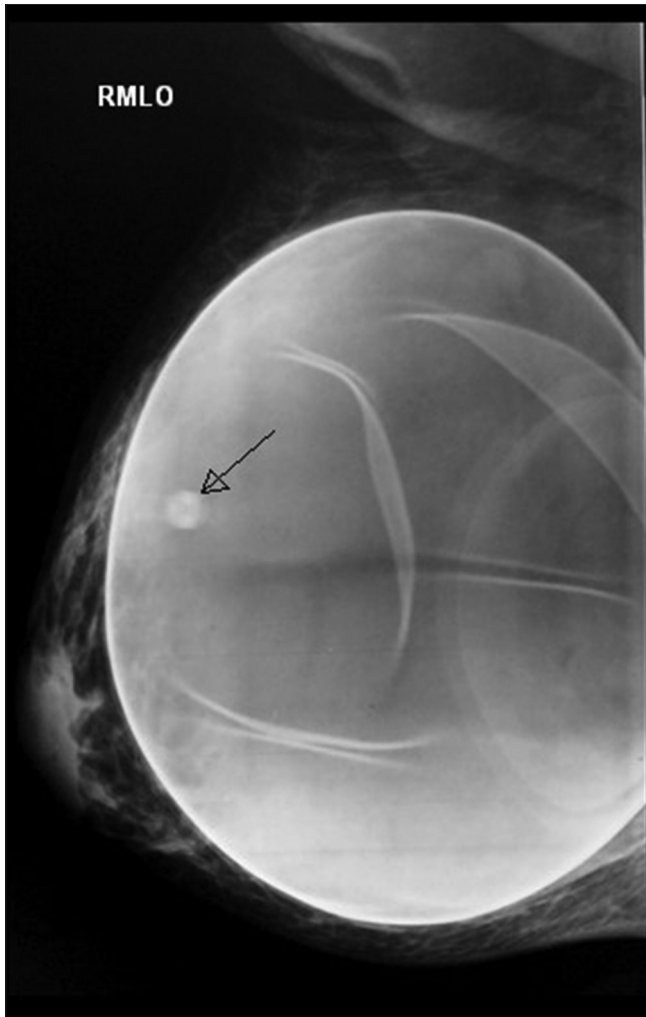
Figure 1: Mammogram showing single lumen saline breast implant. Right mediolateral oblique (MLO) view showing less radiodense saline implant. A valve is seen as a round density with a slightly lucent center superimposed on the implant (arrow)

Breast implants may have a single lumen or double lumen. Most commonly encountered are single lumen implants which contain either silicone or saline as the filling [Figures 1 and 2]. Other variations such as double lumen (silicone on the inside with an outer saline component) [Figure 3], reverse double lumen (saline on

On mammography, saline implants appear as oval masses with a dense outer silicone envelope and a less radio-opaque center. Often a valve is visible, which is used to fill the saline implant [Figure 1]. Normal membrane foldings may be seen, as also partially the glandular tissue may be seen through the implant depending on the penetration used.

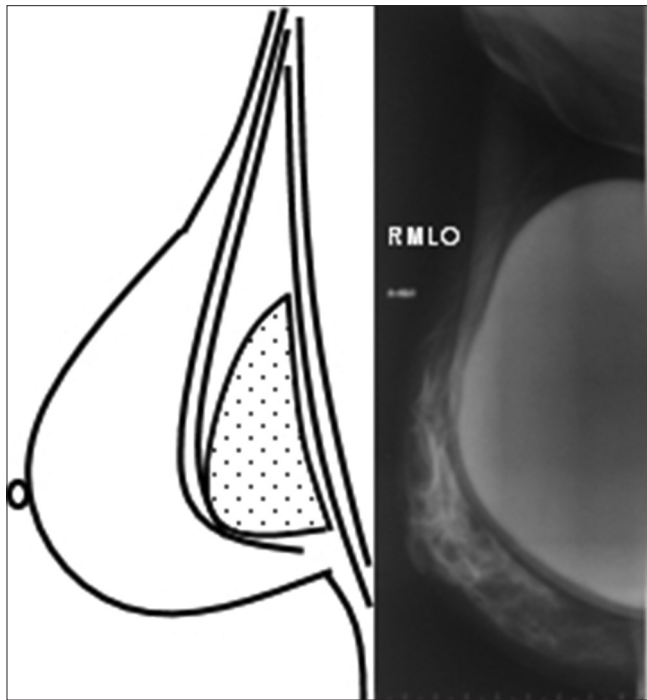
Figure 5: Schematic representation and mammogram showing a retropectoral silicone breast implant. The pectoralis major muscle overlies the implant in the diagram. In the right mediolateral oblique (MLO) view, the pectoralis major muscle is seen anterior to the implant

may also be encountered. All implants have an outer silicone membrane or shell. After placement, a thin fibrous capsule normally forms around the prosthesis as a physiological response to foreign body (encapsulation). The main surgical planes for implant placement are subglandular (in front of pectoralis major muscle) or retropectoral (behind the pectoralis major muscle) planes [Figures 4 and 5].

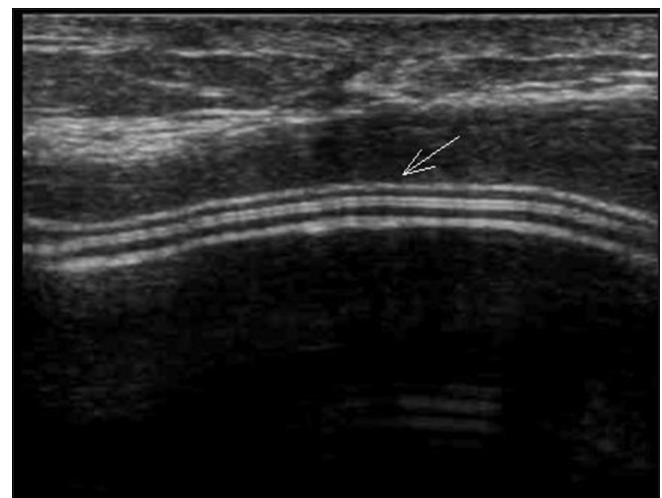
Figure 8: Transverse ultrasound image of a woman with intact implant. Normal contour of the implant is seen with the implant shell and the fibrous capsule visualized as parallel echogenic lines (arrowed)

as two parallel echogenic lines superficial to the implant surface [Figure 8]. Normal undulations of the envelope may be seen as wavy echogenic lines with or without minimal intervening fluid [Figure 9].

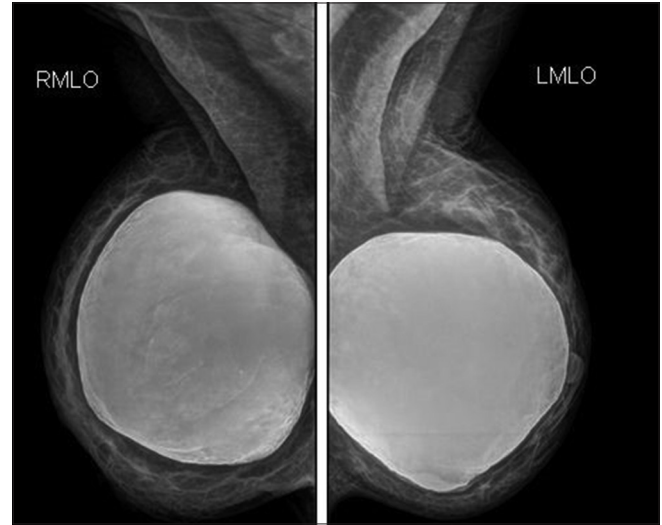
Figure 17: Bilateral mediolateral oblique views. Bilateral subglandular silicone gel implants are visualized with calcifications adherent to the fibrous capsule. The left breast implant shows a bulge inferiorly

It may develop unusual areas of bulging, irregularity, or tenting. On USG and MRI, loss of the normal triangular configuration of the implants may be seen with an increased anteroposterior diameter of the implant [Figures 13 and 14]. Thickening of the echogenic fibrous capsule and increase in the number of radial folds [Figures 15 and 16] may be noted. Peri-implant calcifications may be seen [Figure 17].
