Case report

Drill bit failure and retrieval during arthroscopic ACL reconstruction

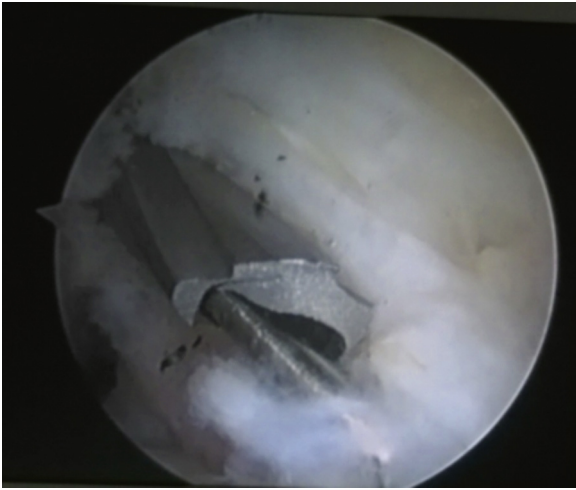
The femoral tunnel was being drilled using the trans-tibial tunnel technique with the knee in 90° of flexion. The femoral over-the-top aiming guide was placed through the tibial tunnel aiming for the 11 o' clock position after debriding the ACL stump and ensuring good visualisation of the posterior femoral cortex. The over-the-top guide was removed and a guidewire was passed through the distal femur, which exited the thigh antero-laterally and was held in place there by a holding forceps. The guidewire used was straight and had no abrasions on it. A 4.5 mm cannulated drill bit was now advanced over the guidewire via the tibial tunnel. After penetrating the lateral femoral condyle for a distance of about 1 cm, the drill bit gave away suddenly (Fig. 1).

Fig. 1. Arthroscopic image showing broken drill bit tip lodged in the lateral femoral condyle with dissipated minute fragments in the near vicinity.

Inflow of irrigation fluid into the knee joint was immediately stopped to prevent dissipation of small metal particles. On attempting to remove the broken drill bit mechanically using various types of grabbing forceps including a Kocher's forceps, the broken drill bit did not budge from its position. We then passed another cannulated 4.5 mm drill bit in a retrograde direction on the same guidewire. When both the drill bits came into contact, the

One of the possible explanations of this complication is the repeated usage of the same cannulated drill bit for multiple surgeries which probably lead to the fatigue of the material. Arthroscopic instruments must be regularly replaced after a certain number of surgeries by the operating room personnel in accordance with the specifications provided by the manufacturer.³ Prior to this incident, we followed a policy of using the same cannulated drill bit for around 20–25 ACL cases. Following this incident, we have started replacing the drill bit every 10 cases. Also, repeated autoclaving of instruments may have an effect on the material properties.³ Therefore, it is essential to limit the

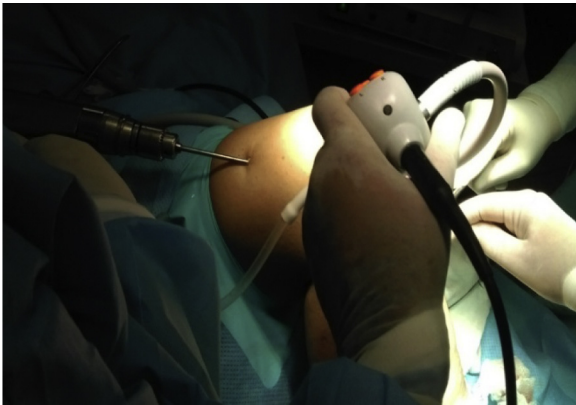
Fig. 2. Image showing reverse drill-out technique of retrieval of broken, impacted drill bit.

broken drill bit disimpacted and we further pushed it out of the knee down the tibial tunnel. The broken drill bit piece was then retrieved easily using a Kocher forceps (Figs. 2 and 3).

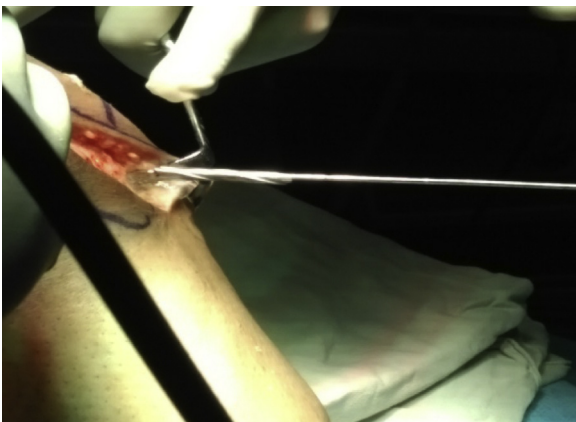
Fig. 3. The broken drill bit which has been mechanically pushed out of the tibial tunnel over the guidewire.
