Research Article

Analysis of Carbon Fiber Reinforced PEEK Hinge Mechanism Articulation Components in a Rotating Hinge Knee Design: A Comparison of In Vitro and Retrieval Findings

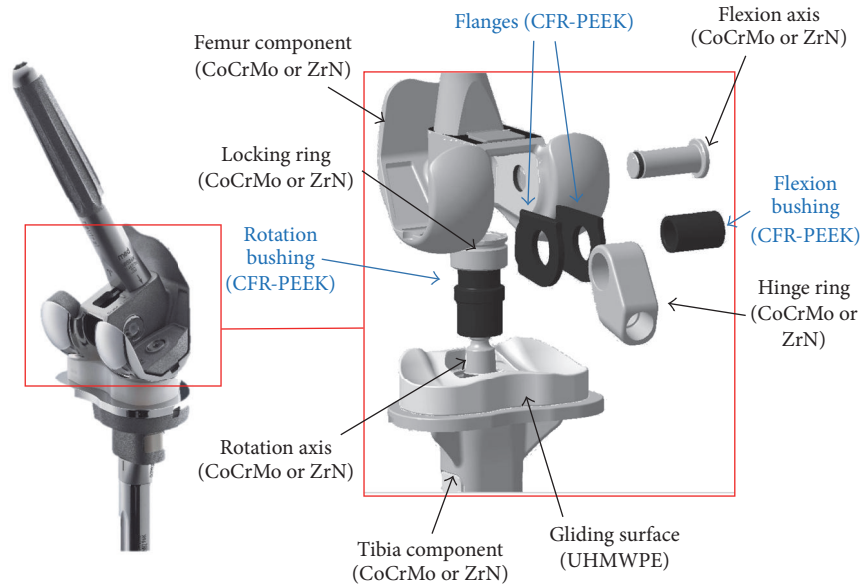
FIGURE 1: RHK Enduro and CFR-PEEK HMA components marked (blue arrows).

The flexion bushings were articulated with the hinge ring and the flanges (outer surface) and with the flexion axis (inner surface). The rotation bushing contacted the tibial tray and the locking ring (outer surface) and the rotation axis (inner surface). The flanges were articulated with the femoral component and the hinge ring, whereby only the results for the hinge ring side are reported as there is no relative movement between the flanges and femoral component. The overall knee system including the CFR-PEEK components

used in this study is shown in Figure 1. The CFR-PEEK components (Table 1) of 12 revised EnduRo knee systems in all three available implant sizes (Table 2) were analysed.

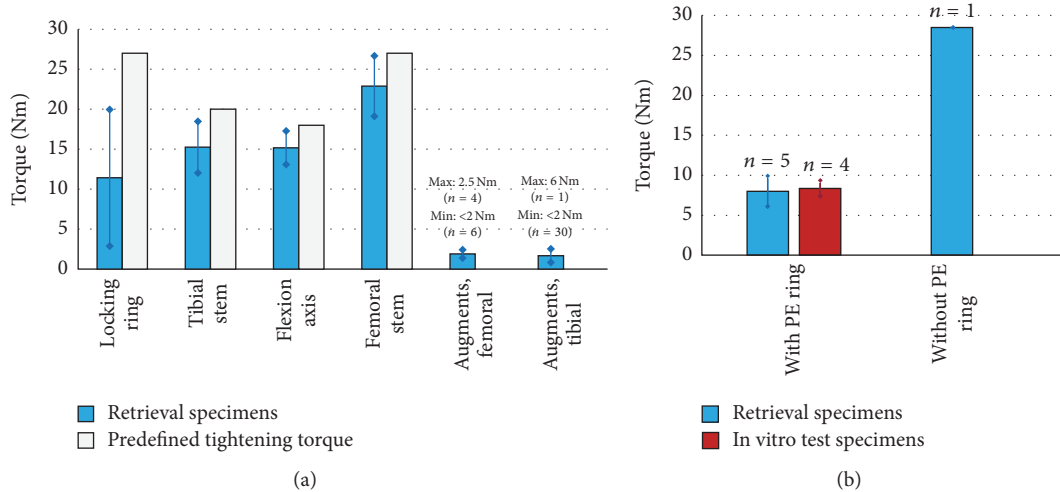
3.1. *Loosening Torque Measurement.* The mean loosening torques (Figure 2(a)) were decreased by 57.7% (locking rings), 23.8% (tibial stem), 15.7% (flexion axis), and 15.2% (femoral stem) compared to the predefined tightening torques. In 36/41 cases the loosening torques for the augments were < 2 Nm.

Five (out of six) retrieved tibial rotating systems included a locking ring with PE ring. The comparison of the loosening torques (design with PE ring: 8.0 ± 1.9 Nm, design without PE ring: 28.5 ± 0.0 Nm) showed a higher loosening torque for the new design (introduced in 2009) without PE ring.

FIGURE 2: (a) Mean loosening torques in comparison with predefined tightening torque for assembly, where applicable. (b) Loosening torques of the locking ring with two different designs and comparison with in vitro test results.

The increased loosening torque of the retrieved locking ring without PE ring ($n = 1$) underlined the efficacy of the new implant design.

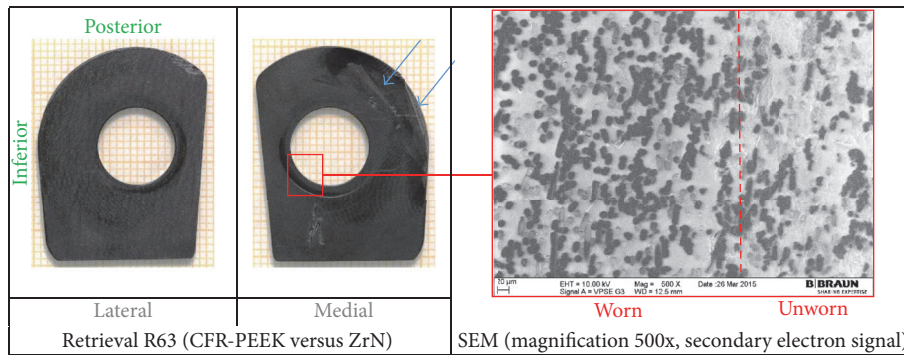
FIGURE 3: Hinge ring side of retrieved CFR-PEEK flanges with SEM image, with iatrogenic damages (blue arrows).

hole for the flexion bushing. Some iatrogenic damages on the retrieved specimens were visible as scratches (Figure 3) or broken out edgings. In some cases, it was difficult to distinguish between iatrogenic damages and wear-induced damages, particularly between scratches and chipping.

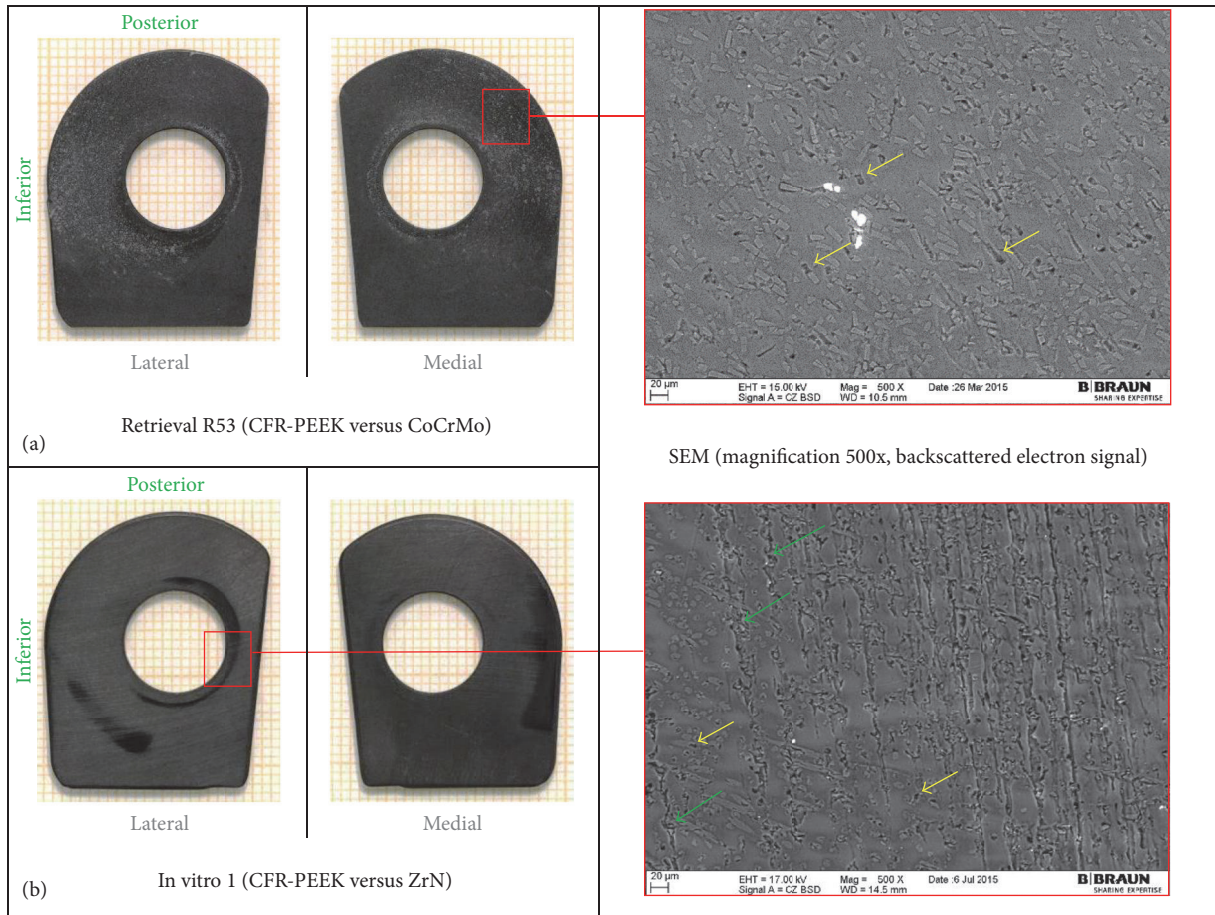
On the flanges (Figures 3 and 4), additional rims close to the hole for the flexion bushing (all retrieved flanges and lateral in vitro flanges) and scratches in direction of movement (retrieval specimens) were observed (Figure 5). The wear damage locations on the flanges were comparable between retrieval and in vitro specimens, whereby higher variability was present on the retrieval specimens. Polishing on retrieval and in vitro specimens was mainly concentrated on the inferior-posterior part and anterior to the hole for the flexion bushing. Rims appeared superior-anterior to the

FIGURE 4: Hinge ring side of CFR-PEEK femoral flanges with SEM images. (a) Retrieved flanges adjacent to CoCrMo and (b) in vitro tested flanges adjacent to ZrN. Holes due to fiber pull-out (yellow arrows) and machining marks (green arrows) are shown.

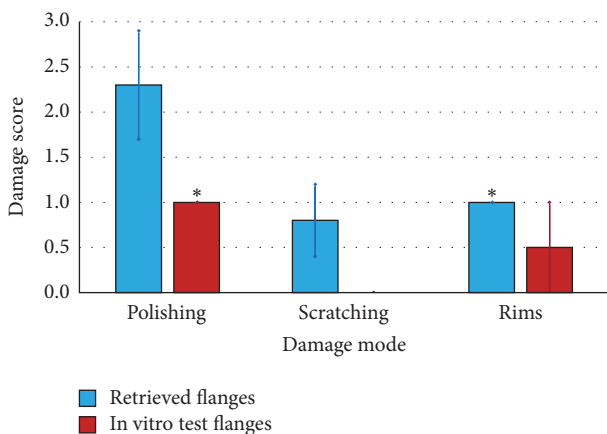
FIGURE 5: Wear damage modes on retrieved and in vitro wear tested flanges. *Standard deviation = 0 for equal values on all analysed specimens.

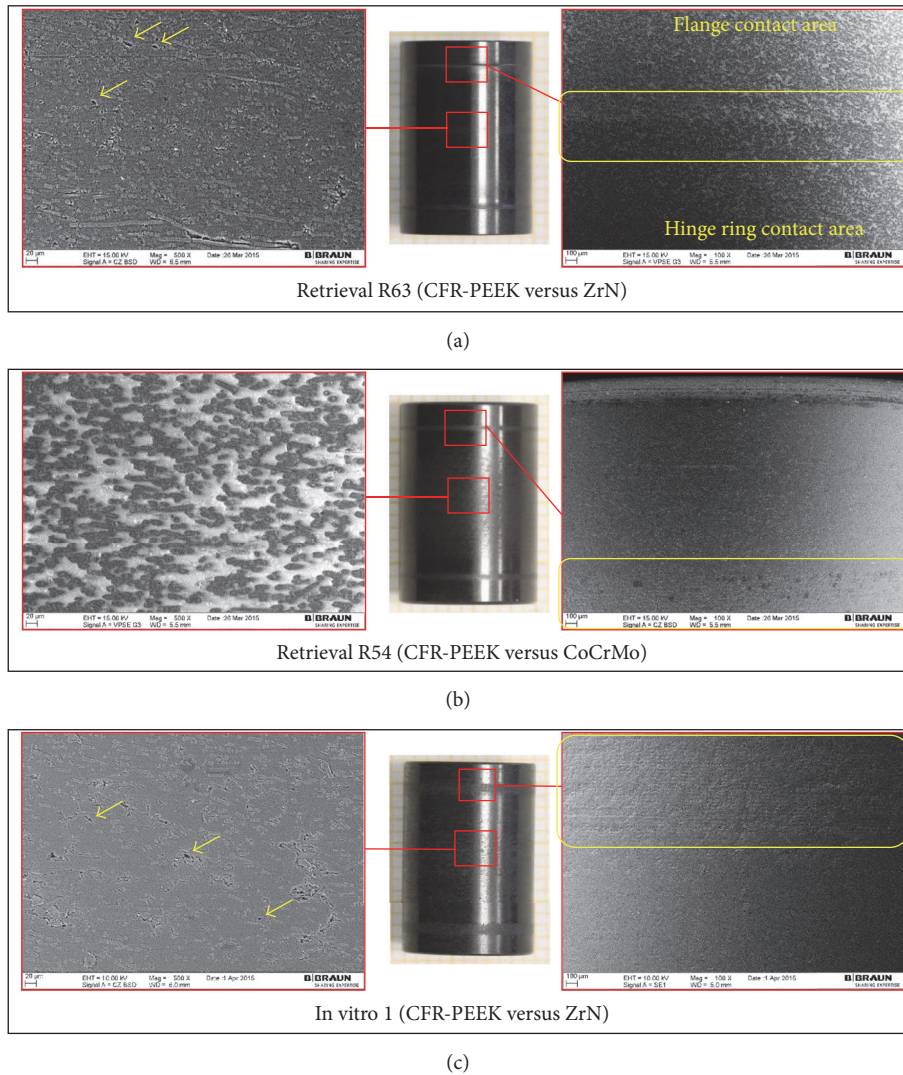
Retrieved and in vitro tested flexion bushings were mainly polished on the outer surface (Figure 6) with a mean score of 2.4 ± 0.7 for retrieval and 2.0 ± 0.0 for in vitro specimens. Circumferential rims divided the hinge ring contact surface from the flanges contact surface on 7/8 retrieved specimens (mean score 0.9 ± 0.4), whereas the in vitro specimens showed circumferential lines (Figure 6, yellow boxes). SEM analysis revealed a worn out PEEK matrix in the polished regions resulting in a smooth surface appearance, as well as fragmented fibers, some holes due to fiber/fiber fragment pull-outs, and cracks along the fibers (Figure 6, left-hand side) on retrieved and in vitro flexion bushings. The number of holes seemed to be more significant for retrieval than for in vitro specimens. ZrO_2 -particles which could indicate bone cement inclusions were present on 2 out of 4 analysed retrieved flexion bushings.

FIGURE 6: ((a) and (b)) Hinge ring/flanges contact area of retrieved flexion bushings. (c) Corresponding contact area on in vitro specimen 1. Images: DSLR camera and SEM with magnification 100x (right-hand side) and 500x (left-hand side). Holes due to fiber pull-out are marked with yellow arrows.

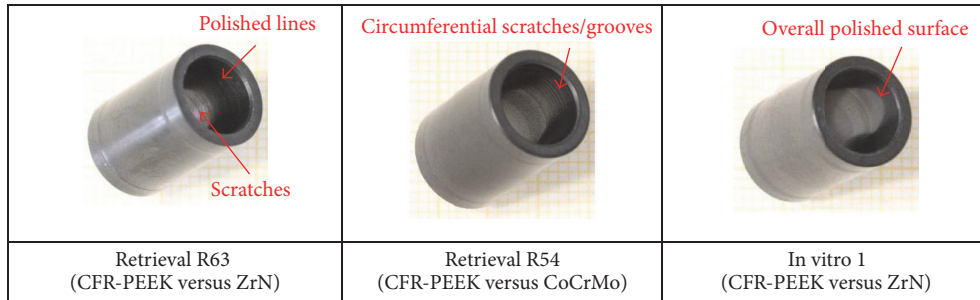
The inner surfaces of the retrieved flexion bushings were, in 5/8 cases, affected by polished lines (mean score 1.6 ± 1.4) and in 4/8 cases by slight scratches (mean score $0.6 \pm$

0.7) in circumferential direction, whereas the corresponding surfaces of the in vitro specimens showed an overall polished appearance (Figure 7).

FIGURE 7: Contact surface of flexion bushings with flexion axis.

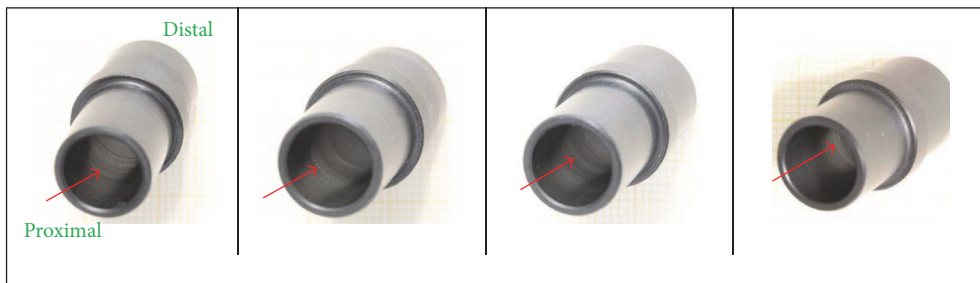
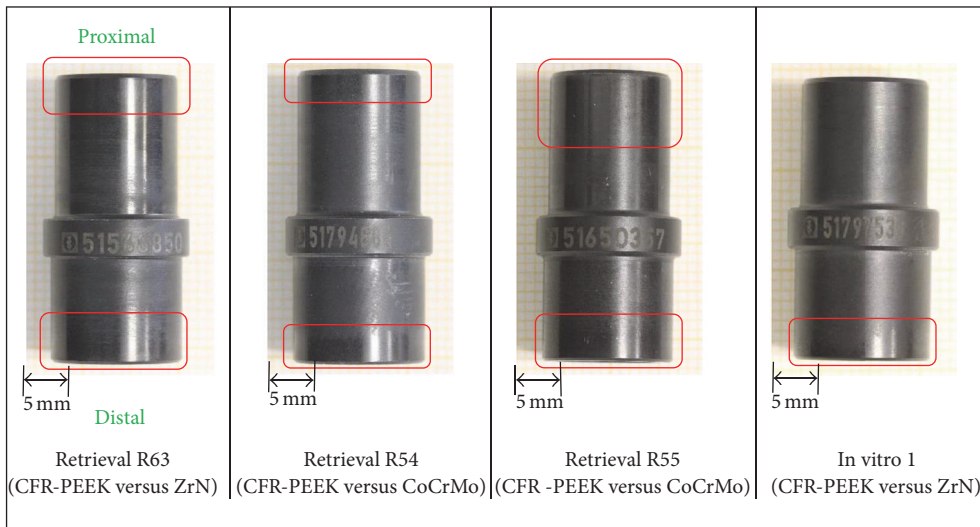
The outer surface of the retrieved and in vitro rotation bushings was polished (mean score 1.7 ± 0.7 for retrieval and 1.0 ± 0.0 for in vitro specimens) on the edgings (Figure 8(b), red boxes). On the inner surface of all rotating bushings, polished circumferential lines (red arrows) could be observed (mean score 1.0 ± 0.7 for retrieval and 1.3 ± 0.6 for in vitro specimens) (Figure 8(a)).

FIGURE 8: (a) Contact surface of rotation bushings with rotation axis (proximal view). (b) Contact surface of rotation bushings with tibial tray and locking ring.

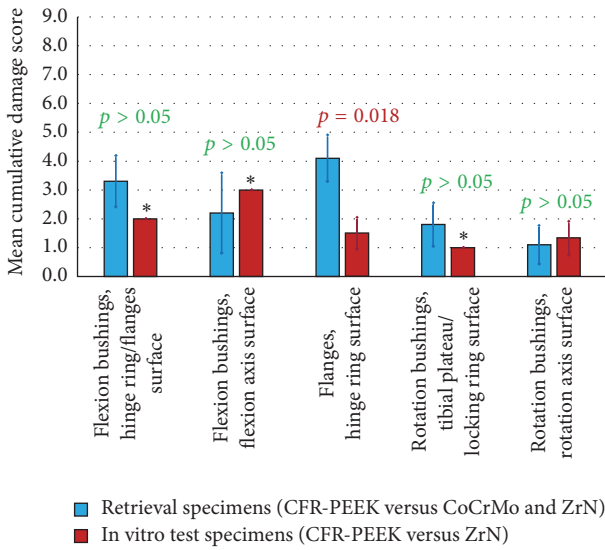
3.3. *Cumulative Damage Score.* Mean cumulative wear damage scores were higher for the retrieval than for the in vitro specimens, except for the axis contact surfaces of flexion and rotation bushings (Figure 9). The trend in linear regression of CDS and time in vivo was found for the hinge ring/flanges contact surface of flexion bushings ($R^2 = 0.8003$ and $p = 0.0123$).

FIGURE 9: Mean cumulative damage score separated according to component type and origin. *Standard deviation = 0 for equal values on all analysed specimens.

The cumulative wear damage scores within the present study were higher for the retrieval than for the in vitro specimens (except inner surface of rotation and flexion bushings). Harman et al. [35] also found that wear simulations underestimated the size of damage pattern and variety of damage modes in vivo for unicondylar tibial inserts. The same author reported underestimation of magnitude of damage area and extent for retrieved tibial inserts [36], a finding which is also supported by the results of Rawlinson et al. [37]. Furthermore, a higher variation of damaged areas (size of affected surface area and cumulative damage score, resp.) for retrieval than for in vitro specimens was observed. This was also found by Harman et al. who showed a considerably higher variation of damaged areas within retrieval specimens of 27 to 81% [36] and more dispersed damage pattern on retrieval than on in vitro specimens [35]. A trend for correlation of cumulative damage score and time in vivo was only found for the outer surface of flexion bushings with

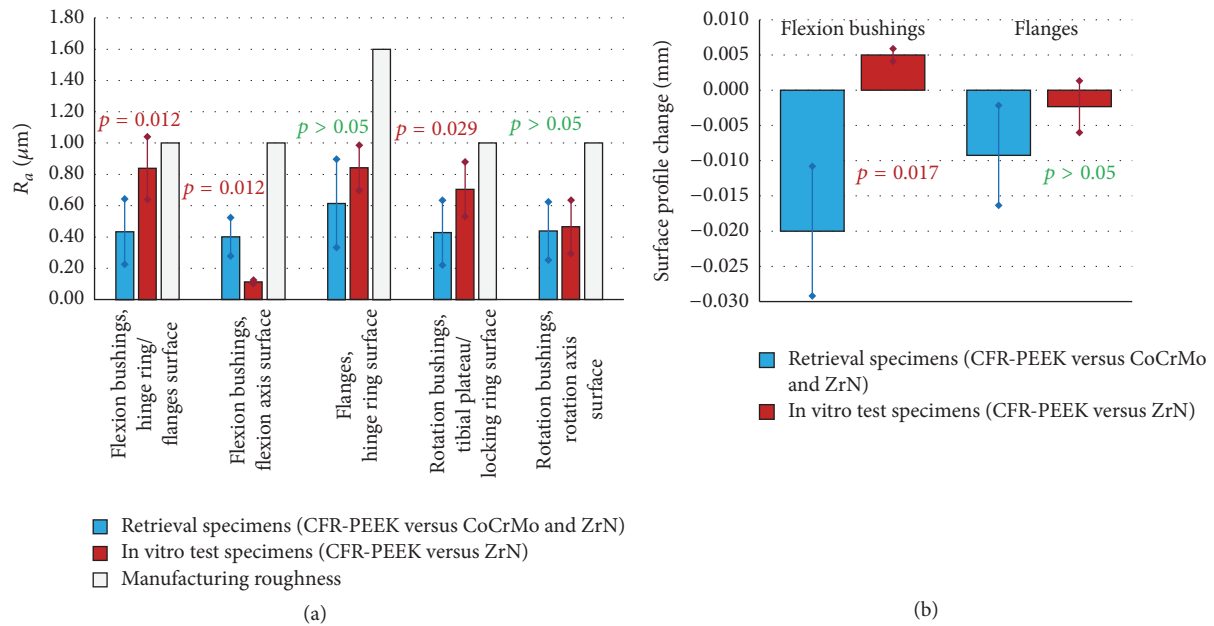
3.4. *Surfaces Roughness and Profile Measurement.* The polishing in the worn areas was confirmed by reduced average roughness (R_a) values in comparison with the manufacturing roughness (Figure 10(a)). The overall polished appearance on the inner surface of the in vitro flexion bushings was confirmed by the R_a values, more significantly decreased

than for the retrieval specimens. No statistically significant correlation of decreased roughness values and time in vivo was found ($p > 0.05$ in all cases). The surface profile measurement revealed rims on 7/8 retrieved flexion bushings (hinge ring/flanges contact surface), whereas the in vitro specimens showed an elevation at the same location (Figure 10(b)). Linear regression of rim depth and time in vivo was calculated and a poor correlation was found for the flanges ($R^2 = 0.4253$, $p = 0.0496$).

FIGURE 10: (a) Average roughness (R_a) values of the retrieved flexion bushings, flanges, and rotation bushings in comparison with in vitro test specimens and the nominal average roughness. (b) Surface profile variations on flexion bushings and flanges.
