Housing as a Determinant of Tongan Children's Health: Innovative Methodology Using Wearable Cameras

Abstract: Housing is a significant determinant of health, particularly in developing countries such as Tonga. Currently, very little is known about the quality of the housing in Tonga, as is the case with many developing countries, nor about the interaction between children and the home environment. This study aimed to identify the nature and extent of health risk factors and behaviours in Tongan houses from a child's perspective. An innovative methodology was used, Kids'Cam Tonga. Seventy-two Class 6 children (10 to 13-year-olds) were randomly selected from 12 randomly selected schools in Tongatapu, the main island. Each participating child wore a wearable camera on lanyards around their neck. The device automatically took wide-angled, 136° images of the child's perspective every seven seconds. The children were instructed to wear the camera all day from Friday morning to Sunday evening, inclusive. The analysis showed that the majority of Tongan children in the study live in houses that have structural deficiencies and hazards, including water damage (42%), mould (36%), and electri

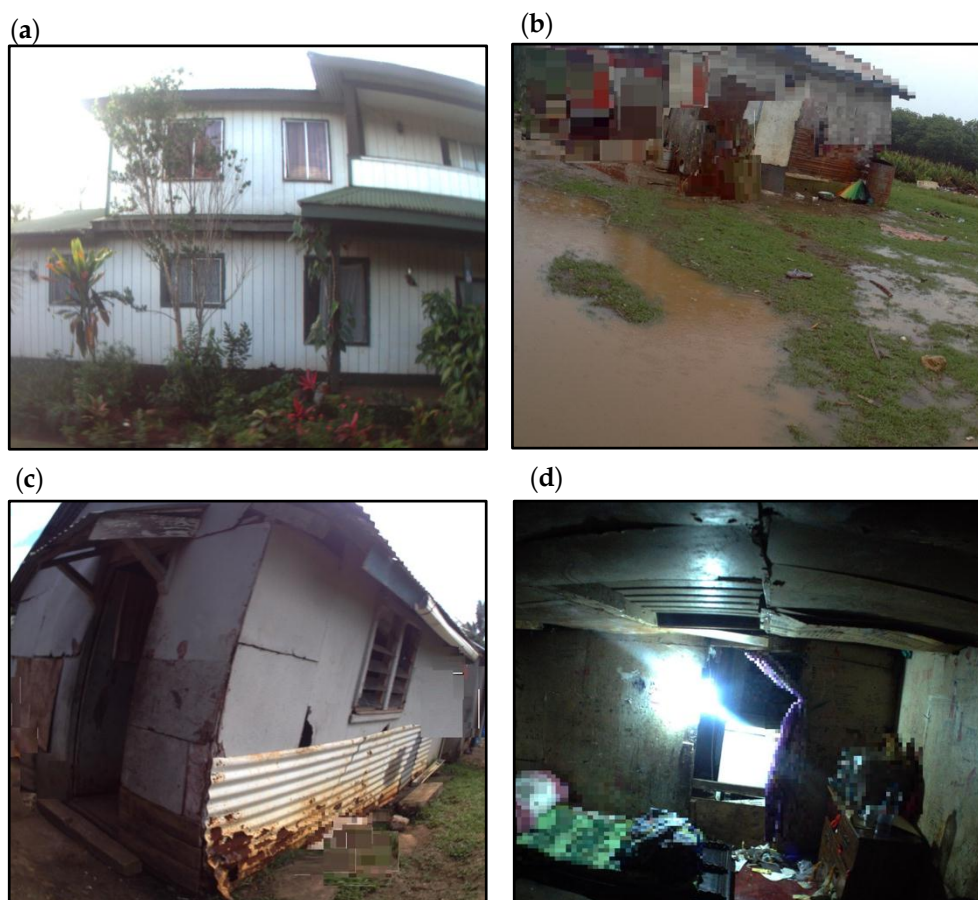
Over a quarter of the houses had no evidence of structural damage or water permeation into the home (Figure 1a). Eleven houses (15%) had significant and extensive structural damage, which could present a significant risk to the health of the occupants (Table 1). These houses did not appear structurally secure or weather tight, and would not provide adequate shelter from the outside environment (Figure 1b–d). Housing with poor structural integrity also incorporated low quality, informal materials to patch up internal walls and ceiling holes; examples included cardboard, tarpaulin, and plastic wrap. The most prevalent structural issue was the evidence of water damage in 42% of houses (Table 1). The water damage in these houses was indicated by rotten wood, water staining on a ceiling and walls, peeling paint, rusted metal, damaged flooring, and the use of plastic sheets or buckets to capture residual water flow. In six houses, the sleeping areas were in rooms with holes in the ceiling or walls, and there was insufficient natural lighting so the sleeping area appeared dark during daylight hours (Figure 1d). In 32% of the houses, the windows were permanently boarded up with wood or the windows were damaged so that they no longer provided a physical barrier to the outside environment (Table 1). The cause of the damage observed in many houses was suggestive of high-velocity wind damage, particularly for those houses with missing corrugated roofing and a loss of windows. Houses where the damage was less extensive were likely to be due to the progressive degradation of low-quality building materials.

Figure 1. Range of house quality observed: (a) House without any evidence of structural damage and exterior is well maintained; (b) House surrounded by pools of rain water due to insufficient drainage, interior of house water damaged; (c) Poor building quality indicated by holes in the external wall and use of building materials to patch up exterior; (d) Children’s bedroom with damaged ceiling and walls, and evidence of water staining on the cardboard covering holes in the ceiling.

The housing stock in Tonga has multiple structural hazards which may contribute to injury burden. One of the most alarming findings regarding the housing quality was the proportion of houses with significant structural deficiencies and water damage. The susceptibility of the housing to damage is attributed to the imported building materials and western-style design [6,27], with housing constructed as square builds with solid walls and corrugated metal roofing. When cyclone winds meet the resistance of vertical rigid walls they are directed upwards, providing the force to lift corrugated metal sheets from the rafters [28]. Torn corrugated metal is likely to cause significant harm to occupants compared to the softer thatching materials of the traditional *fale* [27]. Returning to indigenous architecture, traditional building practices, and using locally sourced materials may be essential in the development of disaster-resilient communities [6,7,27]. The Tongan *fale* is designed to allow high-velocity wind to pass through the open oval-shaped structure [9]. The curved contour of the roof means that wind moves around the surface without encountering resistance [9]. The building is secured with plaited rope of dried coconut fibre, which adds strength and provides greater flexibility [7]. If the traditional *fale* is damaged it can quickly be repaired, as construction materials are locally sourced and communities have the building skills required to make such repairs [7].

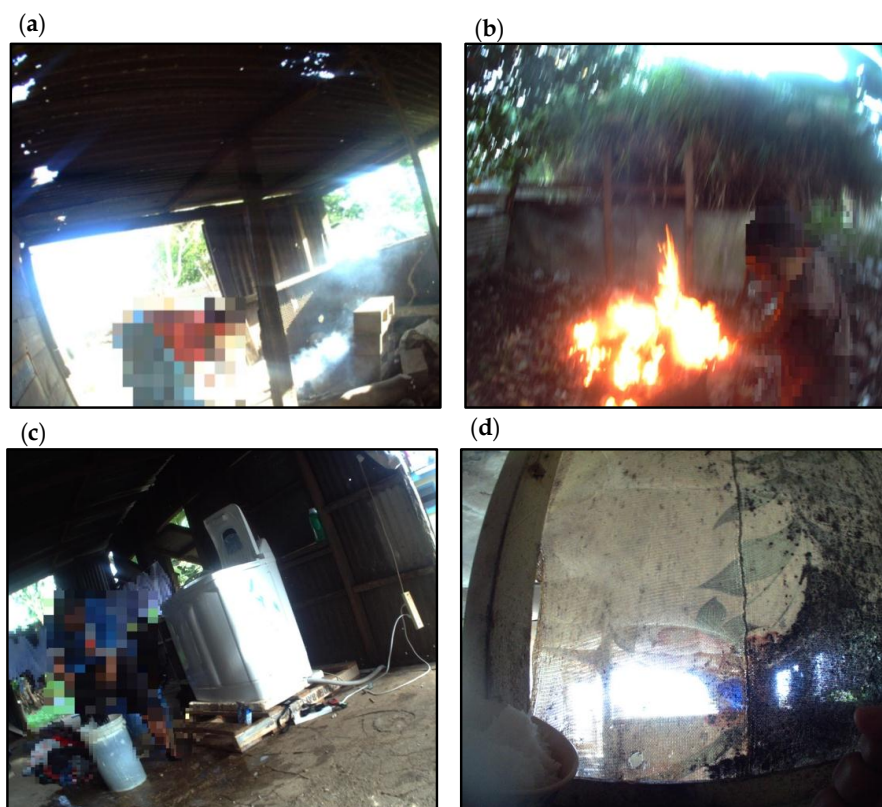
Nine houses did not have a formal kitchen, but had a separate cooking shed that was physically detached from the house (Table 1). The cooking sheds were more roughly constructed from rusted metal sheets and lumber. Seven of the nine cooking sheds identified had poor structural integrity, indicated by damaged walls and ceilings and evidence of water damage (Table 1). The sheds had limited storage and food preparation space, often contained large amounts of waste, and were easily accessible to dogs, pigs, or other animals kept around the home. Families spent a reasonably large proportion of their time in these cooking facilities throughout the day, sometimes spending more time in the cooking shed than the actual house. Families would prepare food in these sheds on the ground or in plastic buckets. If a gas cooker was not present, then some families cooked on an open solid fuel fire in the shed (Figure 2a). This was observed in 4% of households (Table 2).

Figure 2. Risk factors and behaviours observed in the home environment that increase the risk of injury or harm to children: (a) Cooking on an open fire in a cooking shed filled with smoke. Low-quality building materials used in structure; (b) Child burning rubbish and standing near flame; (c) Electrical extension blocks and power cables next to a washing machine and in the vicinity of a water spill; (d) Fabric covered in mould next to a food preparation surface.

Although electricity was widely used in the kitchen, only 13% of households had an electrical cooker (Table 3). Gas cookers were the predominant method of cooking, and these were used by 54% of homes (Table 3). Gas cookers require Liquefied Petroleum Gas (LPG) cylinders for fuel, and these were visibly present inside of 21% of houses (Table 2). The majority of gas cylinders were located in the cooking areas, but some were also observed in the sleeping areas and living areas. A few families had used an inventive solution to safely store the gas cylinder outside by running the gas hose through the external wall to the cooker (Figure S1). In 7% of homes, informal gas cookers were observed, specifically portable camping stoves or barbecues. These systems are not designed for indoor cooking, as they leak harmful gases and present a fire risk. In three homes, indoor cooking was observed with solid fuels (wood and coconuts), and the images contained evidence of smoke buildup in designated, enclosed cooking areas (Figure 2a).
