Case report

Distal radius re-fracture with bending of implant and neurovascular compromise

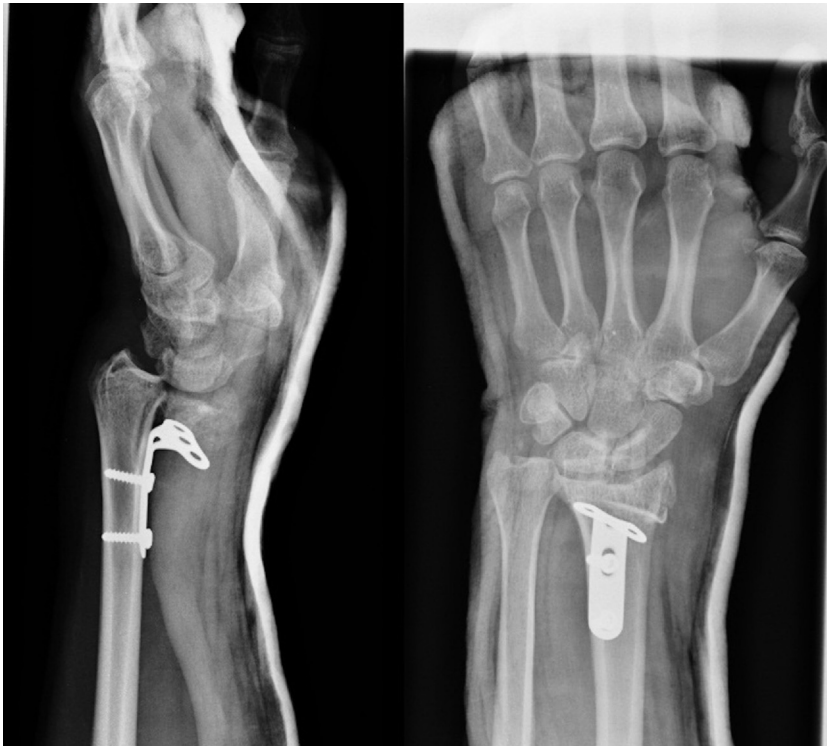
Fig. 1. Lateral and Anterior-Posterior (AP) Left Wrist Radiograph.

Imaging undertaken in plaster cast. A previous orthopedic internal fixation (Buttress T plate) is seen to the palmar aspect of the distal radius, this is now bent to almost 90°. A comminuted fracture is seen in the distal radius with multiple fragments displaced anteriorly adjacent to the distal end of the plate.

During the operation, the bent buttress ‘T’ plate had caused gross swelling and tissue damage with tenting of the flexor tendons and concern about the median nerve. The ulnar nerve was neither exposed or explored. This plate was removed, and the fracture was reduced leading to immediate decompression of the soft tissues. The distal radial bony fragments were temporarily held with K wires, and then fixed with a Synthes™ variable angle locking plate. Intra-operative fluoroscopy was used to confirm position and alignment of the fracture and plate (Fig. 2). The comminuted radial styloid was fixed with a Mini QUICKANCHOR™ Plus (#0 Suture). The wound was washed and closed primarily and a back slab plaster cast applied. Antibiotics were given for 2 postoperative doses, and the arm elevated in a Bradford sling for 24 h. Clinical review of the patient at 6 h post op revealed no remaining neurological deficit.

fixation with buttress 'T' plate. Usually, these fractures manifest as stress fractures which occur at or near the distal end of the implant. Our case is quite unusual in that the fracture is caused by trauma resulting in mechanical bending of the buttress 'T' plate, with an associated fracture of the bone beneath the deformed plate. Such a case, has only been described once in the literature according to our search.

The presence of bent metalwork in this volar displaced fracture resulted in ulnar nerve symptoms and reduction of this fracture around a bent T plate may have worsened these. As such it required urgent surgical exploration and definitive fixation.

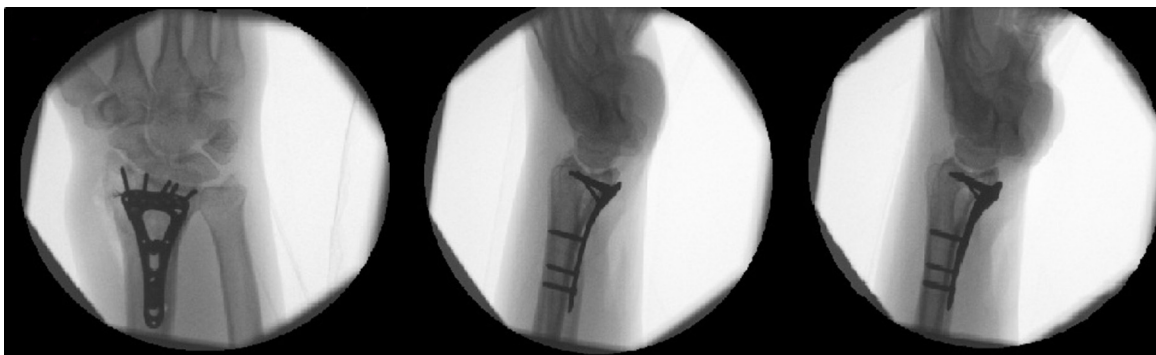
Fig. 2. Intra-operative Fluoroscopy.

A Fluoroscopic intra-operative image of a left distal radius and ulnar, showing a distal radius locking plate and suture anchor.

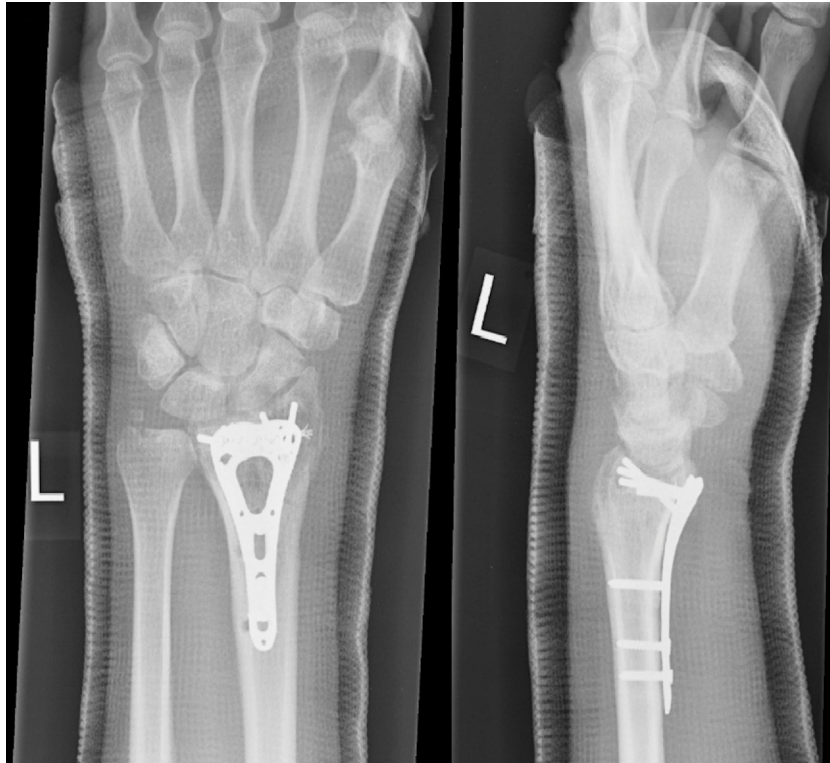
Fig. 3. AP and Lateral Left Wrist Radiograph.

The wrist is held in a Plaster of Paris in neutral carpal alignment. Distal radius has a volar plate fixation with distal locking pegs and proximal non-locking screws. There is a single anchor within the distal radial styloid. There is some evidence of bony union within the distal radius, the ulnar styloid does not show signs of union.

6 weeks later a check x-ray (Fig. 3) was performed and resistance physiotherapy commenced. Two months after the injury, the patient was able to perform most of his farming duties with the support of a Futura splint on the affected wrist for heavy lifting. At his 6 month follow up he had regained full function, including both motor and sensory, as compared to prior to the injury
