Article

# Application of Crack Identification Techniques for an Aging Concrete Bridge Inspection Using an Unmanned Aerial Vehicle

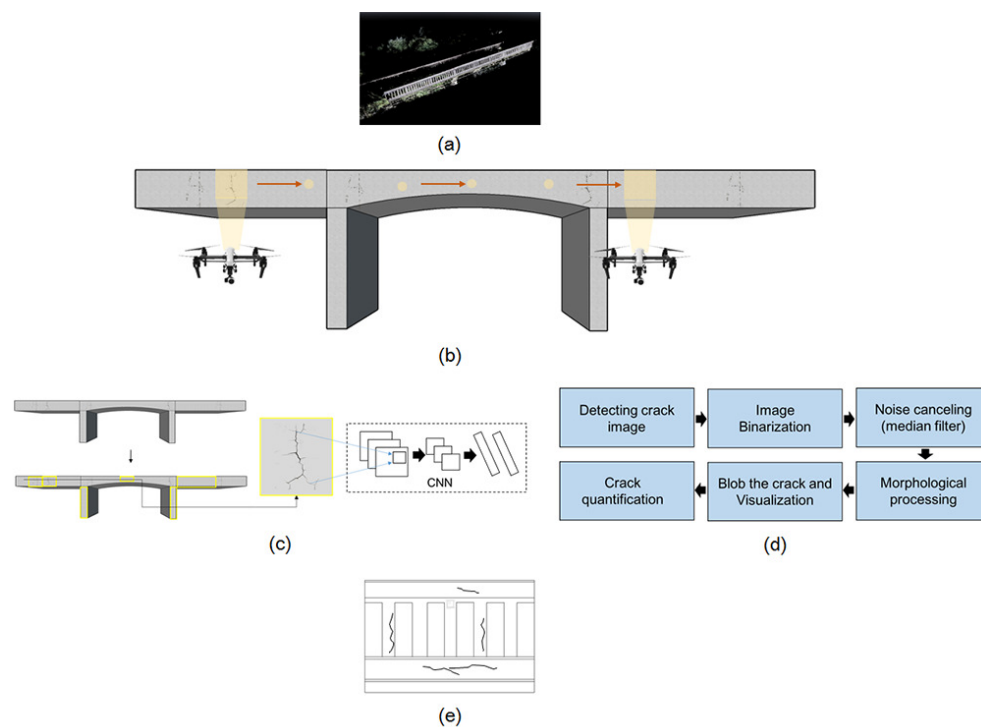
**Figure 1.** Overview of the UAV-based crack identification: (a) Generating background model; (b) Image acquisition to scan appearance status; (c) Crack detection using deep learning algorithm; (d) Crack quantification using image processing and (e) Visualization of identified crack on the inspection map.

Figure 1 shows a schematic of the crack identification using UAV. As shown in this figure, UAV-based crack identification consists of five main phases: (1) the generation of the point cloud-based background model to build a damage map by visual inspection (inspection map); (2) image acquisition using a camera mounted on a UAV; (3) crack detection using the deep learning method; (4) crack quantification using image processing; and (5) visualization of the identified crack on the inspection map. The proposed approach collects and stores imaging data by using camera-equipped UAV from the region of interest (ROI) on the bridge. The preliminary study to visualize crack information on the inspection map was conducted.

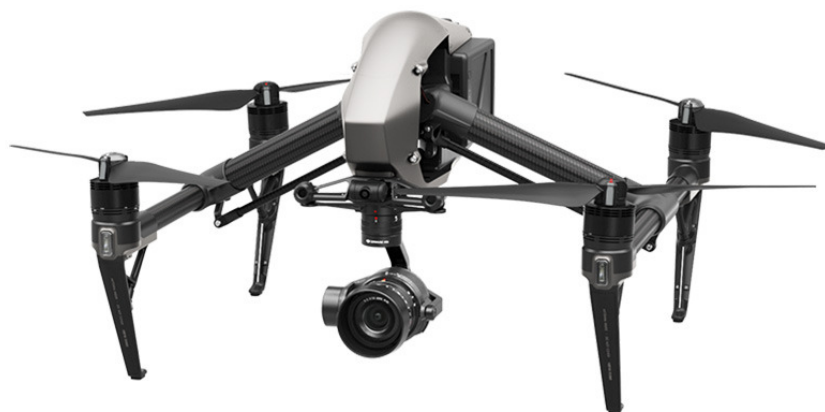
Figure 3. Inspire 2 with Zenmuse X5S for crack identification.

The flight of the UAV at the bridge should consider the safety as the priority. Many guidelines were suggested to ensure safety, but the core contents will be presented in this section. At first, the UAV must fly within a flight altitude of 150 m to avoid collisions with aircraft. The UAV should also refrain from flying over the vehicle in the case of a fall. Finally, the operation speed of the UAV should be limited to 80% of the maximum speed to cope with an unexpected situation such as denied GPS and gusts of wind around the bridge. It is very important to keep the distance between the UAV and the target element to collect images because the pixel size for quantification can be calculated by the exact focal distance. However, it is difficult to keep the focal distance in flight, so the localization of UAV is one of the major concerns in bridge inspection due to denied GPS around the bridge. Therefore, planar markers were used as references to calculate the pixel size of images without knowing the location of the UAV and the distance from the target in this study. Several markers with known sizes were attached on the surface of the bridge. The UAV (i.e., Inspire 2) and a vision sensor (i.e., Zenmuse X5S) used in this study were manufactured by DJI Co., Ltd. (Shenzhen, China), and the two systems were connected by a gimbal, as shown in Figure 3. The gimbal could tilt the camera up from  $-130^\circ$  to  $+40^\circ$ , pan  $320^\circ$  and roll  $20^\circ$  in either direction. The UAV type was a rotary-wing, and the resolution of the camera was  $5280 \times 2970$  pixels when the aspect ratio was 16:9. The flight control was manually operated, and the UAV flew while scanning the appearance of the bridge and keeping its distance at approximately 2 m from the concrete deck.

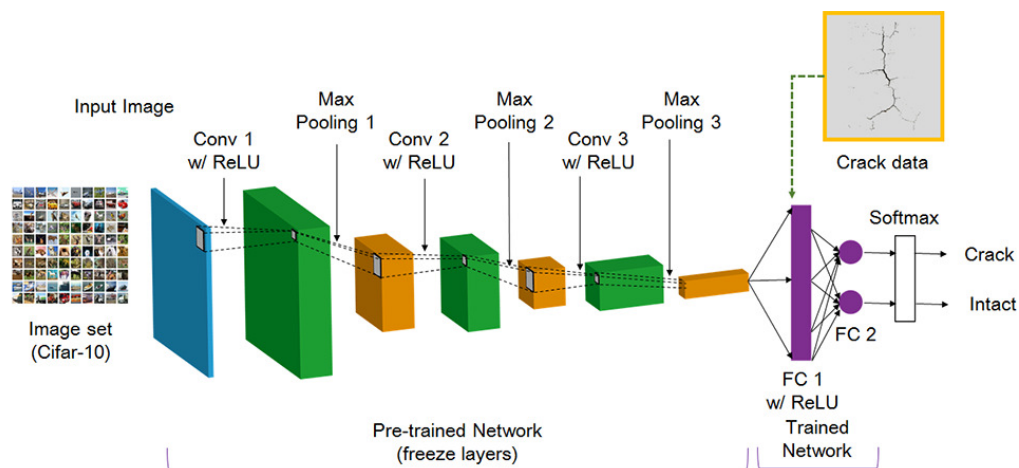
Figure 4. Schematic of the deep learning architecture.

image using selective search, feature extraction by using CNN after cropping and image detection after bounding-box regression [41]. In the feature extraction step, insufficient data made it difficult to train the features. Therefore, the transfer learning method is commonly used in deep learning applications. The concept of transfer learning is to use features and parameters extracted from a large image set with many labeled data when the labeled data are insufficient. This method conducts the training of a large image set such as ImageNet [42] and Cifar-10 [43] in advance. Then, new dataset, which was comprised crack data in this study, is connected with the pre-trained network by using fine-tuning. Figure 4 presents the deep learning architecture to extract the feature for crack detection in this study. The input layer is 50,000 image of  $32 \times 32 \times 3$  pixel resolution in the Cifar-10 image set, which is large image dataset of 10 classes. In the convolution layer, 32 filters (also called the kernel) with a size of  $5 \times 5$  were used, and a stride of 1 and a padding of 2 to prevent image downsizing. The ReLU as a nonlinear activation function was used because of its fast computation and high accuracy [44]. The max pooling with  $3 \times 3$  kernel and a stride of 2 was used. The fine-tuning was applied to the fully-connected layer to classify the crack. Table 1 lists the detailed information of each layer.

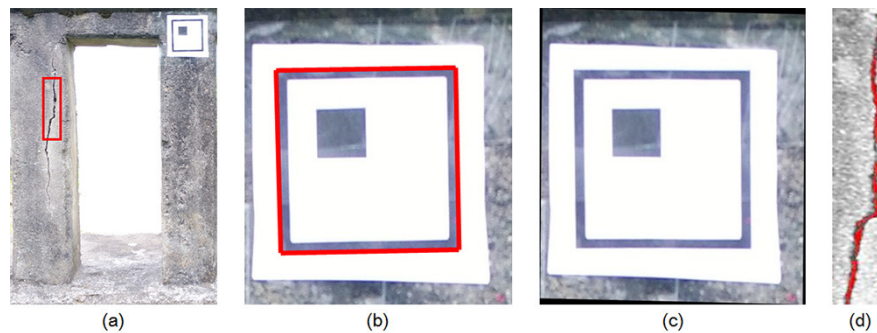
**Figure 5.** Image processing procedure of crack length and thickness estimation: (a) Image capture; (b) Marker detection; (c) Calculation for fixel size and (d) Crack quantification.

to the distorted image. From the undistorted image, as shown in Figure 5c, the diagonal length and its thickness can be calculated, as shown in Figure 5d. To detect the horizontality and verticality of edges that can be defined as cracks, the detected image was rotated in the longitudinal direction, and image convolution was performed with the following mask:  $\mathbf{h} = [-1 \ -1 \ -1; 1 \ 1 \ 1]^T$ .

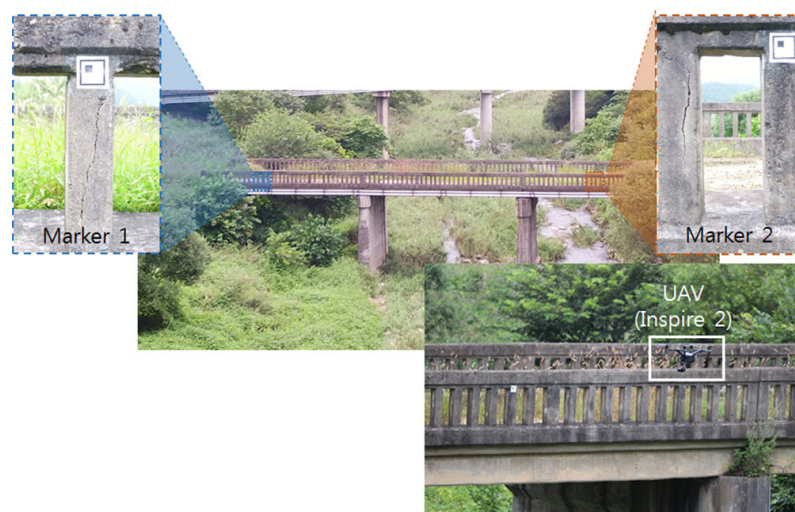
**Figure 6.** Experimental setup.

A field test was conducted to verify the proposed crack detection method based on the UAV with an imaging device in an old concrete bridge. In this study, target elements in bridge were examined for UAV-based visual inspection. At first, the inaccessible elements such as abutments, piers and pylons could be targeted. The bridge deck could be included if the camera were pointing up through the gimbal. The bridge rails were only targeted in this study, but further study will cover other elements. In the experiment, the UAV made a flight for two purposes (i.e., generating the background model and image acquisition for crack detection), and different flight methods were applied. The flight for generating the background model considered driving repetition number and image overlap rate, and the camera mounted on the UAV took a picture along the path. On the other hand, the flight for inspection considered the scanning speed, FOV and dynamics, focusing on obtaining high-quality images. Figure 6 shows the experimental setup for the crack detection using the UAV. Two markers were attached on the bridge to quantify crack size because it is challenging to exactly know both the location of the UAV and the distance from the target. Further study will be conducted to address the challenges without the marker. In this experiment, a square-shaped planar marker was designed and applied. Thus, the pixel size and rotational angle could be estimated from the marker.

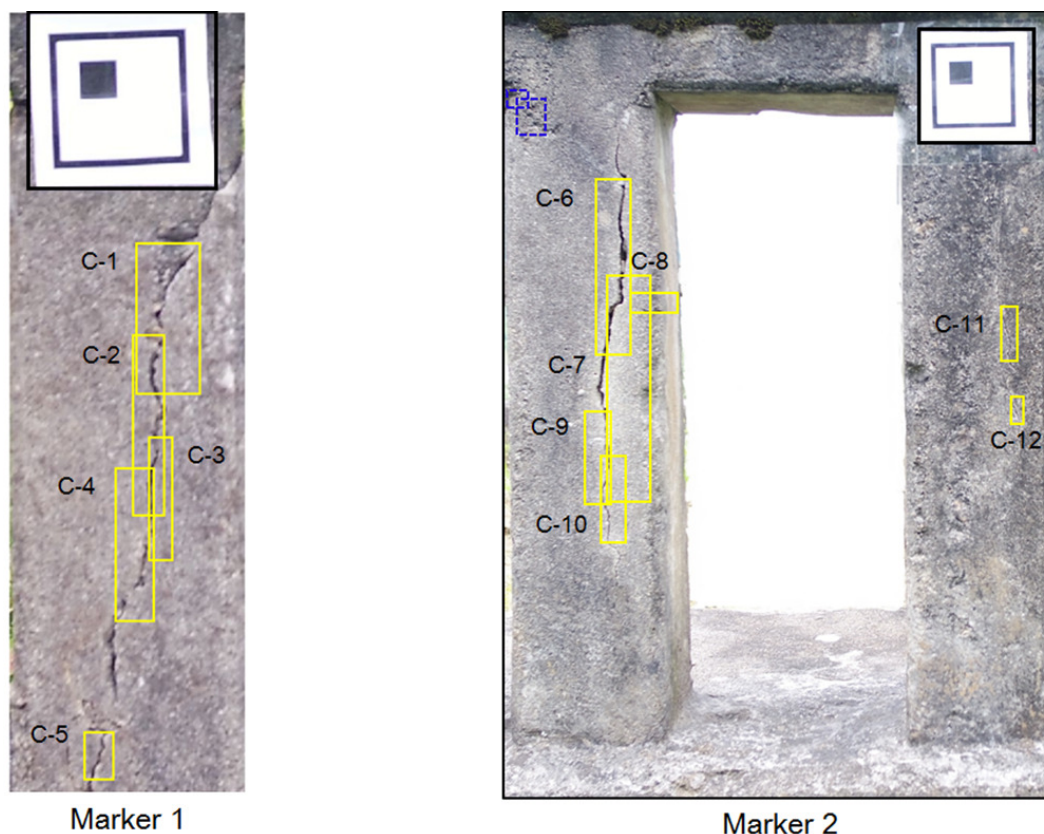
Figure 8. Results of crack (C) detection.

In this study, two regions of interest including both the crack and marker were specified and cropped. Figure 8 shows the results of crack detection by using deep learning. In the figure, there are water marked rectangle boxes, which show the accuracy of the results. The labeled boxes are detected cracks (C) obtained by the deep learning process. The dotted boxes are also detected cracks, but they do not seem like cracks due to blurring. These results show that the deep learning method has better detection performance than the traditional image processing techniques. However, the parameters of the selected region should be modified so that the box can contain the crack size. In this study, the deep learning was trained considering the direction of cracks. In addition, training data were acquired through image rotation to reduce the unbalance between vertical crack and horizontal crack data. As a result, the deep learning model was able to detect the horizontal crack, C-8. Therefore, the proposed approach can be validated to conduct the tasks well, which are classification and localization of cracks.

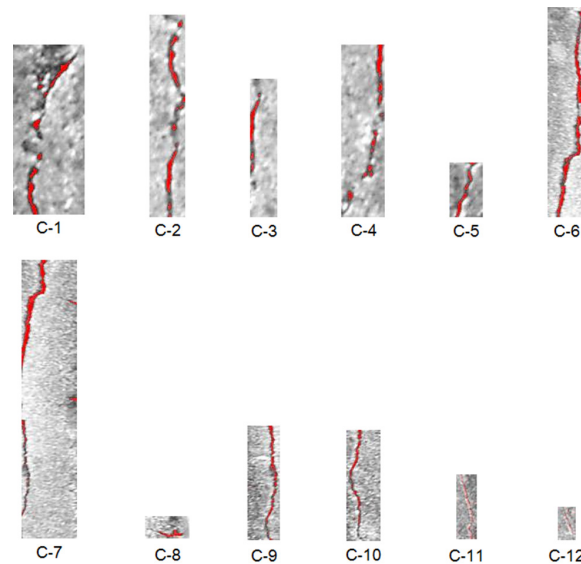
**Figure 9.** Crack quantification by using image processing.

In this section, the quantification of the detected and cropped cracks is described. To quantify the cracks, it is necessary to know the exact pixel size in the image. UAV-based systems can use GPS data and focal distance to predict pixel size, but there is an error that affects the resolution. To estimate pixel size, planar markers sized  $70 \times 70$  mm were attached on the structure, and the vision sensor mounted on the UAV captured the structure including the marker and cracks. In the field test, the conventional square-type marker has been used. The procedure of estimating the length and thickness estimation were identical to as described in Section 2.3. The crack quantification algorithm, which was verified in a small-scale laboratory test that provided a relative error of 1~2%, has been used to calculate length and thickness. Figure 9 shows the results of the marked crack by using the image processing method, and Table 2 shows the estimated results. In this study, the crack quantification based on image processing was considered for the bounding boxes. From the results, it was possible to quantify cracks,

but it was difficult to estimate information on some cracks (i.e., C-11 and C-12). Because the dark surface of the surrounding crack makes quantification of the crack hard work, two cracks were hardly quantified. The crack quantification algorithm based on image processing could be affected by the surrounding environment such as shadows and the intensity and direction of sunlight. Some of these problems could be addressed by considering the lighting equipment and post-processing method.

Crack Thickness (mm)	Crack Length (mm)
C-1	1.92	48.68
C-2	1.10	60.09
C-3	1.10	27.94
C-4	1.37	48.59
C-5	1.37	17.08
C-6	1.92	63.56
C-7	2.47	78.43
C-8	1.59	6.60
C-9	1.10	35.01
C-10	0.53	30.79
C-11	0.55	19.96
C-12	0.55	8.32

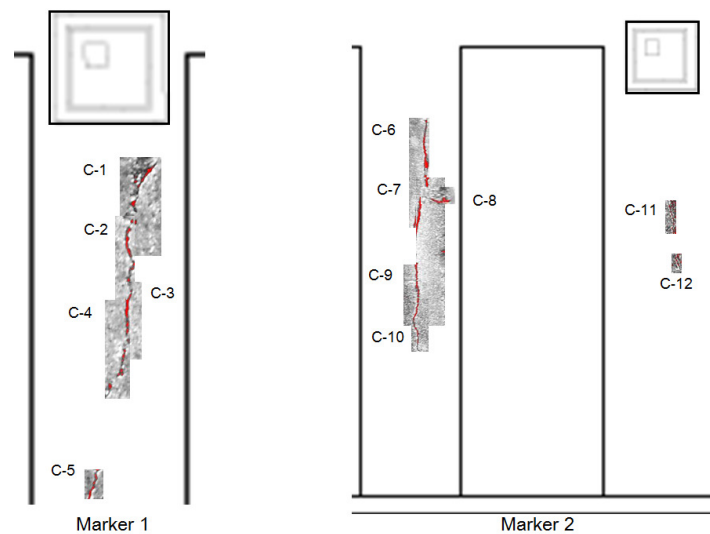
Figure 10. Bridge inspection results.

In the previous section, we confirmed that the thickness and length of cracks can be quantified via image processing. The coordinates and area of the detected crack, the quantified crack information, can be manually displayed on the inspection map as shown in Figure 10. The cracks expressed in the inspection map were realistic and could be stored and compared with later inspection results. We are investigating ways to link the results to the bridge management system (BMS) and to be processed automatically in the future.
