Article

Feasibility of Distributed Fiber Optic Sensor for Corrosion Monitoring of Steel Bars in Reinforced Concrete

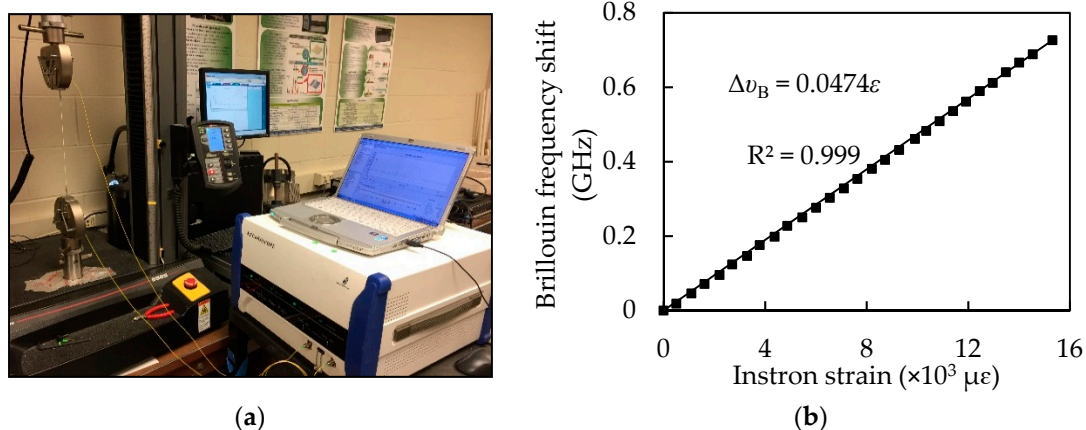
Figure 1. Uniaxial tensile testing for calibration of the fiber optic sensor: (a) laboratory test set-up; (b) sensor calibration curve.

Telecommunication-grade single-mode optical fibers were used as distributed sensors [24–26]. Each fiber consisted of a core (diameter: 8.2 μm), a cladding (diameter: 125 μm), an inner coating (diameter: 190 μm), and an outer coating (diameter: 242 μm). The fiber core and cladding were made of high-purity silica; the inner and outer coatings were made of acrylic for mechanical protection. The strain sensitivity coefficient of the sensor was calibrated using the method in [19]. Three optical fibers with a gauge length of 250 mm were tested in tension at a displacement rate of 0.16 mm/min using a low-capacity load frame (model: Instron 5965, load capacity: 100 N) and a Neubrescope at room temperature (22 °C), as depicted in Figure 1a. Each optical fiber was passed through two protective sleeves that had a steel rod measuring 1.5 mm in diameter for mechanical protection. The protective sleeves were then bonded to the ends of the optical fibers and gripped by the load frame fixture for testing. The applied load and the fiber elongation were recorded by Instron at a sampling frequency of 10 Hz. Given the initial length of optical fiber, the strain values can be calculated from the elongation. At each load, the strain in the optical fiber was simultaneously measured using the load frame and the Neubrescope. The Neubrescope was used to measure the Brillouin frequency shift that can be converted into the strain change from Equation (1) when tested in the ambient temperature. Figure 1b plots the Brillouin frequency shift against the tensile strain of the optical fiber. The coefficient of determination (R^2) for the linear regression is 0.999, indicating a good correlation. The strain sensitivity coefficient is represented by the slope of the line with the value of 4.74×10^{-5} GHz/ $\mu\varepsilon$.

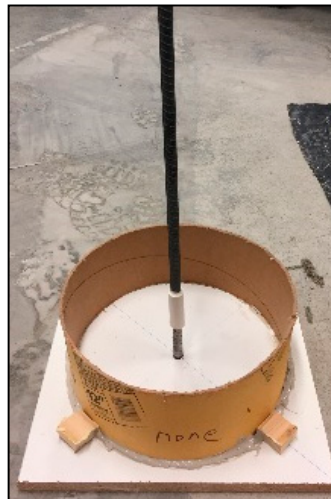
Figure 2. Pull-out test specimen.

The pull-out specimens were designed in compliance with RILEM-II-128 [30] and modified to ensure the specimens failed in the pull-out pattern. Each cylinder measured 305 mm in diameter and 128 mm in length. In each cylinder, a half of the embedded length of the steel bar was in direct contact with the concrete, while the other half was isolated using a polyvinyl chloride (PVC) tube [31], as shown in Figure 2.

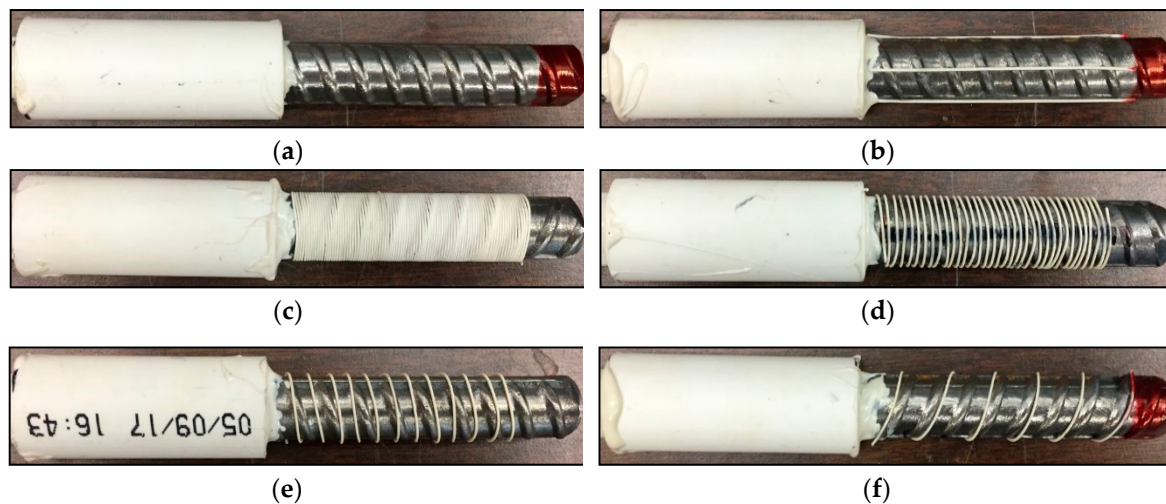
Figure 3. Photograph of steel bars in concrete cylinders for pull-out test: (a) Ref; (b) L4; (c) S0; (d) S2; (e) S5; (f) S10.

Figure 3 shows the steel bars with optical fibers. The specimen without any fiber on the bar is taken as the control specimen, designated as Ref (Figure 3a); the specimen with four fibers equally spaced along the bar is designated as L4 (Figure 3b); the specimens with spirally wound fibers are designated as S0, S2, S5, and S10, corresponding to the spacing of 0 mm, 2 mm, 5 mm, and 10 mm, respectively, as shown in Figure 3c,f. The PVC tube that covers a half of the embedded bar length is the bond breaker. Styrofoam strips were installed on the bars to ensure the bar was centered in the PVC tube. The bond breaker was fixed on the bar using a two-part epoxy at the ends of the concrete cylinder.

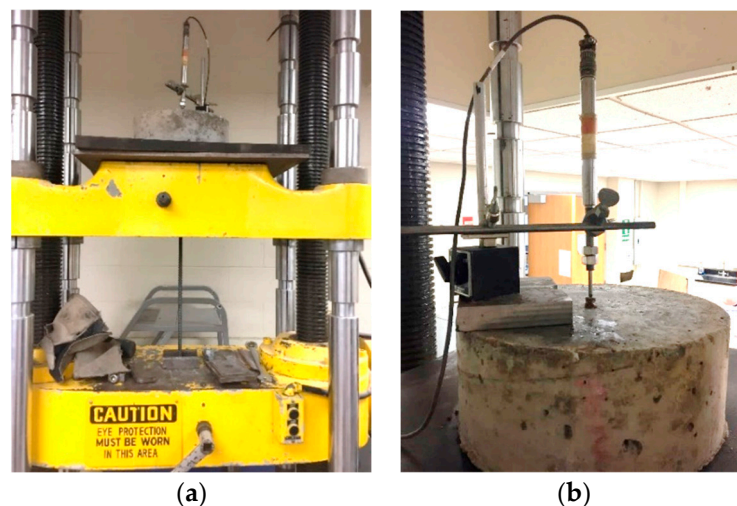
Figure 4. Pull-out test: (a) loading set-up; and (b) instrumentation.

The pull-out specimens were tested using a load frame (capacity: 890 kN) at a constant loading rate of 2.5 mm/min, as shown in Figure 4. The bar was passed through a neoprene pad (20 mm thick), a steel plate (10 mm thick) and the load frame, and gripped by the fixture of the load frame (Figure 4a). The steel plate was used to provide support to the concrete base; the neoprene pad was used to alleviate stress concentration. A linear variable differential transformer (LVDT) was used to measure the relative slip between the bar and concrete, as shown in Figure 4b.

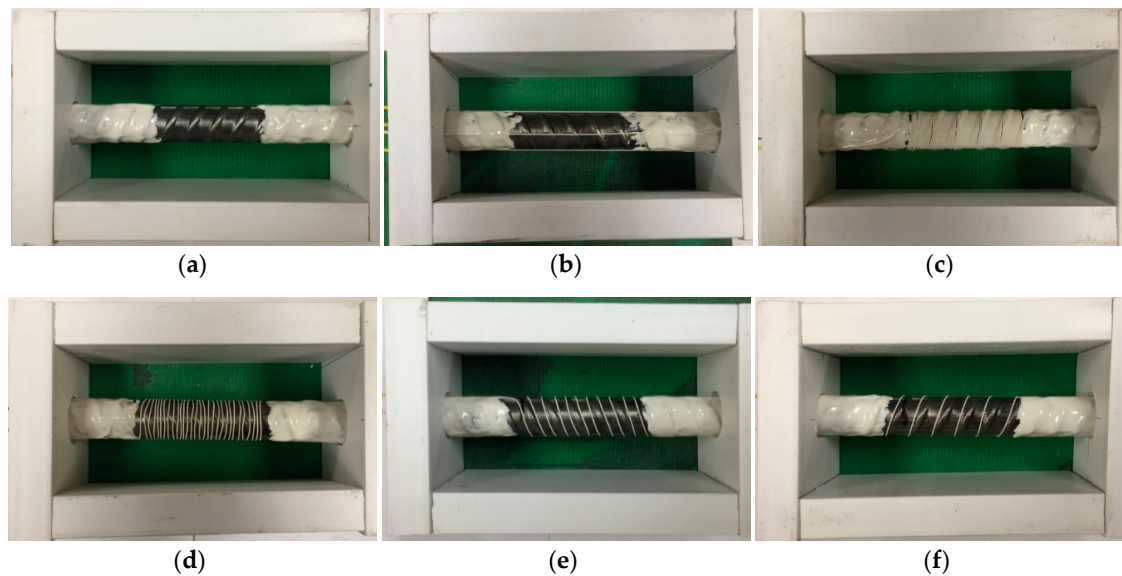
Figure 5. Steel bars in the beams for corrosion testing: (a) Ref; (b) L4; (c) S0; (d) S2; (e) S5; (f) S10.

Reinforced concrete beams measuring 140 mm in length with a 70 mm by 70 mm square cross section were prepared for corrosion test, as depicted in Figure 5. The steel bar was 180 mm long, and had a nominal diameter of 19.1 mm. The surfaces of steel bars were sand blasted to remove the rust and then cleaned using alcohol. A copper wire was soldered at each end of the steel bar for accelerated corrosion testing and electrochemical test measurement. The installation of optical fibers on the bars was consistent with that for the pull-out test, as shown in Figure 5b–f. A two-part epoxy was used to cover a 60-mm length of the bar at each end to enforce electrochemical reactions within the middle length of the bar. Different specimens had different fiber lengths, due to the different fiber installation methods and different spacing. In this research, the length of fiber installed on the steel bars varied from 0.2 m to 2.9 m; the total fiber length was in the range of 0.7 m to 3.4 m.

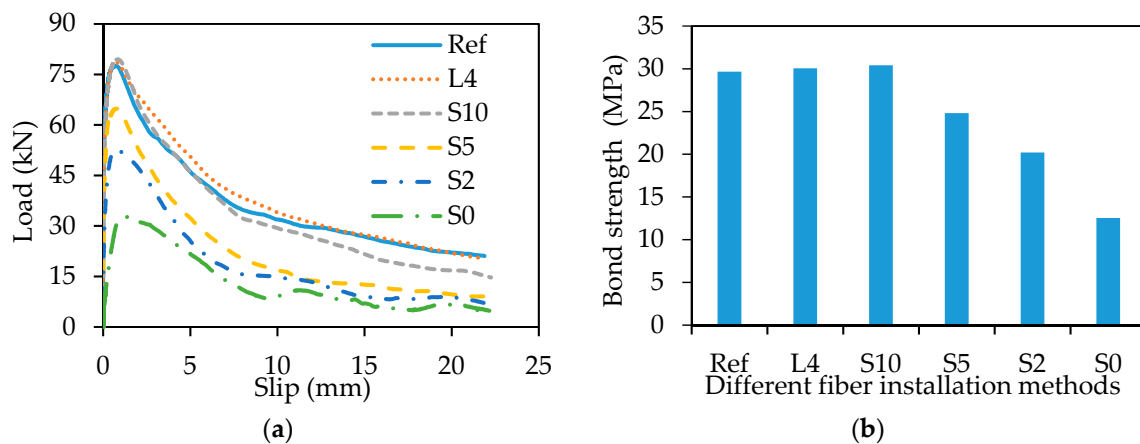
Figure 6. Pull-out test result: (a) load-slip curves; (b) bond strength.

Figure 6a shows the load-slip curves. Each curve is composed of three parts. First, the applied load approximately linearly increases with the slip. Then, the applied load increases with the slip at a reduced increasing rate until reaching the peak. Finally, the load decreases with the slip until the bar is pulled out. The bond strength is calculated using [31]:

No significant difference was observed from the load-slip curves and the bond strengths of the specimens Ref, L4, and S10, indicating that the fiber installation of L4 and S10 do not significantly affect the bond strength. However, as the spacing is reduced from 10 mm to 5 mm, the bond strength is reduced by 18% (Figure 6b).

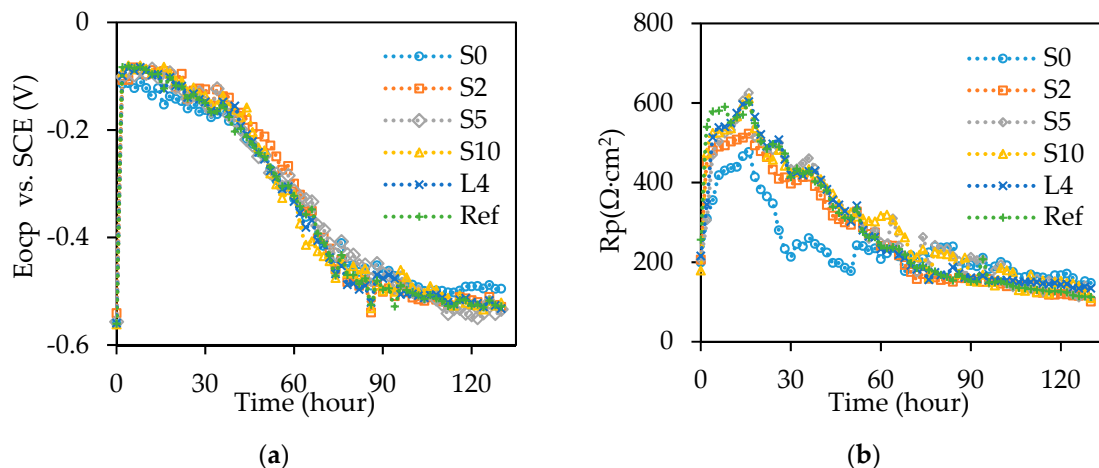
Figure 7. Electrochemical test results of: (a) OCP, and (b) R_p . SCE stands for saturated calomel electrode.

Figure 7a,b respectively show that the OCP and R_p results of all the reinforced concrete beams follow the similar trends over the time up to 130 h. Before the accelerated corrosion test, the OCP is around -0.55 V. After the accelerated corrosion test for 2 h, the OCP increases to around -0.10 V, followed by a slow decrease to -0.15 V at 36 h. Then, the OCP approximately linearly decreases to -0.45 V at 72 h. Finally, the OCP decreases at a smaller rate until the end of the test. Except for the specimen S0 of which OCP stabilizes at -0.50 V, the OCPs of the other specimens stabilized around -0.53 V.

Before the accelerated corrosion test, the R_p values of all the specimens are lower than $250 \Omega \cdot \text{cm}^2$. After the accelerated corrosion test for 2 h, R_p of the specimens S0, S2, S5, S10, L4, and Ref rapidly increases to $309 \Omega \cdot \text{cm}^2$, $450 \Omega \cdot \text{cm}^2$, $305 \Omega \cdot \text{cm}^2$, $475 \Omega \cdot \text{cm}^2$, $344 \Omega \cdot \text{cm}^2$, and $540 \Omega \cdot \text{cm}^2$, respectively; at 16 h, R_p of the specimens S0, S2, S5, S10, L4, and Ref gradually increases to $476 \Omega \cdot \text{cm}^2$, $522 \Omega \cdot \text{cm}^2$, $625 \Omega \cdot \text{cm}^2$, $611 \Omega \cdot \text{cm}^2$, $603 \Omega \cdot \text{cm}^2$, and $600 \Omega \cdot \text{cm}^2$, respectively. After that, the R_p values decrease quickly to $210 \Omega \cdot \text{cm}^2$, $170 \Omega \cdot \text{cm}^2$, $263 \Omega \cdot \text{cm}^2$, $231 \Omega \cdot \text{cm}^2$, $184 \Omega \cdot \text{cm}^2$, and $190 \Omega \cdot \text{cm}^2$ for the specimens S0, S2, S5, S10, L4, and Ref, respectively, until 68 h, followed by a linear reduction until completion.

Compared with the other specimens, S0 has relatively lower R_p values from 0 to 60 h and higher values after 60 h. The different OCP and R_p values indicate that the corrosion process is associated with the sensor installation method.

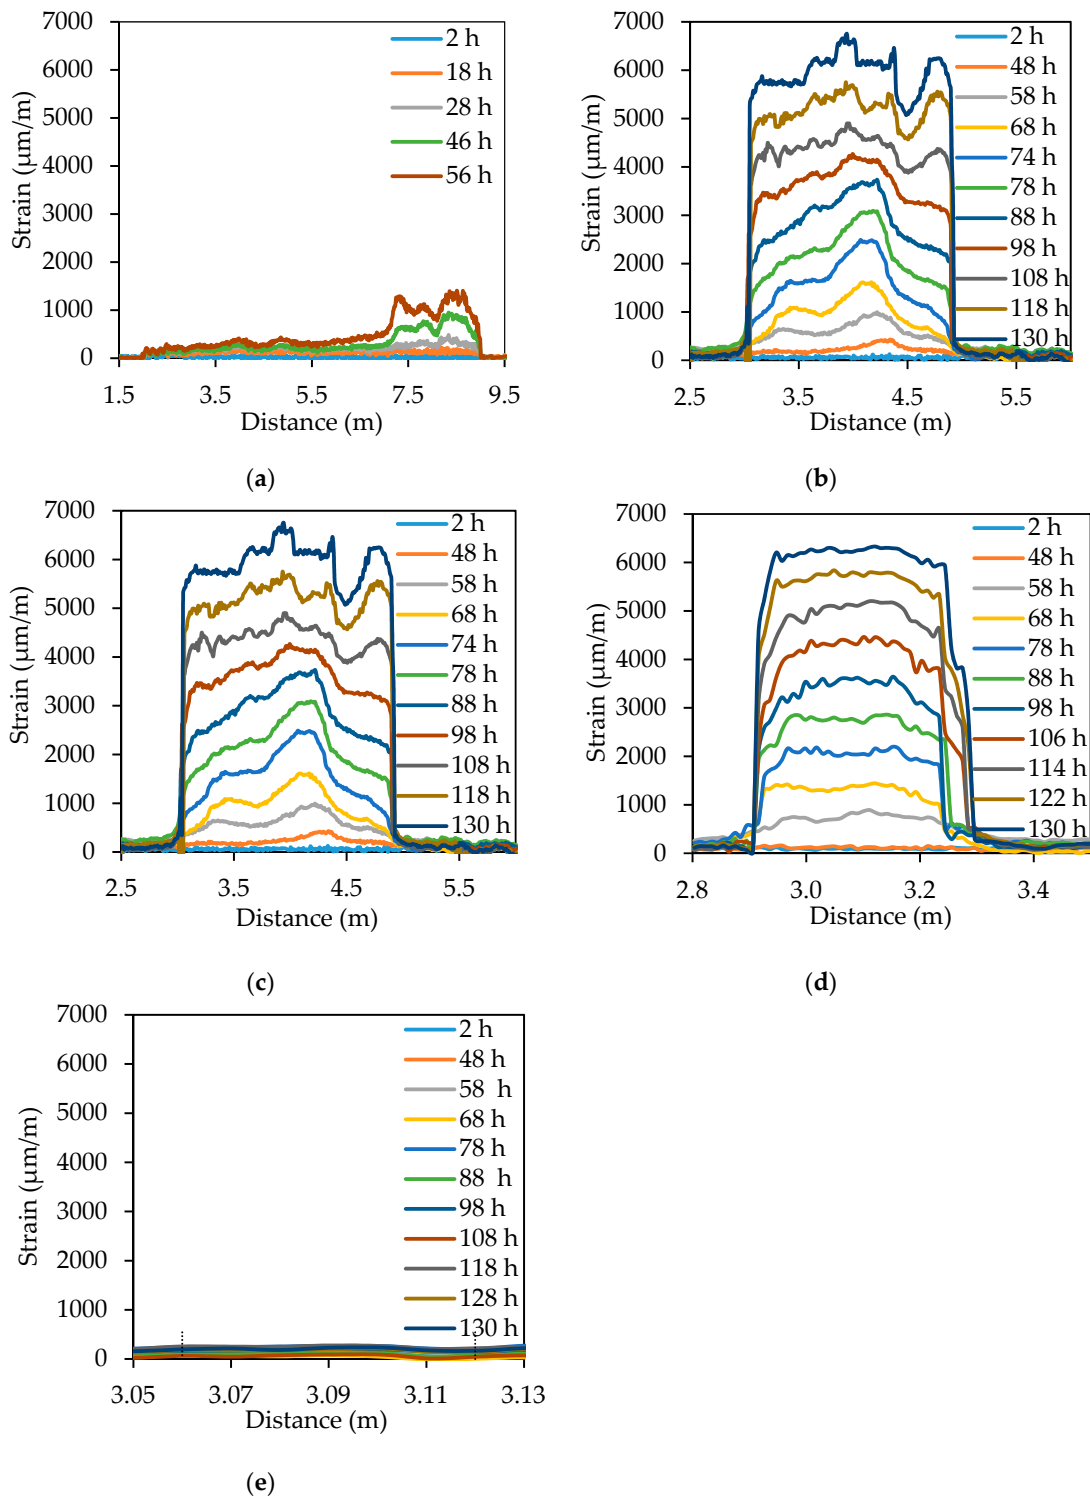
Figure 8. Detailed strain distributions along the distributed fiber optic sensor for different installation methods: (a) S0; (b) S2; (c) S5; (d) S10; and (e) L4.

Figure 8 shows the strain distributions measured from the distributed sensors installed in the reinforced concrete beams. The X-axis represents the distance along the fiber length; the zero distance is at the pump end of the data acquisition system. The Y-axis represents the strain measured from the distributed sensor; tensile strain is positive. Each figure displays the strain in the length of the fiber wound on the steel bar and a short length of the fiber at each of its two ends.

Figure 8a shows the strain results from S0. There is no obvious strain change within the first 18 h. Then, the strain increases with time until 56 h. The strain change within the length 7.2 m to 9.0 m is larger than the strain change in the other parts of the fiber, indicating that corrosion of the bar length that corresponds to the fiber length from 7.2 m to 9.0 m is more severe. After 56 h, the distributed sensor failed to measure, because of significant signal loss caused by the corrosion induced macrobend of the optical fiber. The macrobend loss is dependent on the bend radius and number of circles. Thus, S0 is more susceptible to macrobend loss compared with the other specimens. Figure 8b shows the strain distributions from S2. The fiber length from 3.0 m to 5.0 m is subjected to strain changes that increase over time until 118 h. The distributed sensor continued to be functional and provided reasonable measurement after 130 h. Once again, non-uniform strain distributions are observed at each time instant. Similarly, Figure 8c,d show the strain distributions from S5 and S10, respectively. The distributed sensors in S5 and S10 continued to be functional after 130 h. Figure 8e shows the strain results from L4. The fiber length from 3.06 m to 3.12 m was in contact with the steel bar. There was negligible strain change over 130 h, revealing that the distributed sensor in L4 failed to detect corrosion of the bar.

Typically, corrosion of a steel bar is uniform along the bar length when the bar is impressed with a constant current. In this test, the strain distributions measured from S0, S2, and S5 are non-uniform along the bar; the strain distributions measured from S10 are more uniform. This indicates that the fiber wrapping spacing influences the corrosion pattern. A small fiber spacing tends to cause non-uniform distribution of corrosion.

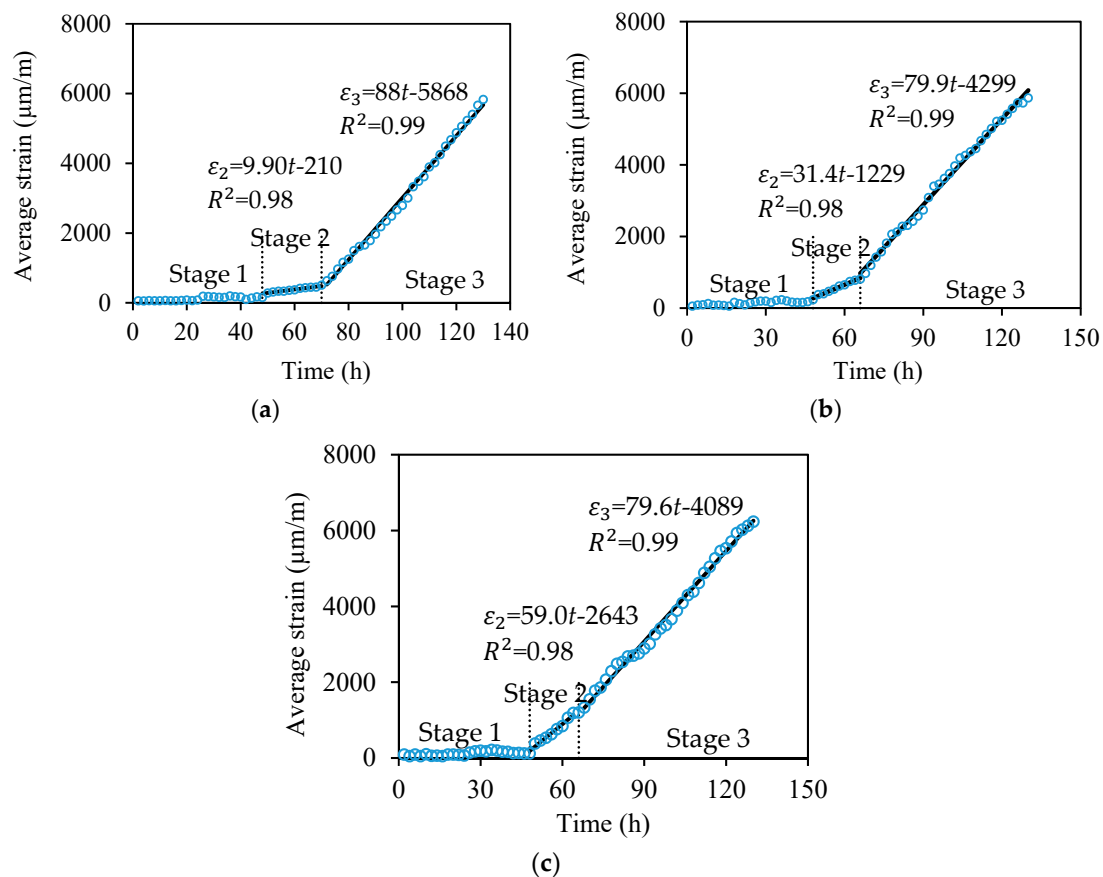
Figure 9. Relationships between the average strain (ε) and corrosion test time (t) of (a) S2, (b) S5, and (c) S10, show three stages (Stages 1, 2, and 3); in Stages 2 and 3, ε approximately linearly increases with t .

To investigate the strain increasing rate in different specimens, the expansion strain measured from the distributed sensor is averaged over the fiber length in contact with the steel bar at each time instant. Figure 9a–c plot the averaged strains of S2, S5, and S10, respectively. Each curve can be divided into three stages. In Stage 1, the corrosion products diffuse and gradually filled the surrounding concrete pores [7,34]. This is corroborated by the very small strain change (less than $150 \mu\epsilon$) measured from the distributed sensors. Stage 1 is terminated when the majority of concrete pores at the steel–concrete interface is filled up and the corrosion products starts to increase the tensile strains. In Stage 2, the corrosion products continue to expand and tend to increase the tensile stresses in the concrete matrix. Stage 2 ends when concrete cracks. In Stage 3, ingress of water and oxygen is accelerated due to the concrete cracking [6,20]. Thus, the average strain increases approximately linearly with time at an increasing rate larger than that of the Stage 2. A linear regression analysis is conducted for Stage 2 and Stage 3, respectively. For the specimens S2, S5, and S10, the strain increasing rate of Stage 2 is $9.9 \mu\epsilon/h$, $31.4 \mu\epsilon/h$, and $59.0 \mu\epsilon/h$, respectively; the strain increasing rate of Stage 3 is $88 \mu\epsilon/h$, $79.9 \mu\epsilon/h$, and $79.6 \mu\epsilon/h$, respectively.

In Stage 2, the strain increasing rate decreases with the spacing, because the tightly spaced fibers occupy more space outside of the steel bars, hindering ingress of oxygen and water to the bars, thus decelerating the corrosion rate. In Stage 3 when the concrete cracks, ingress of oxygen and water is largely promoted by the cracks, and thus the effect of fiber spacing becomes less predominant. Therefore, the strain increasing rates of S2, S5, and S10 are close in Stage 3.

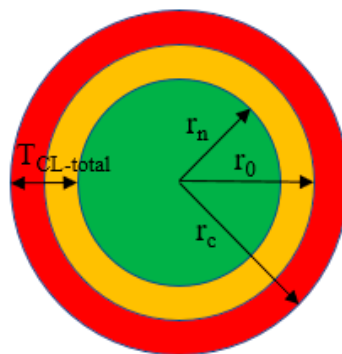
Figure 10. Schematic of the radius change of steel bar under corrosion.

The total thickness of the corrosion layer is denoted by $T_{CL-total}$ as shown in Figure 10 [23]:
