## Fracture and deformation of ProTaper Next instruments after clinical use

**Background:** The aim of this study was to evaluate the fracture and defects observed in ProTaper Next files discarded after a normal clinical use.

**Material and Methods:** 571 ProTaper Next rotary instruments were collected after clinical use from the clinic of endodontics over 12 months. The length of the files was measured using a digital caliper to determine any fracture, later all the files were evaluated under a stereomicroscope to observe defects such as unwinding, curving or fracture. The data obtained were analyzed using a chi-square and z test.

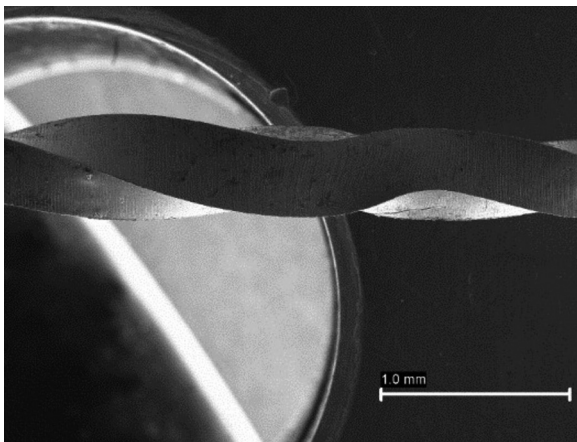
**Fig. 1:** Images captured by stereomicroscope. Unwinding file.

Unwinding (Fig. 1) was also observed mainly in the 17.04 file (17 files, 10.56%), like the presence of cur-

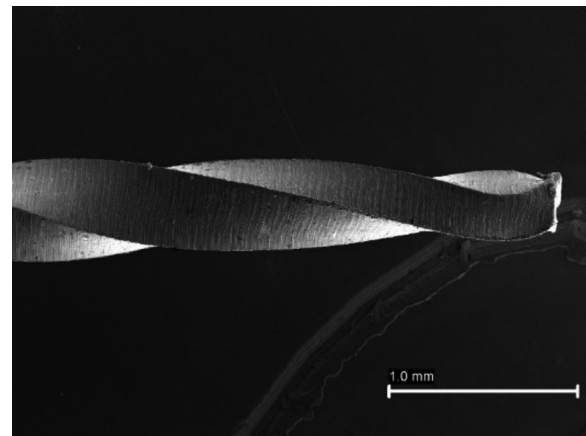
**Fig. 2:** Images captured by stereomicroscope. Fractured file by torsional.

Fractured instruments were divided according to the type of fracture, torsional (Fig. 2) or flexural fatigue (Fig. 3), the number and percentage of files of each group are shown in Table 3. The stereomicroscope evaluation revealed the reason for the separation of 34 (79.07%) files was flexural fatigue and 9 (20.93%) files were torsional.

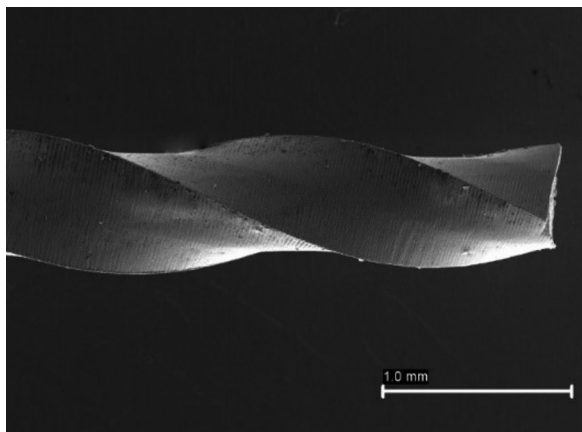
Fig. 3: Images captured by stereomicroscope. Fractured file by cyclic fatigue.

Based on the initial length of the files was 25 mm, the fragment size ranged from 4.27 to 1.29 mm. The fractured instruments due to cyclic fatigue are generally larger.
