Djeffal H, Blouet M, Pizzoferrato A-C, Vardon D, Belloy F, Pelage J-P. Imaging findings in Essure-related complications: a pictorial review. *Br J Radiol* 2018; **91**: 20170686.

## PICTORIAL REVIEW

# Imaging findings in Essure-related complications: a pictorial review

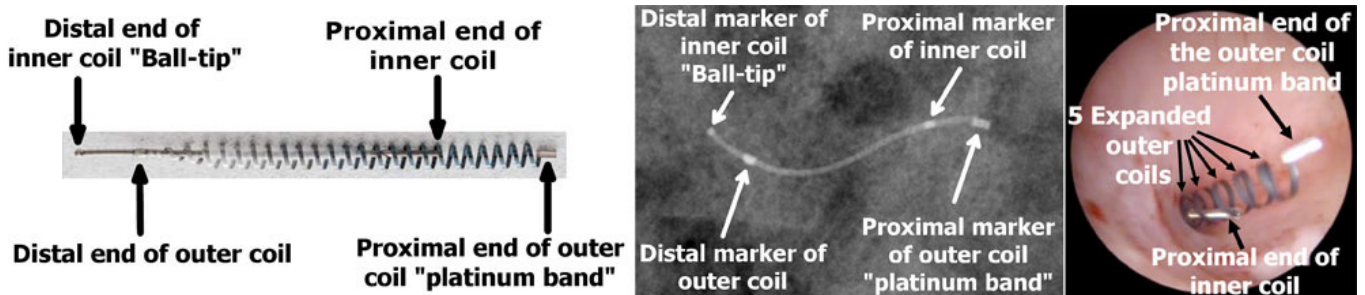
Figure 1. Appearance of the Essure permanent birth control device on a photograph (a), a radiography (b) and a hysteroscopy (c). (a) A photograph of the device, which consists of two coils. The distal end of the inner coil has a small round shape "ball-tip". The proximal end of the outer coil is recognized with its linear shape "platinum band". The inner coil end of the device is inserted into the fallopian tube, and the outer coil end protrudes into the uterine cavity. The inner coil is coated with polyethylene terephthalate fibers, which stimulate a fibrotic reaction, causing the occlusion of the tubal lumen. The outer spring coil expands upon deployment and anchors the device within the cornua. (b) Radiographic appearance of an Essure microinsert with the four radio-opaque markers identified. (c) Hysteroscopic image of an Essure micro-insert with five trailing coils into the uterine cavity, through the tubal ostium. The proximal end of the outer coil is recognized by the platinum band.

The procedure is carried out with hysteroscopic guidance and the insert is placed transcervically into the proximal portion of the fallopian tube. Each insert consists of a nickel-titanium alloy outer coil, a stainless steel inner coil wrapped in a layer of polyethylene terephthalate fibers<sup>2,3</sup> (Figure 1).

The microinserts are easily detectable as two curvilinear and relatively symmetrical metallic devices with radiomarkers at the end of each coil. The lateral or tubal end of the insert is recognized by the distal marker of the inner coil which has a small round shape (ball-tip). The medial or uterine end of the insert is recognized by the proximal marker of the outer coil which has a linear shape (platinum band) (Figure 1b).

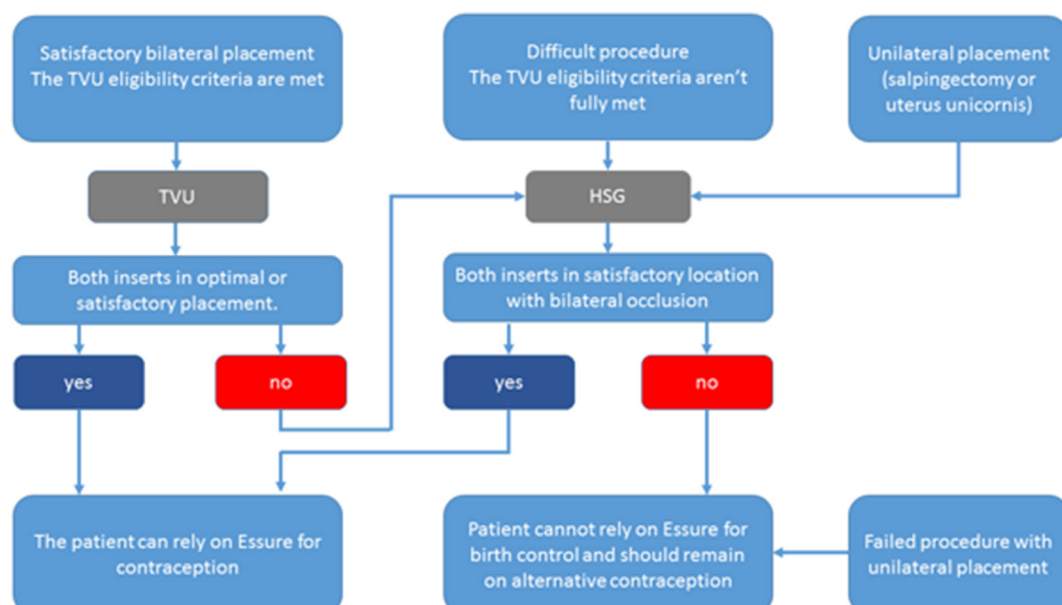
Figure 2. : Essure TVU/HSG confirmation test algorithm. HSG, hysterosalpingography; TVU, trans-vaginal-ultrasound.

detailing the indications of each technique<sup>2,11</sup> (Figure 2). This new protocol was deemed effective in determining if a patient could rely on the Essure device for contraception.<sup>11</sup>

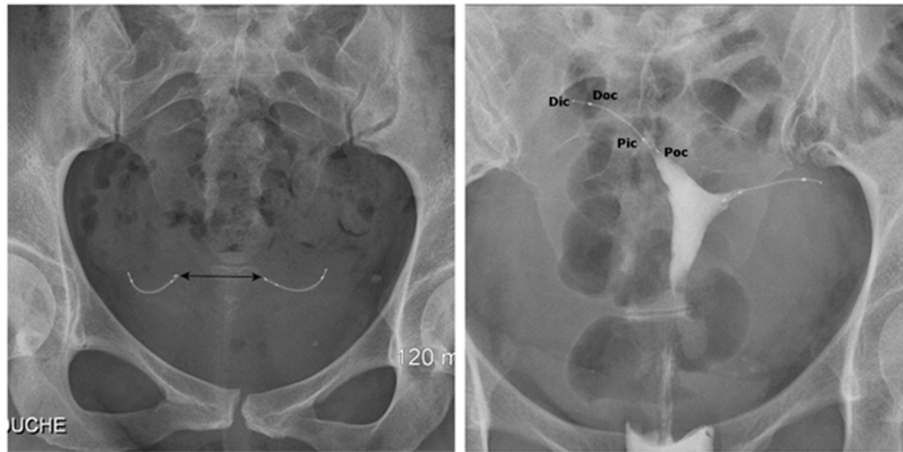
Figure 3. Normal appearance of Essure birth control device on radiography (a) and hysterosalpingography (b). (a) Pelvic X-ray showing two symmetrical inserts, laying in the pelvic area without any abnormal configuration. Their radiomarkers are aligned and the distance between the proximal ends of the inserts is inferior to 4 cm. (b) Hysterosalpingogram showing correct placement of the two inserts with bilateral tubal occlusion. Both inserts have an intrauterine portion, an interstitial portion and a tubal portion. Contrast agent fills both cornual regions without progression into the fallopian tubes or intraperitoneal spillage. Pic/Dic, proximal and distal markers of the innercoil; Poc/Doc, proximal and distal markers of the outercoil.

There are three main parameters to take into account when assessing Essure devices on a pelvic radiography<sup>2</sup> (Figure 3a): (1) The symmetrical appearance of the two inserts. (2) The radiomarkers of each coil should be aligned without angulation of the microinserts. (3) The distance between the proximal markers of the microinserts should be inferior to 4 cm, which is the theoretical distance between the two ostia.

The microinserts are considered “functional” if they are relatively symmetrical, placed adequately in the UTJ with no tubal patency<sup>2</sup> (Figure 3b).

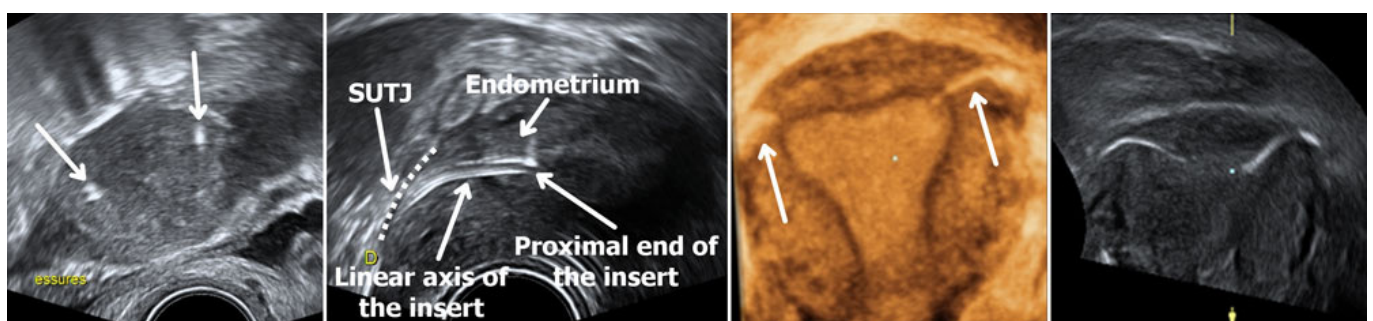
Figure 4. Normal appearance of Essure birth control device on 2D-TVUS (a, b) and 3D-TVUS (c, d). (a) Axial ultrasound image of the uterus showing both inserts in the cornual regions. This acquisition avoids the risk of duplicate imaging of the same insert that can happen if the probe is turned 180 degrees during the examination. (b) An oblique transverse image of the uterus showing the linear axis of the insert in the interstitial portion of the fallopian tube, crossing the right SUTJ. The linear axis is not coiled. The proximal end of the insert is in contact with the endometrium. The insert is not seen beyond the SUTJ. The serosal boundary is delineated by the dotted line. (c) Volume contrast 3D reconstructed image in the coronal plane demonstrating a uterus with two inserts in perfect position (1 + 2 + 3). The medial end of the left insert is in the uterine cavity. The medial end of the right insert is in contact with the endometrium. (d) Coronal reconstruction from a 3D ultrasound acquisition, showing a uterus with two inserts in perfect position (1 + 2 + 3). 2D, two-dimensional; 3D, three-dimensional; SUTJ, serosal-uterotubaljunction; TVU, trans-vaginal-ultrasound.

An insert position is considered satisfactory if the linear axis of the microinsert can be visualized crossing the SUTJ and its medial end is in contact with the endometrium or the uterine cavity. The insert is not necessarily seen beyond the SUTJ<sup>2</sup> (Figure 4b).

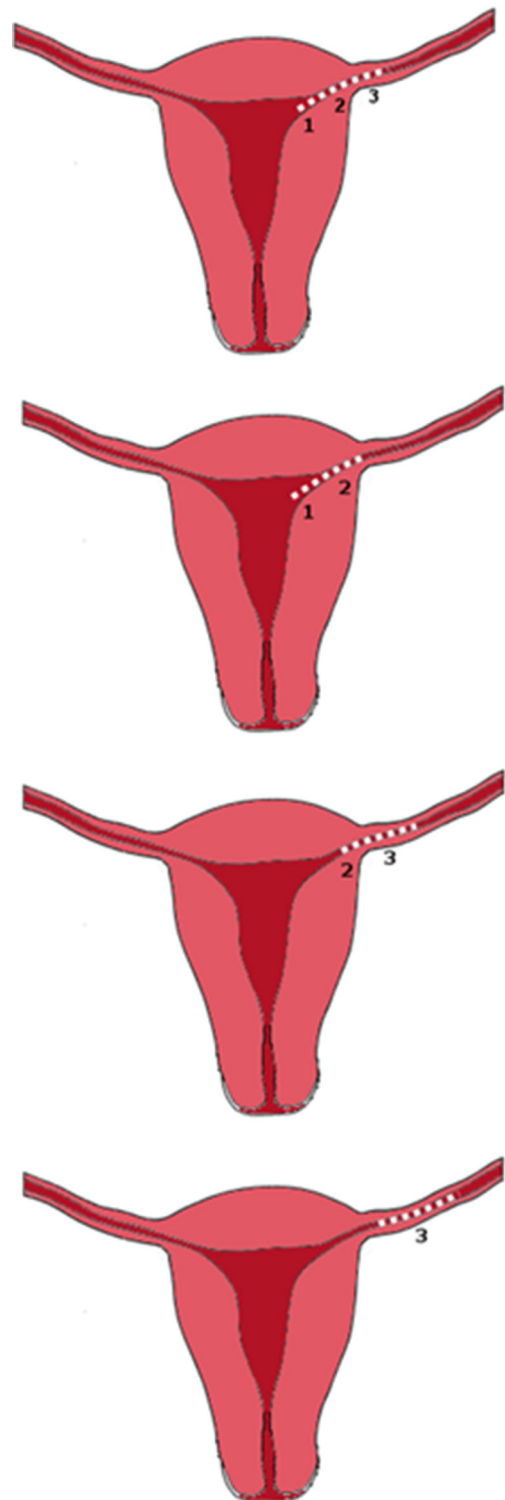
Figure 5. Legendre's three-dimensional ultrasound classification to assess Essure device position: perfect position (1 + 2 + 3), proximal position (1 + 2), distal position (2 + 3) and very distal position (3-only).

Legendre et al developed a classification to assess the position of the Essure device that relies on the coronal section of the uterus obtained after a three-dimensional acquisition<sup>6</sup> (Figure 5).

- (1) The perfect position (1 + 2 + 3) includes an intrauterine portion, a cornual portion and an isthmic portion (optimal).
- (2) A proximal position (1 + 2) includes an intrauterine and a cornual portion (suboptimal).
- (3) A distal position (2 + 3) with no intracavitary portion (suboptimal).
- (4) A very distal position (3 only) located in the isthmic portion of the fallopian tube.

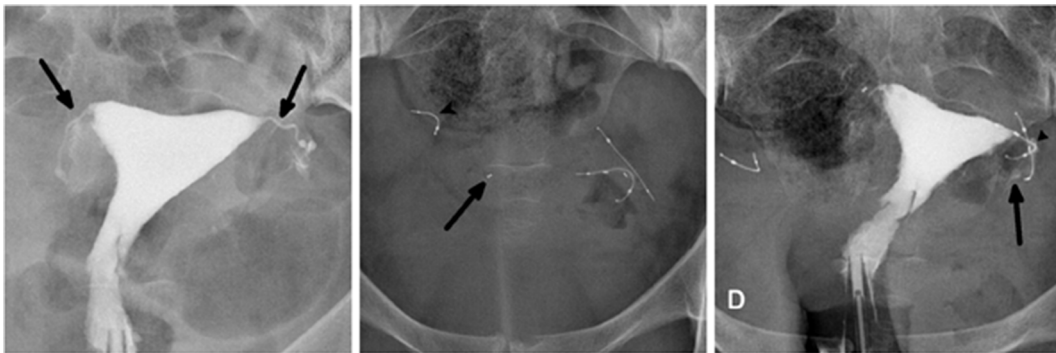
Figure 6. A 34-year-old female with a history of a left-sided tubal stump pregnancy, a year after undergoing laparoscopic tubal ligation. Following the failure in sterilization, tubal occlusion with Essure device was proposed to her. The procedure was described as difficult with poor visibility because of endometrial bleeding and debris. The right implant was deployed with eight trailing coils visible in the uterine cavity. On the left side, a first implant was placed with no trailing coils visible after deployment. The surgeon suspected distal placement and decided to place another insert that left six trailing coils after deployment. (a) Hysterosalpingogram performed before Essure placement, showing bilateral tubal patency in both tubal stumps (arrow). (b) Scout image showing two inserts on the left side of the pelvic cavity, one of them having a straight shape, and distal migration of the right insert (arrow-head) after detachment from its proximal marker (arrow). (c) Hysterosalpingogram showing tubal occlusion of the right side and tubal patency of the left side (arrow) despite a correctly placed insert. On the right side, the outer coil is not delineated by the dye in the tube and the important distance between the proximal marker and the rest of the insert suggests a fracture rather than a stretching. Tubal perforation with the second “left” implant was suspected because the second implant was projected outside the uterine cavity and did not follow the course of the fallopian tube that was delineated by the contrast agent (arrowhead). Tubal perforation was confirmed during laparoscopic surgery.

Structural abnormalities are best identified by pelvic X-ray or HSG. Insert fracture or stretching of the proximal outer coil may occur upon device deployment (Figure 6). These complications are usually noticed during the procedure and removal of the device is generally attempted immediately afterward.

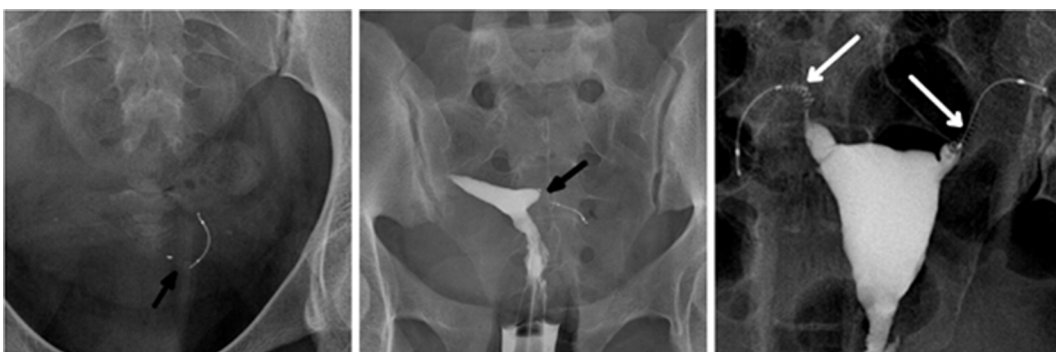
Figure 7. A 26-year-old female with a history of laparoscopic salpingectomy for a right-sided ectopic pregnancy. (a) Scout image showing normal stretching of the proximal end of the outer coil (arrow). (b) Hysterosalpingogram showing correct placement of the left insert with a normal stretching of the outer coil (arrow). The outer coil is slightly visible, connecting the proximal marker to the rest of the insert. Although the outer coils aren't radiopaque, they can be delineated by the contrast filling the tube. (c) HSG image of another patient showing the outer coil being delineated by the contrast in the fallopian tube. HSG, hysterosalpingography.

However, it should be noted that because of the outer coil's flexibility, its proximal marker may seem slightly stretched while the rest of the markers are fixed in relation to one another (Figure 7).

delineated by the contrast agent filling the tube<sup>2</sup> (Figure 7c) and therefore, its integrity and morphology can be evaluated. Additionally, if the distance between the proximal marker and the rest of the insert is important (Figure 6), it is more likely to be due to a fracture than a stretching.

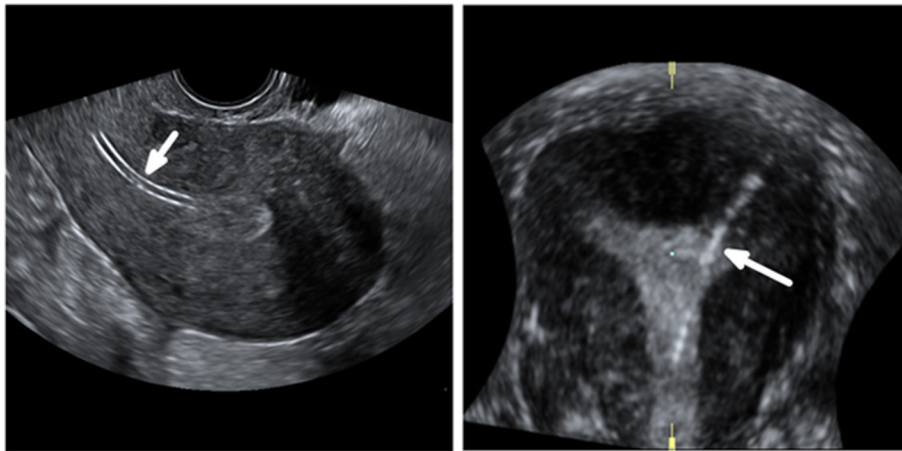
Figure 8. A 48-year-old multiparous female presenting with chronic left iliac fossa pain. The patient had Essure bilateral placement performed 3 years prior to the examination. (a) Transvaginal ultrasound image: midsagittal section of the uterus showing the long axis of the insert (arrow) in the uterine cavity. (b) 3D reconstructed coronal view of the uterus showing proximal migration of the left insert (arrow). 3D, three-dimensional.

After Essure device insertion, inserts can migrate proximally into the uterine cavity (Figure 8), sometimes to the point of expulsion (Figure 9) or distally through the fallopian tubes (Figure 10) and into the peritoneal cavity (Figure 11).

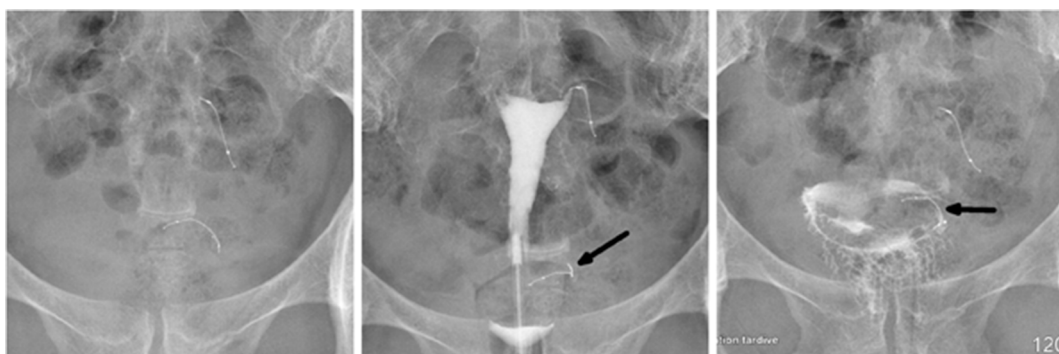
Figure 9. A 44-year-old female who underwent tubal sterilization with Essure implants. The procedure was noted as difficult because of poor visibility and a right-sided tubal spasm. (a) Scout image showing asymmetrical inserts. (b) Hysterosalpingogram showing bilateral tubal occlusion despite a misplaced right implant. Peritoneal extrusion was suspected because the insert wasn't projected inside the uterine cavity (arrow). (c) Delayed HSG image. The patient experienced shortly afterward, a vaginal expulsion of the right insert. This was due to a proximal migration of the insert that positioned itself in the vaginal fornix (arrow), which is consistent with the imaging findings of the image (c). In this case, differentiating between a localization in the recto-uterine pouch and the vaginal fornix cannot be done on radiographic or HSG images. Peritoneal extrusion was suspected because the implant was lodged in the pelvic area for 3 months after the procedure and should have been extruded vaginally earlier in the follow-up period. An approach with a CT scan would have been better suited to localize the implant with more precision. HSG, hysterosalpingography.

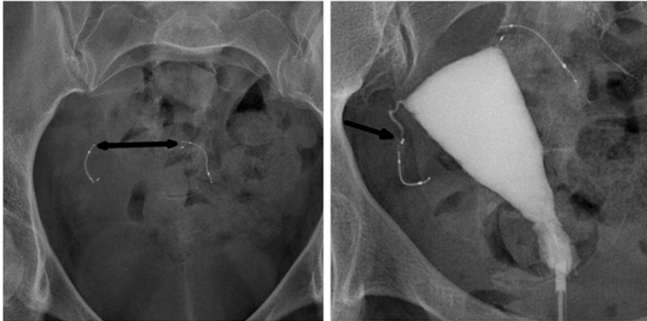
Figure 10. A 35-year-old female who underwent tubal sterilization. (a) Scout image showing an increased inter implant distance superior to 4 cm. (b) Hysterosalpingogram showing distal malposition of the right insert (arrow) with bilateral tubal occlusion.

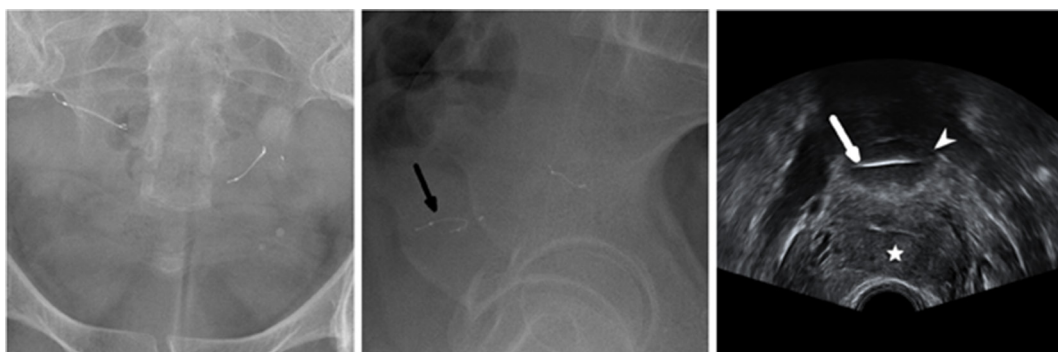
Figure 11. A 41-year-old female presenting with fever and iliac fossa pain, a month after a difficult Essure placement procedure. (a) Anteroposterior pelvic radiography showing asymmetrical inserts. (b) Lateral pelvic radiography showing an anterior position of the left implant (arrow). (c) Transvaginal-ultrasound image: transverse section of the uterus (star) showing a collection (arrow-head) centered around the left insert (arrow) in the peritoneal cavity. Laparoscopic surgery confirmed the extrusion of the left insert which was positioned in the omentum.

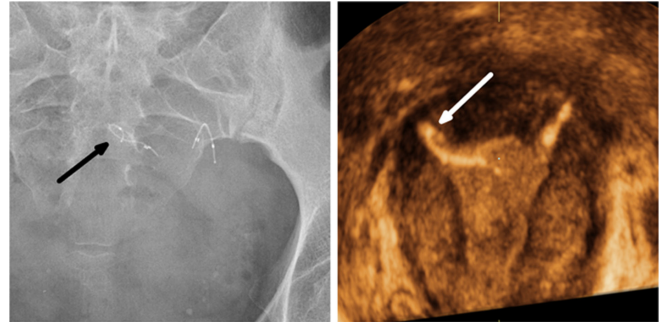
Figure 12. A 45-year-old multiparous female who underwent a complicated Essure procedure because of poor visibility with 14 trailing coils visible after the deployment of the right insert. A history of angioedema after an intravenous urography prevented the use of hysterosalpingography. (a) A pelvic radiography showing a curled right insert (arrow). (b) 3D reconstructed coronal view of the uterus confirming the abnormal configuration of the insert (arrow) in the right cornua. 3D, three-dimensional.

Poor visualization during the procedure is a common factor of device misplacement (Figures 12 and 13).

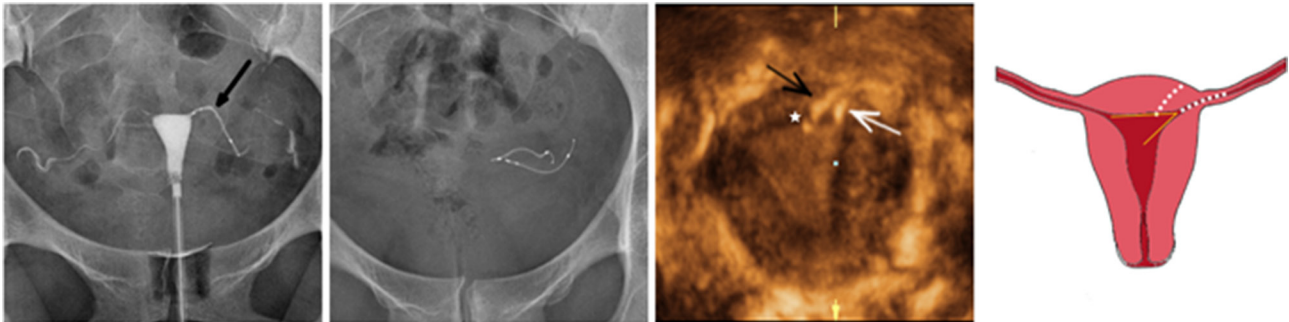
Figure 13. A 45-year-old female who underwent two attempts of Essure placement with a failure inserting the implant in the right ostium during the first attempt. Endometrial bleeding obscured visibility during the second attempt which misled the surgeon to insert a second implant on the left side. Uterine perforation was confirmed during surgery. (a) Hysterosalpingogram (performed before the second attempt) showing a correctly positioned insert in the left side (arrow) with normal bilateral tubal patency. (b) Pelvic X-ray performed after the second attempt, showing two inserts in the left side of the pelvic cavity. (c) 3D reconstructed coronal oblique view of the uterus showing one correctly placed insert (white arrow) localized in the cornua and following laterally the expected course of the fallopian tube. The second implant (black arrow) is localized medially to the cornua and crosses through the myometrium (white star), which is suggestive of uterine perforation. Additionally, the first insert seemed correctly placed in the tubal lumen on the first HSG and the second insert had a different course with a different entrance point (white star) in the uterine wall that couldn't have been the tubal ostium. (d) Illustration depicting the misplaced insert in the coronal plane. The insert is localized medially to the left superior angle of the uterine cavity which represents the left tubal ostium, and crosses through the myometrium. 3D, three-dimensional; HSG, hysterosalpingography

On ultrasound, uterine perforation can be suspected if the linear axis of the insert is parallel to the endometrial stripe in the sagittal view or if the linear axis of an insert is visualized crossing through the myometrium<sup>2</sup> (Figure 13).

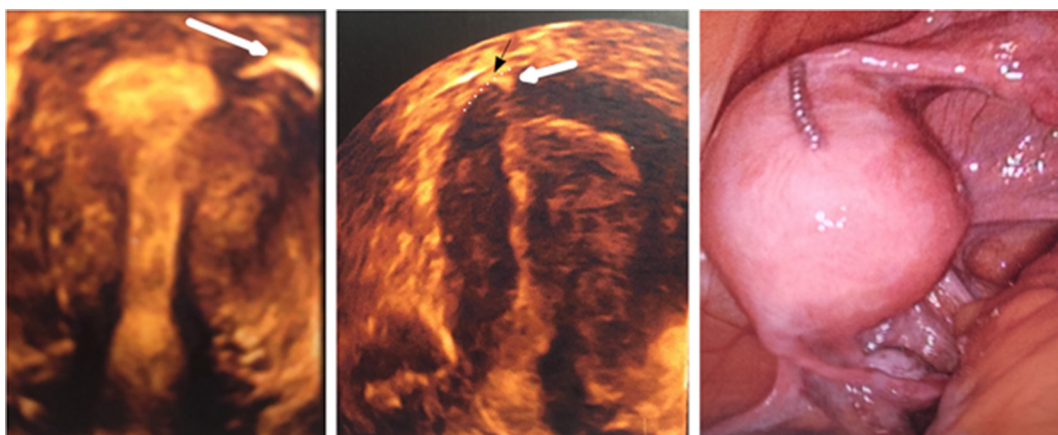
Figure 14. A 36-year-old female who underwent tubal sterilization with the Essure system. A mild resistance was encountered while inserting the right implant. The follow-up test consisted of a TVUS without HSG or X-ray because the surgeon was satisfied with the procedure and confident that the inserts were correctly placed. An unwanted pregnancy occurred 6 months after the procedure and a medical abortion was performed. The patient underwent laparoscopic tubal ligation during which an Essure-related uterine perforation was diagnosed. (a) 3D reconstructed coronal view of the uterus showing a proper position of the left insert (arrow). (b) 3D reconstructed coronal view of the uterus showing a satisfactory placement of the right insert (white arrow) (position 2 + 3 according to Legendre's classification) that comes in contact with the SUTJ (black arrow). The serosal boundary is delineated by the dotted line. The tubal portion of the insert is not visible. (c) Laparoscopic view confirming subserosal misplacement of the right insert. 2D, two-dimensional; 3D, three-dimensional; SUTJ, serosal-uterotubal junction; TVU, trans-vaginal-ultrasound.

Tubal or uterine perforation is a difficult and relatively rare diagnostic. Its rate ranges from 1 to 2%.<sup>1,3</sup> (Figure 14). The difficulty

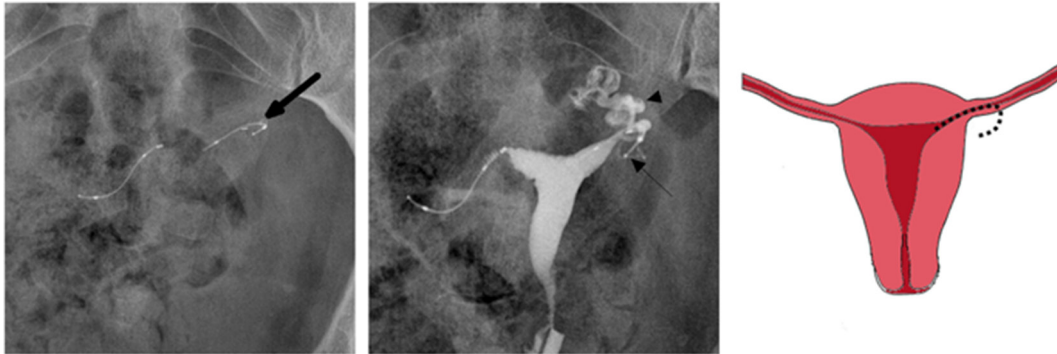
Figure 15. A 37-year-old nulliparous female who underwent bilateral Essure placement. A second hysterosalpingography was required six months after the procedure because of bilateral tubal patency in the first follow-up. (a) Scout image showing an asymmetrical aspect of the inserts with a curved left insert (arrow). (b) Hysterosalpingogram showing proper placement of the two inserts and persistent left tubal patency. The lateral end of the left insert (arrow) deviates from the trajectory of the contrast filled ampulla and infundibulum of the fallopian tube (arrowhead) which is consistent with tubal perforation. Laparoscopic tubal ligation was performed and confirmed tubal perforation with subserosal misplacement of the left insert. (c) Illustration depicting the tubal perforation with the left insert deviating from the course of the fallopian tube.

perforation by showing an embedded insert in the myometrium or an aberrant trajectory of the insert that is different from the tubal dye filled trajectory<sup>2</sup> (Figure 15).

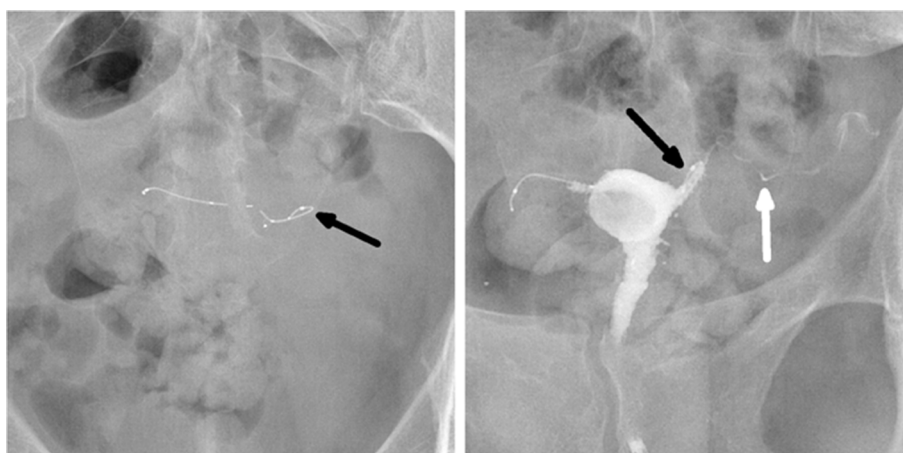
Figure 16. A 43-year-old female who underwent a satisfactory bilateral Essure device placement. (a) Scout image showing a kinked left insert (arrow) (b) Hysterosalpingogram showing a curled insert in the left cornua (black arrow) associated with ipsilateral tubal patency (white arrow). Tubal perforation was suspected because of the kinked aspect of the insert but hysteroscopy confirmed the proximal migration of the left insert with 15 trailing coils inside the uterine cavity.

Tubal patency is defined by the progression of contrast material past the distal end of the outer coil or by intraperitoneal spillage of contrast material. It can be caused by an incorrect placement of the insert, thus affecting the fibrosis process (Figure 16) or by tubal perforation.
