## Case report

## Titanium neck-titanium stem taper corrosion in a modular neck stem

Ronit Shah, BS <sup>a</sup>, Carl Talmo, MD <sup>b</sup>, Sumon Nandi, MD, FACS <sup>a,\*</sup><sup>a</sup> Department of Orthopaedic Surgery, The University of Toledo College of Medicine and Life Sciences, Toledo, OH, USA<sup>b</sup> Department of Orthopaedic Surgery, New England Baptist Hospital, Boston, MA, USA

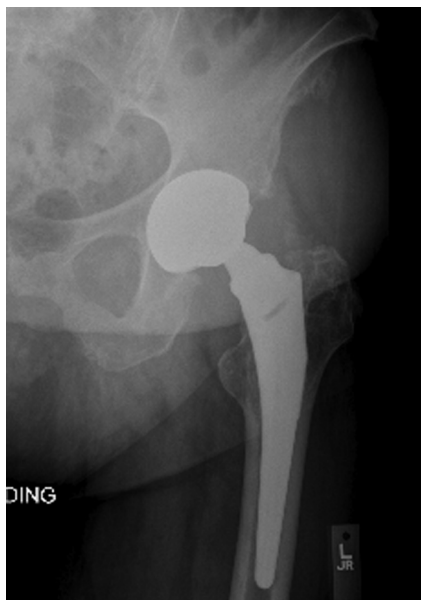
**Figure 1.** Anteroposterior left hip plain film demonstrating Zimmer M/L Taper Kinectiv modular neck stem.

Plain films demonstrated well-fixed left THA without evidence of wear, osteolysis, or fracture (Fig. 1). Serum white blood cell count was 8.08 K/ul (reference range: 5.00-10.00 K/ul), erythrocyte sedimentation rate was 16 mm/h (reference range: 0-15 mm/h), and C-reactive protein level was <2.0 mg/L (reference range: 0-10 mg/L). Serum Co level was 4.8 ppb (reference range: 0.5-3.9 ppb) and Cr level was 1.0 ppb (reference range: ≤5.0 ppb). Ti level was undetectable. Left hip aspiration showed 61 white blood cells using a manual cell count. Cultures were negative. Given elevated Co level with increased Co-to-Cr ratio, metal artifact reduction sequence magnetic resonance imaging of the left hip was obtained, which demonstrated ALTR (Fig. 2). Operative records confirmed the presence of the following implants: size 11 Zimmer M/L Taper Kinectiv Ti-alloy (Ti6Al4V) femoral stem with 12/14 taper, size P straight Ti-alloy (Ti6Al4V) modular neck, 32 mm + 0 cobalt-chrome head, 50-mm Zimmer Trabecular Metal Modular cluster-hole acetabular shell, and 20-degree elevated rim longevity highly cross-linked polyethylene liner (Zimmer Biomet, Warsaw, IN).

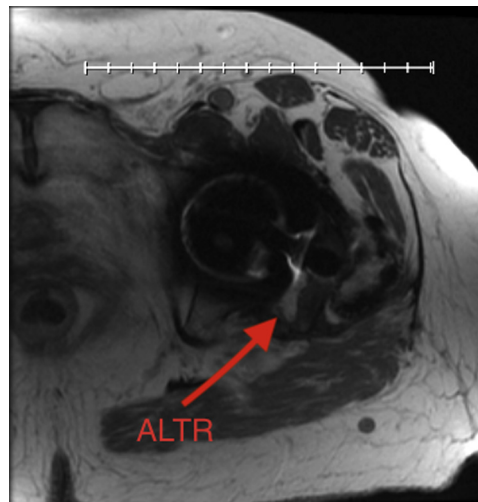
**Figure 2.** Left hip axial proton density weighted MRI demonstrating adverse local tissue reaction (ALTR) with Zimmer Kinectiv stem. MRI, magnetic resonance imaging.

The aforementioned case illustrates several hallmarks of ALTR secondary to taper corrosion. Diagnostically, serum Co-to-Cr ratio was greater than the normal value of 1 due to head-neck taper corrosion [2]. Metal artifact reduction sequence magnetic resonance imaging demonstrated ALTR, characterized by a thick-walled fluid collection and/or increased synovial thickness and volume [9]. The neck-stem taper corrosion observed in this case was possibly associated with in ALTR, not neck fracture, as is more commonly observed with Ti-alloy necks [3]. However, it is possible that symptomatic ALTR prompted early recognition of an impending neck fracture. Of note with the undetectable Ti levels, it is very possible that the ALTR was solely due to the fretting corrosion at the head-neck junction that was also present in this case.

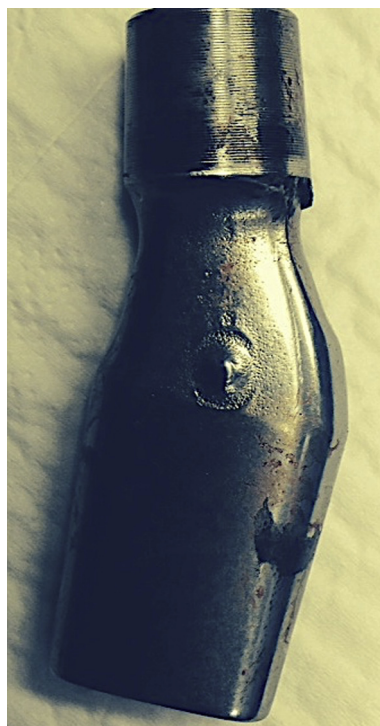
**Figure 3.** Intraoperative image of Zimmer Kinectiv titanium modular neck demonstrating corrosion product at head-neck and neck-stem junctions.

The patient elected to proceed with left hip arthroplasty revision. Metal discoloration, but no purulence, was found intra-capsularly with synovial thickening. Abductor and vastus lateralis integrity were preserved. There was no evidence of bone-implant or implant-implant impingement. Black corrosion and fretting products were observed at both the head-neck and neck-stem junctions (Fig. 3). One frozen section was negative for acute inflammation. The stem was revised to a modular fluted tapered stem. The acetabular component was revised to a more optimally positioned porous metal component. A BIOLOX delta (CeramTec, Plochingen, Germany) ceramic head and highly cross-linked polyethylene liner were implanted.

The metallic composition of the neck and that of the stem in this implant were identical (Ti6Al4V), suggesting there was no galvanic component to the neck-stem taper corrosion observed. The modular neck was not long, so it is doubtful that there was excessive torque at the neck-stem junction resulting in increased fretting. As a result, taper geometry likely contributed most to the neck-stem taper corrosion observed.

When corrosion occurs at the stem taper junction in a modular neck stem, the stem should be revised. Neck exchange does nothing to eliminate the etiology of taper corrosion and may result in accelerated fretting corrosion or mechanical failure due to the already damaged female stem taper. Stem revision was performed with a modular fluted tapered stem with no reports of ALTR due to taper corrosion at its modular junctions, high rate of distal ingrowth, and excellent survival [10]. A ceramic head was implanted to minimize the risk of head-neck taper corrosion.
