## A Cost-Effective Novel Innovative Box (C-Box) to Prevent Cockroach Infestation of Continuous Positive Airway Pressure Equipment: A Unique Problem in Northern Tropical Australia

**Abstract.** Cockroaches and other pests infestation of continuous positive airway pressure (CPAP) equipment has been rarely reported in the medical literature. In this report, we describe a box (C-Box) designed to prevent pest infestation of the CPAP equipment. Over experience, using this C-Box has demonstrated that it can prevent pest infestation and reduce the cost of replacing pest-infested CPAP machines.

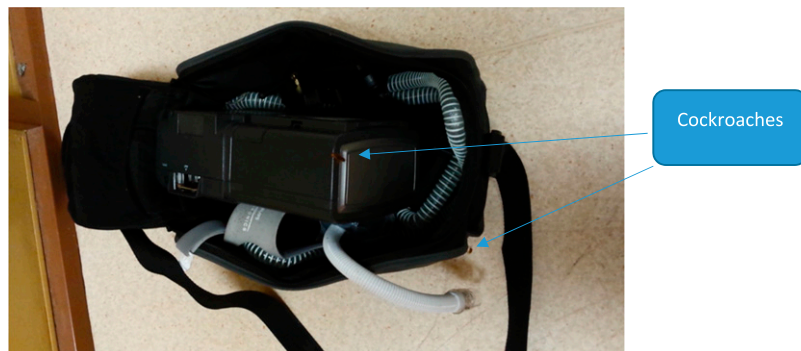
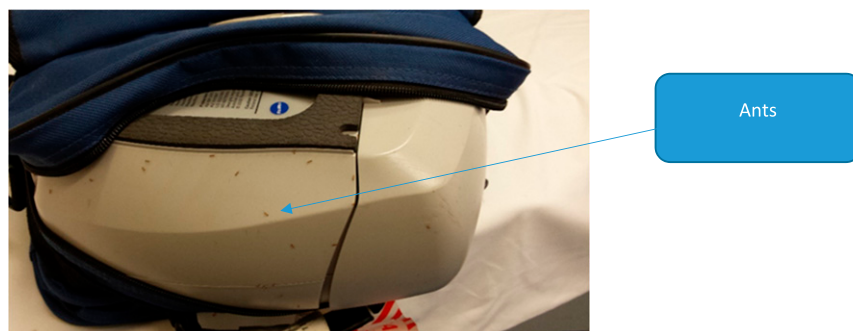
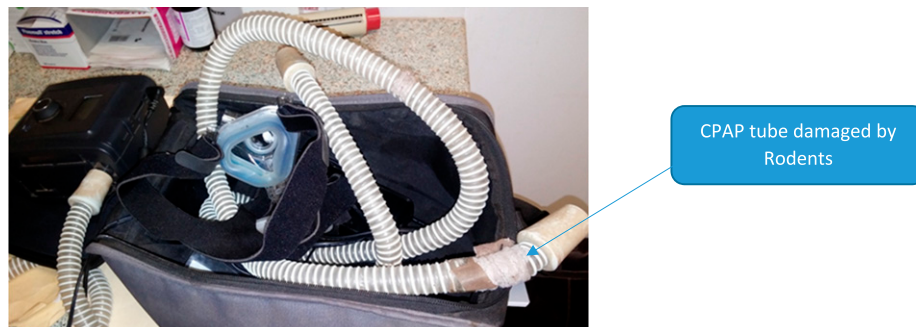
**A** Showing Cockroaches in CPAP machine.

**B** Showing Ants in CPAP machine.

**C** Showing CPAP tube damaged by rodent.

FIGURE 2. (A) Showing cockroaches in continuous positive airway pressure (CPAP) machine. (B) Showing ants in the CPAP machine. (C) Showing the CPAP tube damaged by rodents. This figure appears in color at [www.ajtmh.org](http://www.ajtmh.org).

Through our service, we have encountered several such patients as described earlier for the last few years. We have not only have encountered cockroach infestation but also ants and rodents damaging the device and also the tubes/masks (Figure 2A–C). We have been desperately exploring options to tackle the issue and meanwhile, our practice has been replacing the infested CPAP with a brand-new device and accessories. Obviously, this has increased the cost to our service and resulted in increased health resource utilization as most of the CPAP equipment's are funded through the health department. Hence, we designed a user-friendly simple box to prevent pest infestation of CPAP equipment.

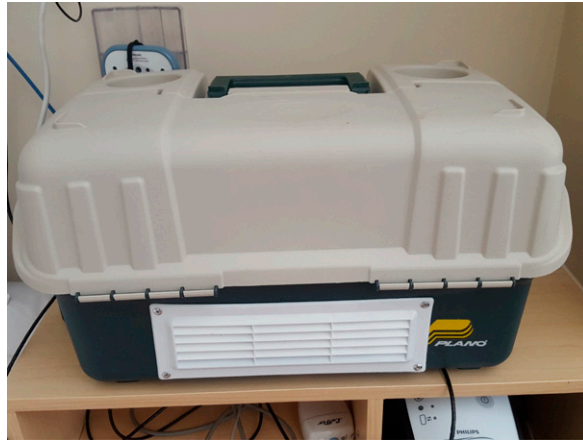
**A** C-Box to place the CPAP machine.

FIGURE 3. **(A)** C-Box to place the continuous positive airway pressure (CPAP) machine. **(B)** Showing CPAP machine placed inside the C-Box. **(C)** Showing CPAP machine placed inside the C-Box while in use. This figure appears in color at [www.ajtmh.org](http://www.ajtmh.org).

**C-box.** We initially experimented with various enclosure devices before settling on this hip roof box presented in this report (Figure 3A) (we named it C-Box) to fit the CPAP machine securely within this box (Figure 3B). The box was designed in such a way that insects and cockroaches cannot have direct access to the CPAP equipment while the CPAP is in use (Figure 3C). Vents for air intake and heat-resistant foam were used to secure the CPAP (Figure 3C). The C-Box was repeatedly tested to find the best combination of materials and covers to enable quick and easy unpack and pack up. The box was designed in such a way that the CPAP tubing and masks can be placed inside the box after overnight use so that cockroaches or other pests cannot have access to the CPAP machine or accessories while it is not in use. The C-Box has been repeatedly tested and trialed on a regular basis, and our patient has not reported any difficulty in operating the device. Moreover, the aforementioned patient has been successfully using the C-Box without any further cockroaches' infestations for more than a year. Furthermore, the C-Box is also been used to protect the CPAP during travel and tropical weather conditions.

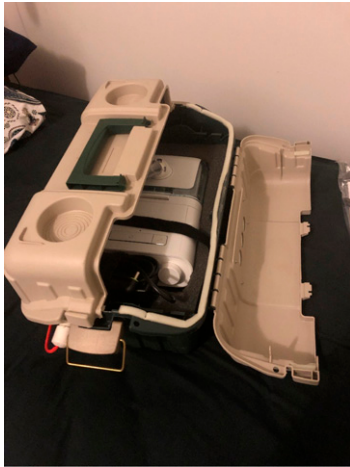
**B** showing CPAP machine securely placed inside the C-Box

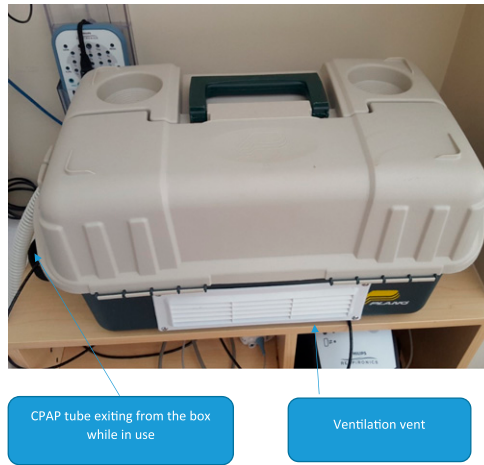
**C** showing CPAP machine placed inside the C-Box while in use

CPAP tube exiting from the box while in use

Ventilation vent
