Severe metallosis-related osteolysis as a cause of failure after total knee replacement

Khaled Hamed Salem^{a, b, c, *}, Norbert Lindner^b, Markus Tingart^c,
Alyaa Daa Elmoghazy^{b, c}

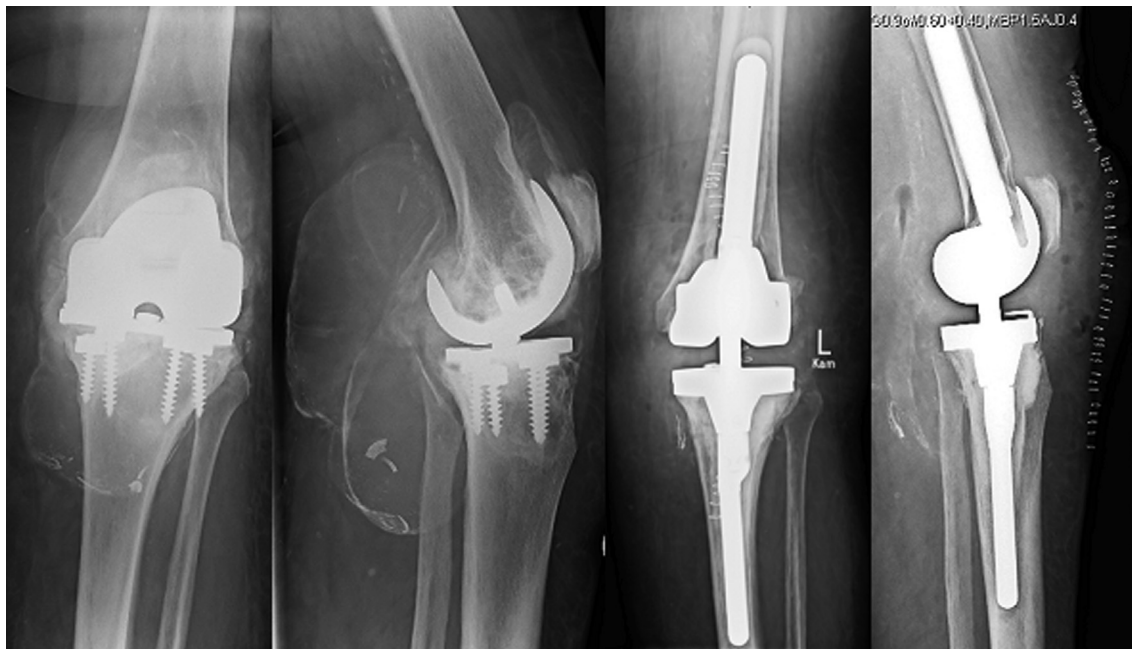
Fig. 1. A case of severe metallosis of the knee joint following fracture of the tibial tray and MoM contact showing the typical radiographic signs (bubble and cloud sign, metal lines and gross metal debris) 20 years after TKA. Revision was done using an RT-Plus system (Smith & Nephew, Memphis, TN).

Preoperatively, all patients were evaluated radiographically using anteroposterior and lateral x-rays of the knee as well as long standing views to assess lower limb alignment and allow computer-based implant planning. Radiologically, advanced PE wear was suspected in the plain x-rays and bubbly radiopaque densities (cloud or bubble sign) were seen with fine linear radiopacities (metal lines) outlining the joint cavity and the suprapatellar pouch in addition to gross metal debris (Figs. 1–4).

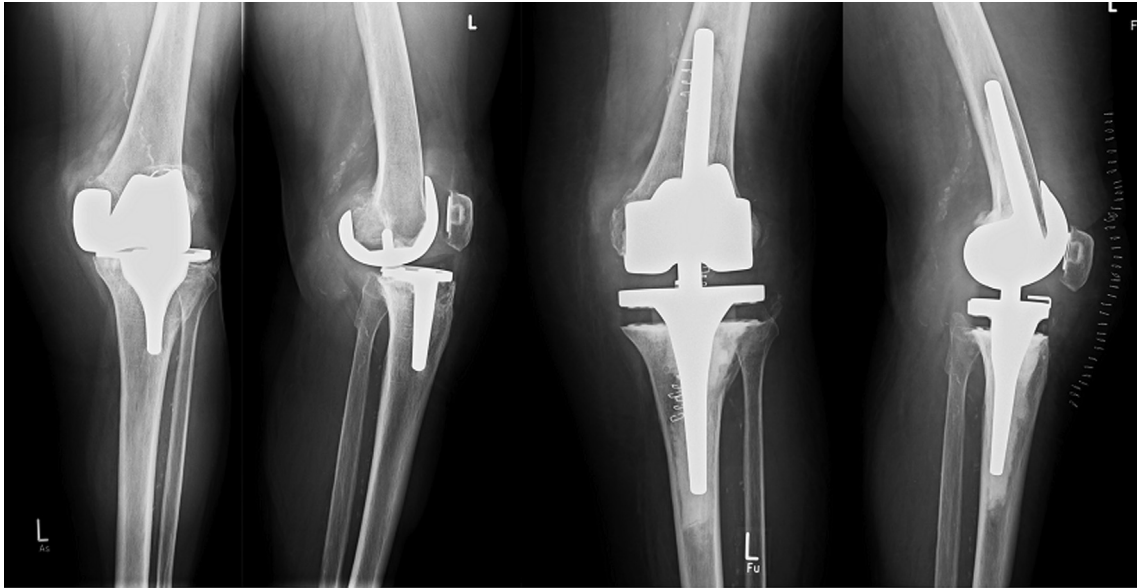
Fig. 2. A case of metallosis due to complete wear of the posteromedial part of the inlay with joint subluxation 13 years after TKA. Revision was done using an RT-Plus system with 10 mm tibial augmentation block (Smith & Nephew, Memphis, TN).

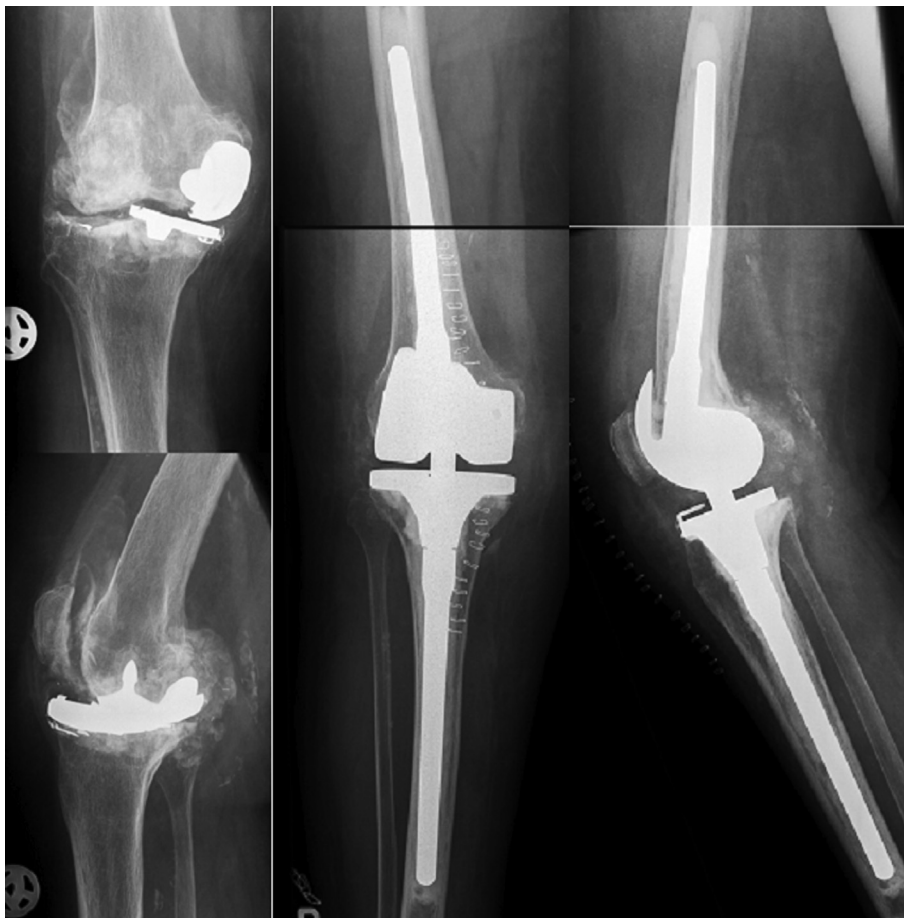
Fig. 3. A case of advanced metallosis with bone loss and metal debris due to MoM contact with aseptic loosening of a unicondylar knee replacement. Revision was done using an RT-Plus system (Smith & Nephew, Memphis, TN).

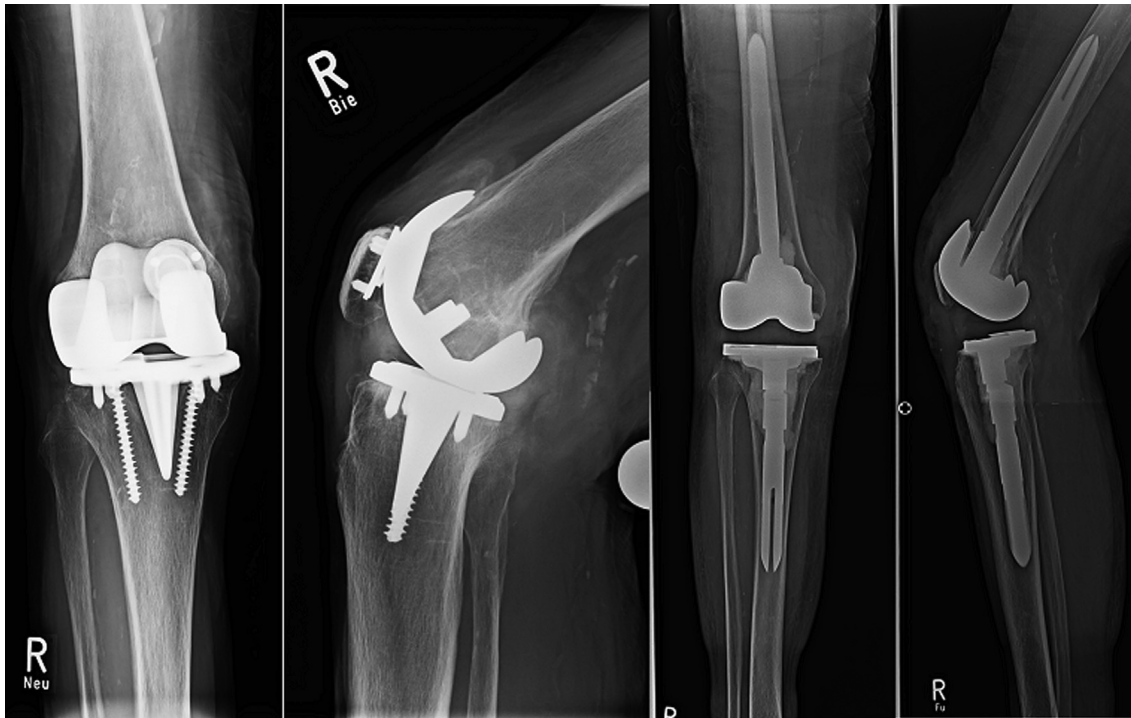
Fig. 4. A case of metallosis due to MoM contact at the tibiofemoral and patellofemoral articulation 30 years after TKA. Revision was done using a Legion Revision Knee system (Smith & Nephew, Memphis, TN).

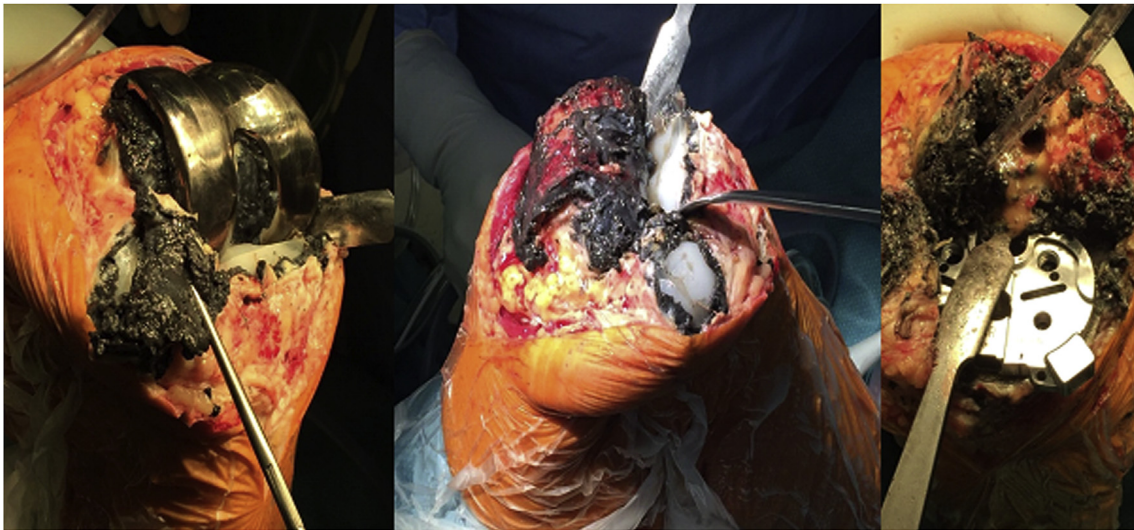
MoM contact at the patellofemoral interface. All knees showed a severe metallosis of the joint with extreme black staining of the synovial tissues (Fig. 5). Furthermore, some knees showed cystic cavities extending from the joint capsule into the popliteal fossa with metal-debris pseudotumor formation. In one knee there was even a complete fracture of the medial part of the tibial tray after the medial part of the PE inlay has totally worn away. A profound synovectomy was done in all cases and biopsy specimens were sent for pathological examination using haematoxylin and eosin staining and polarised light microscopy. Samples for culture and sensitivity testing were also taken. The implants were removed using a combination of small oscillating saws and narrow osteotomes. Advanced osteolysis with holes filled with black metal debris was seen underneath the prosthetic components. Local debridement was done until all macroscopic evidence of metallosis were removed and bone cysts were curetted. This was followed by extensive jet lavage of all bony and soft tissue surfaces using at least 3 L of normal saline.

Fig. 5. Intraoperative photographs of the last case showing dark black staining of the synovial tissues and advanced osteolysis with holes filled with metal debris underneath all prosthetic components.

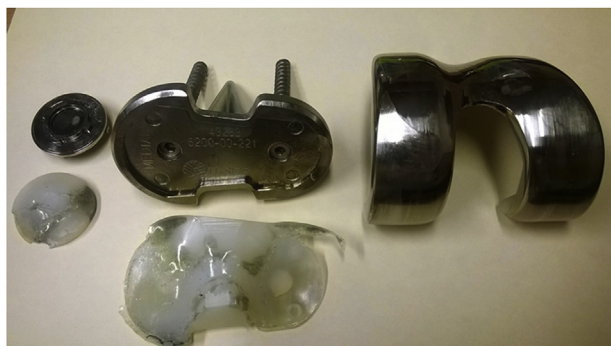
Fig. 6. Retrieved implants showing linear scratches on the femoral component and PE-wear of the metal-backed tibial and patellar components.

Intraoperatively, the macroscopic appearance of the knee joint with extensive black metal staining of the synovium and marked linear scratching of the femoral component is striking and unmistakable. Synovial biopsies consistently showed the typical histological features of metallosis-related synovitis. Although the real degree of associated bone loss is variable, it always exceeded what we expected to encounter when reviewing the preoperative radiographs. This may limit reconstructive options in this technically demanding revision setting. It is therefore essential for the surgeon to obtain a preoperative CT-scan of the affected joint and to have a wide armamentarium of modular revision components available during the operation in these cases that may sometimes require the implantation of a tumor prosthesis in case of advanced bone loss.

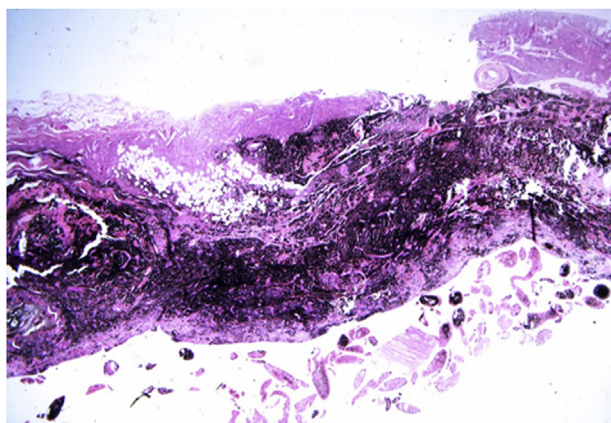
All cases were revised using a cemented constrained modular revision knee system (Smith & Nephew, Memphis, TN): the RT-Plus system in three knees and the Legion Revision Knee System in one. Long modular stems with offset adapters, wedges and/or blocks were needed in all revisions. No cases required the implantation of tumor prostheses. Cultures from intraoperative samples remained negative for bacterial pathogens. The retrieved implants showed deep linear scratching visible to the naked eye coinciding with the axis of frictional motion (Fig. 6). Histological examination of the synovial tissue samples obtained revealed the picture of chronic inflammation with hyperplasia and extensive fine black metal particles partially engulfed by macrophages with no or few particles of PE wear (Fig. 7).

Fig. 7. Microscopic picture of metallosis-associated synovitis from the last case.
