# Predicting Microstructural Void Nucleation in Discontinuous Fiber Composites through Coupled *in-situ* X-ray Tomography Experiments and Simulations

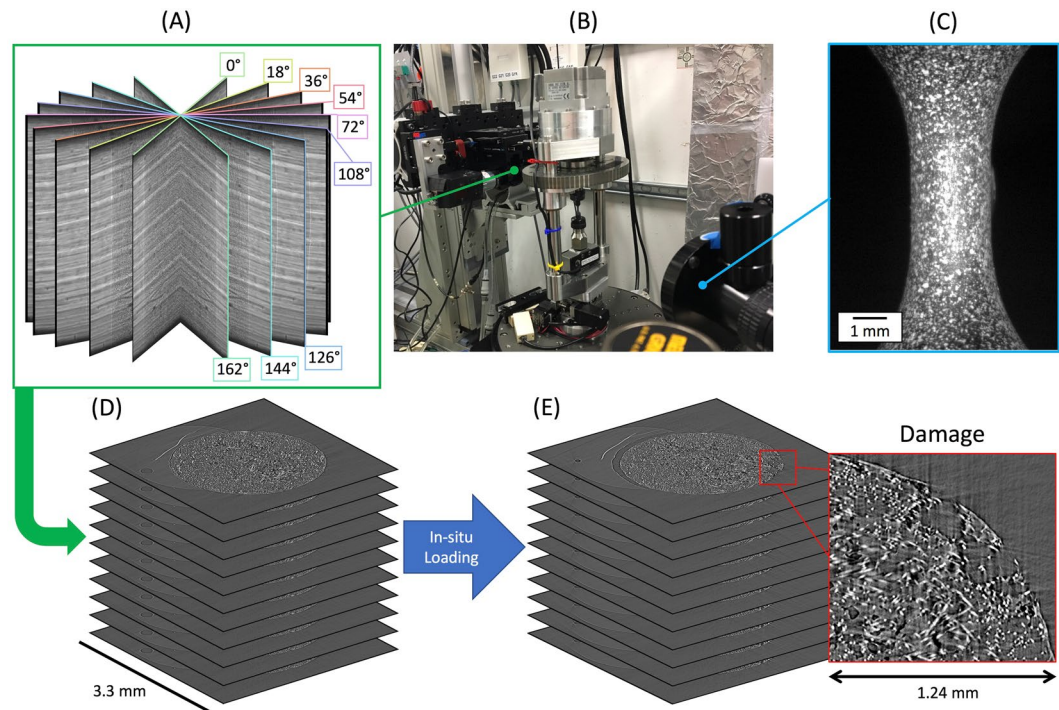
**Figure 1.** An overview of the *in-situ* study where (A) shows a sample 9 of the 1500 X-ray projected radiographs captured by the detector over 180°, (B) shows the *in-situ* loading set-up with the miniature load frame, (C) shows the view of the speckled specimen from the optical camera used for computing macroscopic strain, and (D and E) show the reconstructed tomography images at 0 load and at maximum load (just before fracture), respectively.

**Experimental details.** The material used in this work was a polypropylene thermoplastic reinforced with 30% by weight E-glass fibers which were approximately 10  $\mu\text{m}$  in diameter and were pre-treated with a tailored silane solution to promote fiber-matrix adhesion. The composite material was injection molded into a cylindrical rod measuring 1.27 cm in diameter and 45.72 cm in length where the flow direction was in the length direction of the rod, and the rod was then machined into a dog-bone shaped specimen with a gauge section diameter of 2.4 mm and length of 5 mm containing fibers that were, on average, approximately 300  $\mu\text{m}$  long<sup>31</sup>. The specimen was studied *in-situ* by applying tensile load (at a quasi-static strain rate of approximately 0.001  $\text{s}^{-1}$ ) using a custom motorized screw driven miniature load frame, interrupting the tensile load by holding the cross-head displacement, and acquiring an *in-situ* X-ray  $\mu$ -CT scan. A total of 58 interruptions and scans were conducted from the unloaded state to final fracture which occurred at 5.77% strain. The experiments were conducted at Argonne National Laboratory using synchrotron X-rays with an X-ray energy of 25 keV, collected on an area detector placed 75 mm downstream from the specimen. Each X-ray projection was acquired with a 100 ms exposure time every 0.12° while the specimen and load frame were rotated at 0.5°/s through a 180° range. The use of synchrotron X-rays enabled a full  $\mu$ -CT scan to be acquired in 6 minutes. The 1500 X-ray projections captured at each scan

were reconstructed using TomoPy<sup>32</sup> resulting in 2D images which stack to form a 3D image with dimensions 2560 by 2560 by 1240 pixels, and a pixel size of  $1.3 \mu\text{m}$ . The exterior surface of the specimen was painted to exhibit a black and white speckle pattern which was optically imaged at each tensile increment, in order to compute (using VIC-2D) the macroscopic strain experienced by the specimen. The reconstructed tomography images acquired just before failure were visually inspected in order to identify the region that contained the ductile fracture zone, which was traced back to the tomography images at the unloaded state shown in Fig. 5A using slice-by-slice 2D image correlation. The time lapse tomography images of the ductile failure zone were then inspected to identify the location of damage initiation, which was determined to be the region shown in Fig. 5C. The microscopic strains in the matrix at this region were computed using a DVC algorithm which makes use of fast Fourier transform based cross-correlation in conjunction with an iterative deformation method<sup>33</sup> that was conducted on the tomography images at the unloaded state and at 30% of the macroscopic failure strain using a subset size of 64 pixels and a subset spacing of 4 pixels. In analyzing the DVC results, locations of high  $\epsilon_{zz}$  strain were defined as voxels with computed strain in the 99.7<sup>th</sup> percentile of the distribution of  $\epsilon_{zz}$ . Finally, the tomography images at this region were further inspected in a 2D slice-by-slice comparison between the unloaded state, 30%, and 50% of the macroscopic failure strain to identify the locations of microvoid nucleation during damage initiation within the microstructure, which were then post-processed in 3D using the three detection approaches described below.

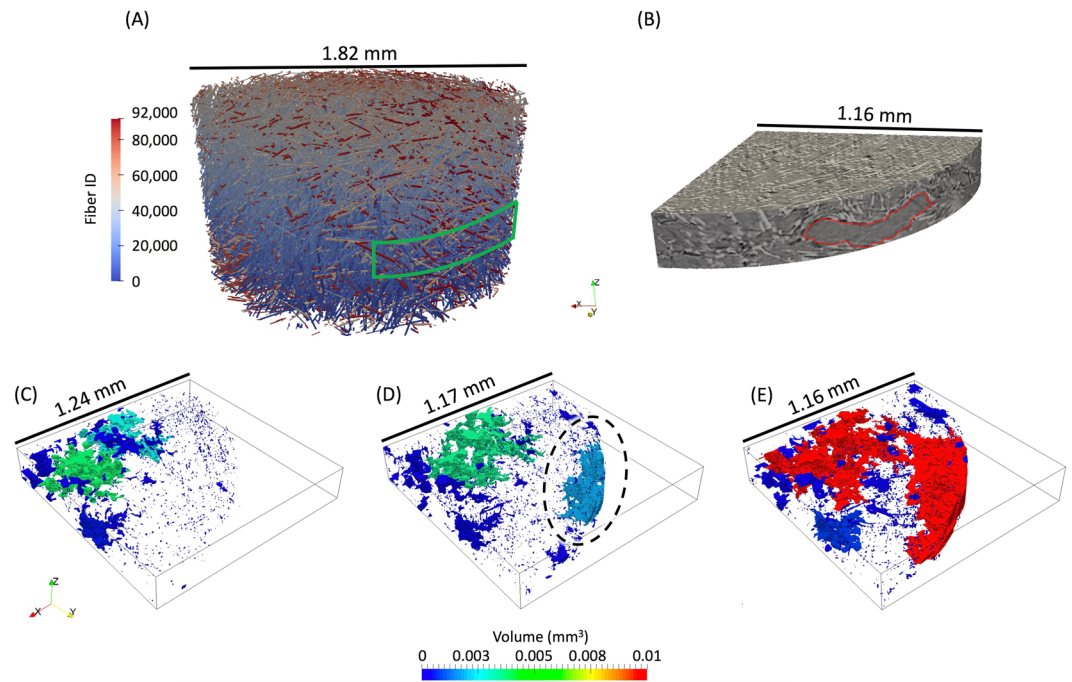
**Figure 2.** Shown in (A) are the fibers detected within the gauge section of the specimen at 0 load where each fiber is individually detected and assigned a fiber ID, and where the green outline indicates the location of ductile fracture observed experimentally, which is also shown in the tomography images just before fracture in (B). Preexisting porosity, microvoid nucleation, and eventual void coalescence in the ductile fracture zone are shown in (C) at 0 load, (D) at 96% of failure, and (E) just before failure.

**The role of porosity manufacturing defects and the ductile fracture zone.** The specimen was loaded in tension until fracture, and the *in-situ* X-ray  $\mu$ -CT images allowed for the observation of the fibers, porosity manufacturing defects, as well as the tracking of microstructural damage events that led to final fracture. Each fiber detected in the cylindrical specimen is shown in Fig. 2A, with a green outline highlighting the region of the specimen which experienced ductile fracture that led to final fracture, shown in Fig. 2B. Manufacturing defects in the form of preexisting large pores were detected in the center of the specimen as can be seen in Fig. 2C,

with preexisting small pores present closer to the free surface. As the specimen was loaded and ductile fracture occurred, it was found that these large pores did not significantly coalesce and grow leading to final fracture as expected in typical ductile fracture<sup>25</sup>. Instead, a large void nucleation event occurred near the free surface of the specimen circled in Fig. 2D, which - just before fracture - finally coalesced with the preexisting large pores leading to final fracture shown in Fig. 2E. This shows that while porosity manufacturing defects have historically been viewed as a major detriment to a composite's strength<sup>26</sup>, in this discontinuous reinforced thermoplastic, a variety of complex microstructural features exist which can be more detrimental to the overall mechanical performance. In this composite specimen, it was found that these features existed at the critical region near the free surface circled in Fig. 2D, which was analyzed in more detail to detect the exact locations of damage initiation, and simulated through a finite element model to compute the stresses and strains.

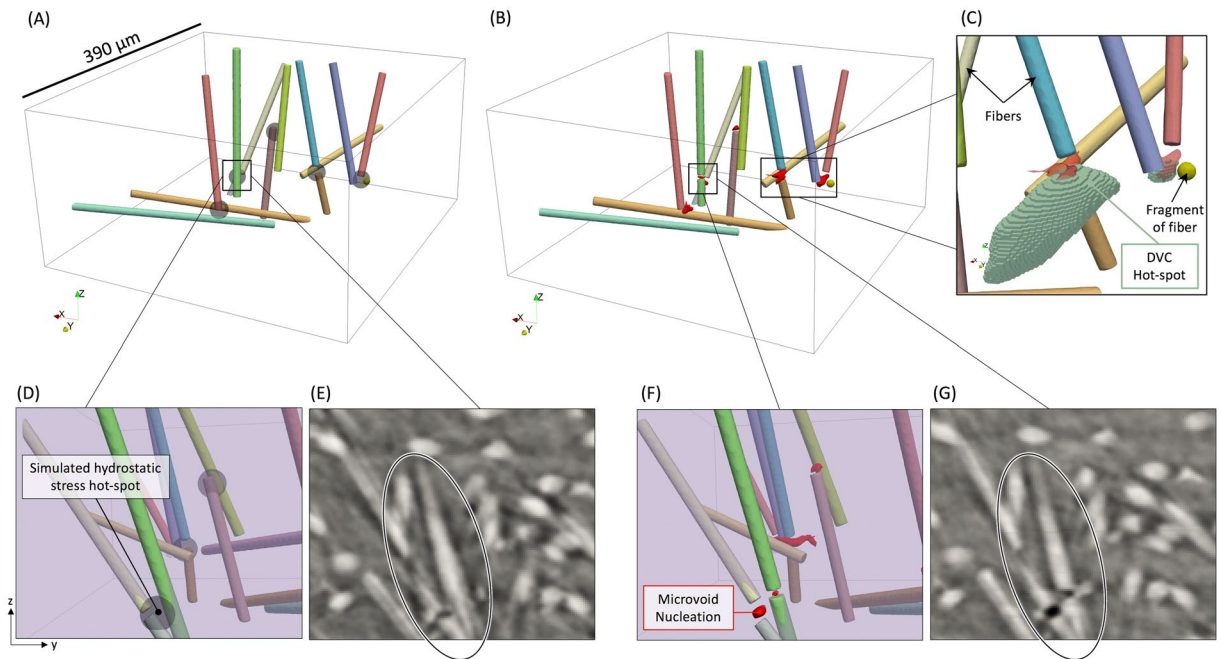
**Figure 3.** The fibers that interacted with the microvoid nucleation events (A) at the unloaded state with grey spheres at the locations of simulated matrix hydrostatic stress hot-spots, and (B) at 50% of the macroscopic failure strain with the experimentally determined microvoid nucleation shown in red, with (C) an overlay of a sample of the DVC  $\varepsilon_{zz}$  strain hot-spots. The coupled microvoid nucleation and early fiber breakage is shown in (D and E) at the unloaded state, and in (F and G) at 50% of the macroscopic failure strain.

**Experimental microvoid nucleation during damage initiation.** Experimentally, five locations within the critical region showed evidence of microvoid nucleation during damage initiation and have been visualized at the unloaded state in Fig. 3A and at 50% of the macroscopic failure strain in Fig. 3B, with a sample of the DVC results overlaid in Fig. 3C. Two of the five locations consisted of T-type intersections, where at least one fiber was well aligned with the loading direction and interacted with fiber(s) that were highly misaligned with the loading direction. One region consisted of two well aligned fibers with slightly overlapping end-points, where a microvoid nucleated at one fiber end-point, but not both. Another region consisted of two fibers highly aligned with the loading direction that had nearly touching end-points, which resulted in microvoid nucleation between the end-points and a coupled early fiber breakage in a neighboring fiber shown in Fig. 3D–G. Lastly, one case of microvoid nucleation consisted of two well aligned fibers with end-points near a small fragment of glass fiber, all of which are shown in Fig. 3B. It is important to note that the locations of microvoid nucleation, while always relating to fiber tips, were not confined to one single configuration of fiber tips, but instead included a few different configurations.

The matrix hydrostatic stress hot-spots computed in the simulation have been overlaid onto the experimental results in Fig. 3A as transparent black spheres within the microstructure. These simulated hydrostatic stress hot-spots correlated directly to the five locations of microvoid nucleation experimentally observed in the microstructure during damage initiation, shown by the red regions in Fig. 3B. Of the five cases of hydrostatic stress hot-spots in the matrix and their corresponding microvoid nucleation events, two were of interest because of their unique behavior. The first case of interest was a location that experienced coupled microvoid nucleation and fiber breakage. Fiber breakage occurring at 50% of the macroscopic failure strain of 5.77%, experimentally observed in Fig. 3D–G, is atypical in these composites<sup>11</sup>. Specifically, the green fiber shown first at the unloaded state in Fig. 3D, and then at 50% of the failure strain in Fig. 3F, was the only fiber that broke in the critical region at this early loading condition; yet this fiber was simulated to experience (prior to microvoid nucleation) only 45% of its ultimate tensile strength<sup>27</sup> at the same loading condition observed experimentally. When overlaying the simulation results, it can be seen that a matrix hydrostatic stress hot-spot was in contact with the fiber at the location of fiber breakage, which experimentally resulted in microvoid nucleation in the matrix next to the fiber, followed by early fiber breakage shown in Fig. 3E,G. This provides evidence that high hydrostatic stress can be used not only as a metric to describe and predict microvoid nucleation during damage initiation, but also - in certain cases - describe microvoid nucleation coupled with other damage mechanisms.

Another case of microvoid nucleation that was of interest consisted of two fibers that were well aligned with the loading direction which interacted with a small fragment of a glass fiber that was approximately spherical, which was also experimentally verified by the DVC analysis shown in Fig. 3C. The experimentally-based DVC analysis showed that the highest strain values were localized in the region of microvoid nucleation, which corresponded spatially to the hydrostatic stress hot-spot predicted by the finite element model. Typically, engineers are not interested in fragments of fibers with aspect ratios close to one because they contribute almost no load bearing capability when compared to their longer cylindrical neighbors present in the microstructure<sup>28–30</sup>. Therefore, techniques and algorithms to detect and characterize fibers are typically not suitable for  $l/d \leq 1$ , which can be easily confused with noise<sup>30,31</sup>. In this work, the fragment of glass was manually observed in the *in-situ* tomography images, detected as a fragment of a fiber, included in the microstructural simulation, and proved to be a region of high hydrostatic stress and a region of corresponding microvoid nucleation, as was seen in Fig. 3A,B, and identified more closely in Fig. 3C. This provides evidence that while short fragments (even as short as  $l/d = 1$ ) in the presence of long fibers can be ignored in elastic stiffness predictions, as they do not strongly influence the elastic properties, they can strongly influence damage initiation past the elastic regime and therefore must be included and considered in strength predictions.

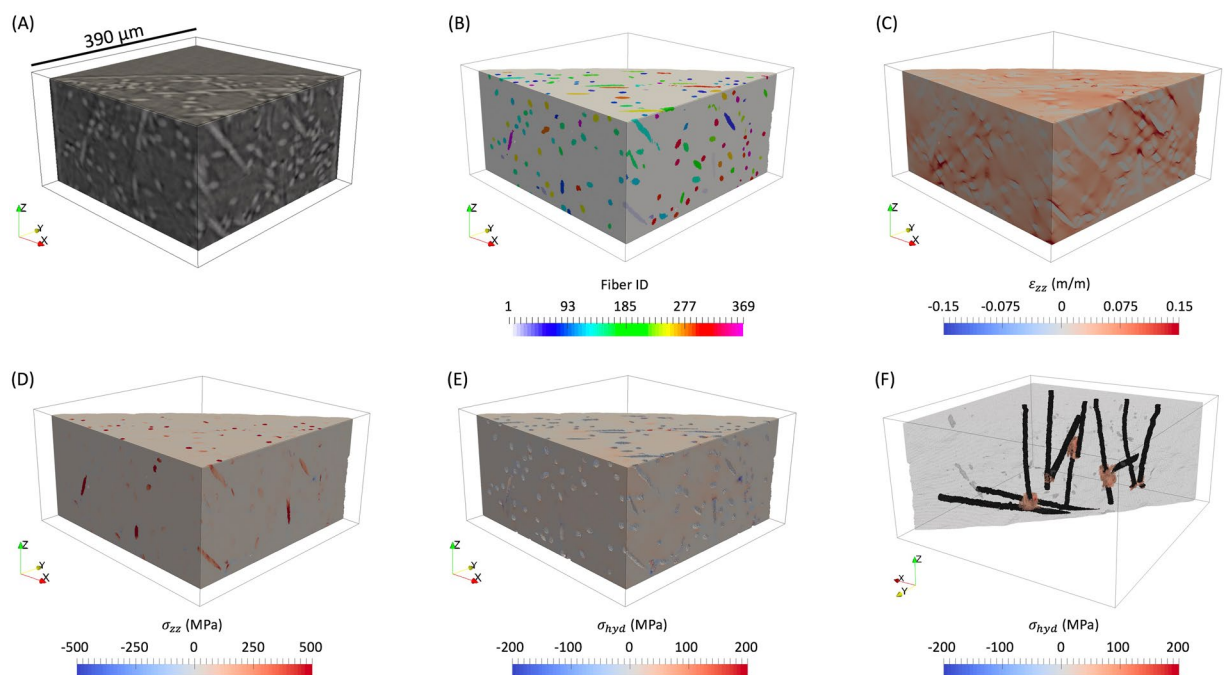
**Figure 4.** An overview of the cropped simulation results (cropped to visualize away from the boundary conditions) of the specimen region shown in the tomography images of (A) which were post-processed for feature detection shown in (B). The heterogeneous strain in the loading direction ( $\varepsilon_{zz}$ ) is shown in (C), the heterogeneous stress in the loading direction ( $\sigma_{zz}$ ) is shown in (D), the heterogeneous hydrostatic stress ( $\sigma_{hyd}$ ) of the matrix is shown in (E), and the agglomerations of matrix elements in the 99.997<sup>th</sup> percentile of hydrostatic stress, with the fibers they interact with, are shown in (F).

**Simulated heterogeneous stresses and strains in the microstructure.** The results of the finite element simulation of the exact microstructure experimentally analyzed, which has been visualized in Fig. 4A,B, showed that there was in fact a large degree of heterogeneity in the strains and stresses. As expected, the ductile thermoplastic matrix experienced most of the deformation as can be seen by the strain plot in Fig. 4C, while the fibers, acting as the toughening constituent in the composite, experienced most of the stress in the specimen, shown by the stress plot in Fig. 4D. The hydrostatic stress was computed by

and was found to be normally distributed in the matrix, visualized in Fig. 4E, with an average hydrostatic stress of 10.83 MPa and a standard deviation of 15.96 MPa. While there were scattered regions within the matrix whose elements experienced high hydrostatic stress (sometimes in a single line of elements and other times isolated only to the side of a fiber at a corner of a 3D voxel), only large agglomerations, referred to as hydrostatic stress hot-spots, were of interest because they ensured that the region of high (99.997<sup>th</sup> percentile) matrix hydrostatic stress was not artificially induced from meshing effects, and are shown in Fig. 4F.

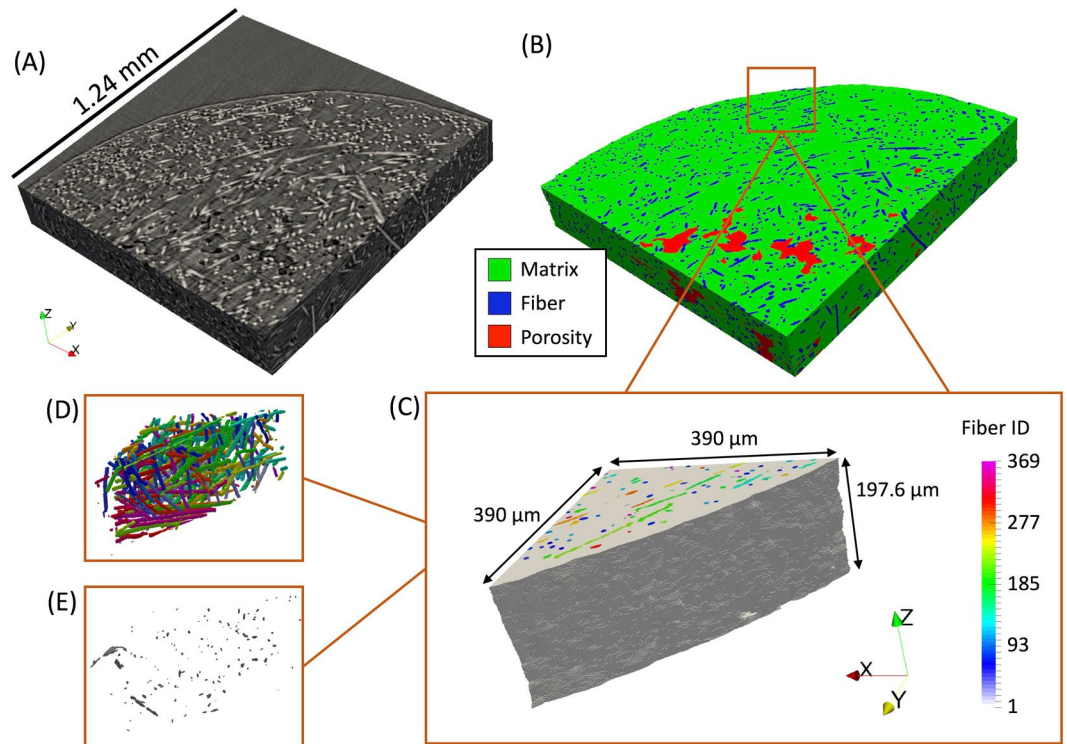
**Figure 5.** The sequence of post-processing the reconstructed tomography images in (A) to achieve high fidelity feature detection shown in (B), which includes specimen edge detection, porosity manufacturing defect detection, and individual fiber detection in 3D, as well as the instantiated model (C), the 368 fibers within the model (D), and the manufacturing porosity defects within the model (E).

**Simulation details.** Fibers were detected using an iterative and supervised 2D and 3D combined algorithm<sup>22</sup>. Porosity manufacturing defects (and in later loading steps, nucleation of microvoids) were detected using a combination of Weka machine learning segmentation<sup>34</sup> and manual correction using ModLayer<sup>35</sup>. The specimen's free surface was detected through 2D image processing of each tomography slice using an in-house MATLAB algorithm that utilized the intensity gradient at the free surface, which can be seen in Fig. 5A, and an initial guess of the approximate center and radius of the cylindrical specimen. This region was then adjusted by mapping the intensity values from a range of [0, 1] to a range of [0.4, 0.9], converted to a binary image using a threshold of 0.655 of the median intensity of the image (which accounts for X-ray energy fluctuations), dilated by a disk structural element with a radius of 4, and finally adjusted to fill any holes in the edge region. The detection of the fibers, pores, and the free surface of the quadrant containing the ductile fracture zone can be seen in Fig. 5B, with the simulated region's free surface, fibers, and pores shown in Fig. 5C–E, respectively.

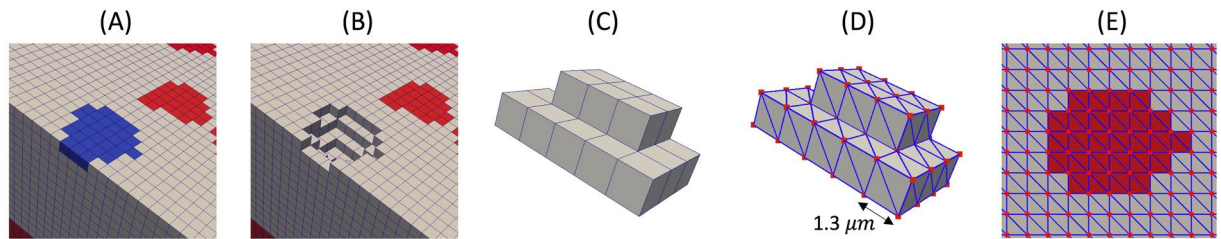
**Figure 6.** The procedure used to mesh the instantiated model where (A) shows a fiber in red, a porosity manufacturing defect in blue, and the matrix in grey, (B) shows the removed manufacturing pore, (C) and (D) show the voxels meshed using tetrahedral elements, and (E) shows a meshed fiber in the matrix.

The voxels (which were  $1.3 \mu\text{m}$  in size) corresponding to porosity manufacturing defects were removed from the rendered 3D volume as shown in Fig. 6A,B, and the remaining matrix and fiber features were meshed using tetrahedral elements directly from the voxelated microstructure shown in Fig. 6C,D. This procedure was conducted in ParaView, and resulted in uniform and ideal tetrahedral elements and perfect bonding between the fibers and the matrix, as shown in Fig. 6E, which can be generally assumed for fiber reinforced thermoplastics
