Article

# IoT-Based Geotechnical Monitoring of Unstable Slopes for Landslide Early Warning in the Darjeeling Himalayas

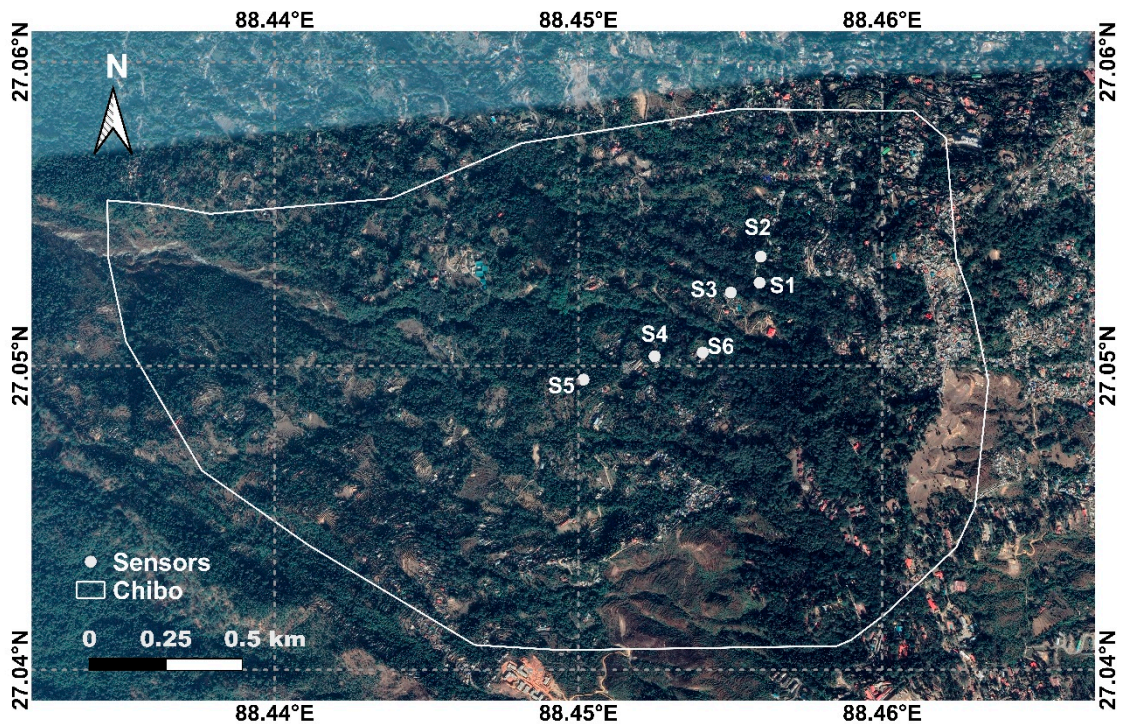
Figure 2. Location of tilt sensors installed in Chibo.

The history of erosion and displacement near the two jhoras justifies the selection of sites for installing the sensors. The effect of rainfall and the flow of jhoras on displacement were monitored continuously for three monsoons from 2017 to 2019. Sensors 1, 2, and 3 are located near Pyarieni jhora, and the remaining three are near OC jhora. The location of sensors, along with the drainage and slope map of Kalimpong, is presented in Figure 3.

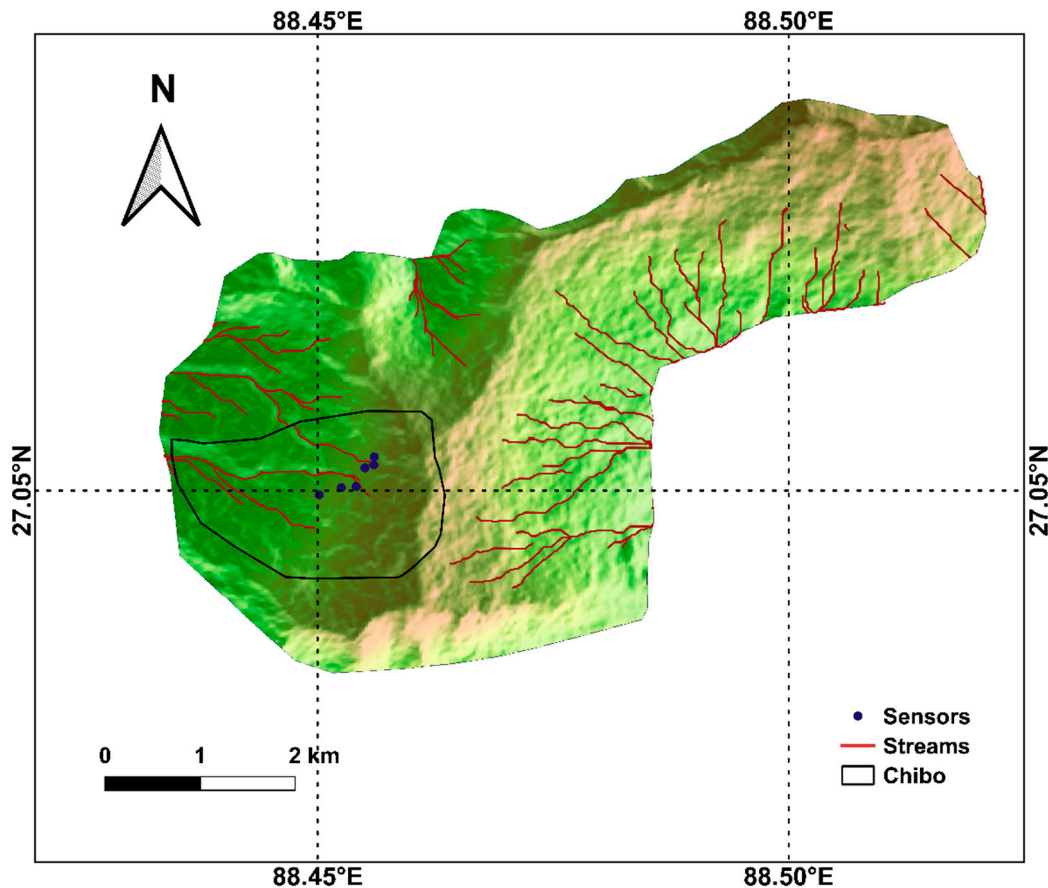
Figure 3. Drainage map of the region with the location of sensors.

Sensor 2 is located in the right bank of Pyarieni jhora, and sensor 3 is on its left bank. Sensor 4 is placed on the left bank of OC jhora, and sensor 5 is also located nearby at the center of the Chibo area. The data logger is also located near sensor 6, which is placed near the OC jhora.

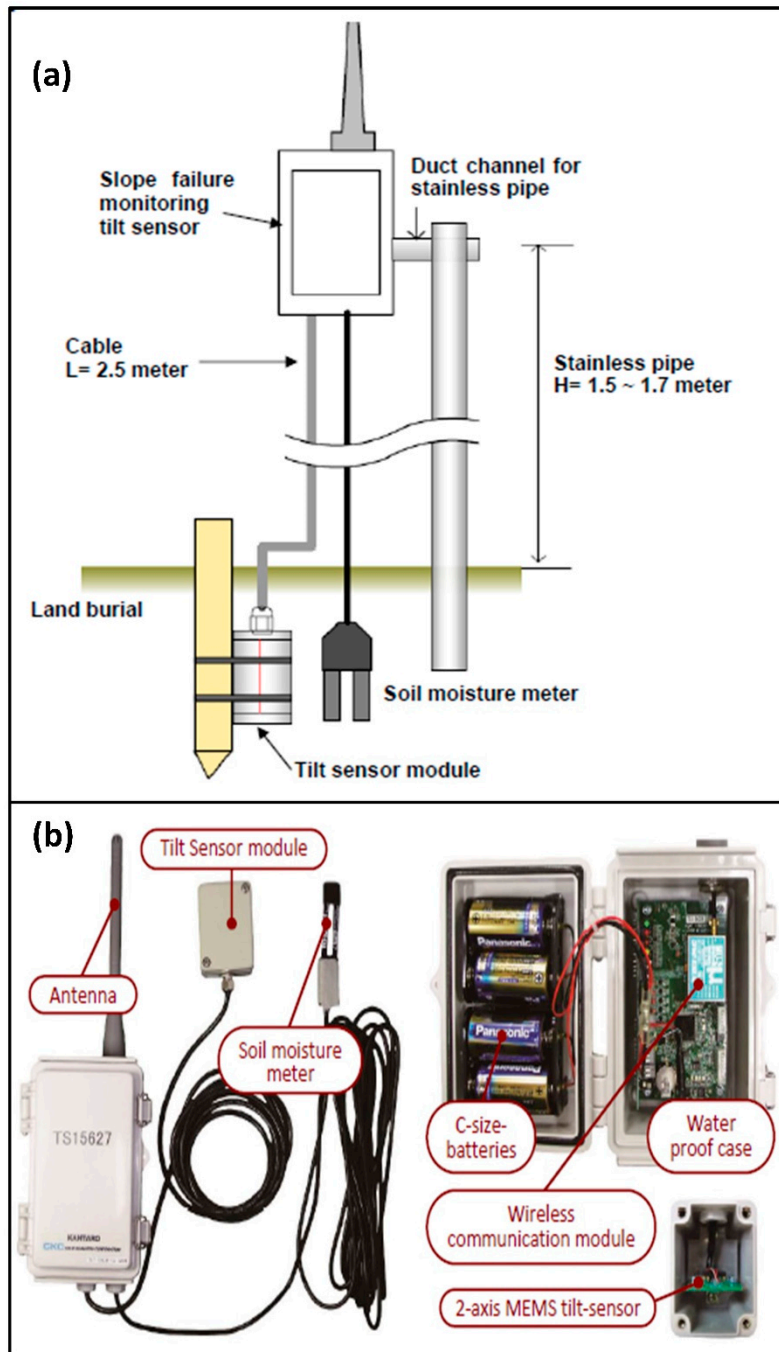
**Figure 4.** Details of tilt sensor: (a) schematic arrangement of the sensor set up and (b) components of a tilt sensor unit.

A steel rod is placed with its bottom at 1 m below the surface. A wireless transmission kit is attached to the rod at its top, and the sensor is kept within a box embedded in soil. The bottom end is stable, and the top can undergo relative motion. For thin unstable layers, the depth of failing mass will be shorter. The average shear deformation of the surface layer is measured by the sensor as tilt angles. From the onset, the amount of displacement can be calculated, and the rate at which warnings are to be issued can be calculated from the observations.

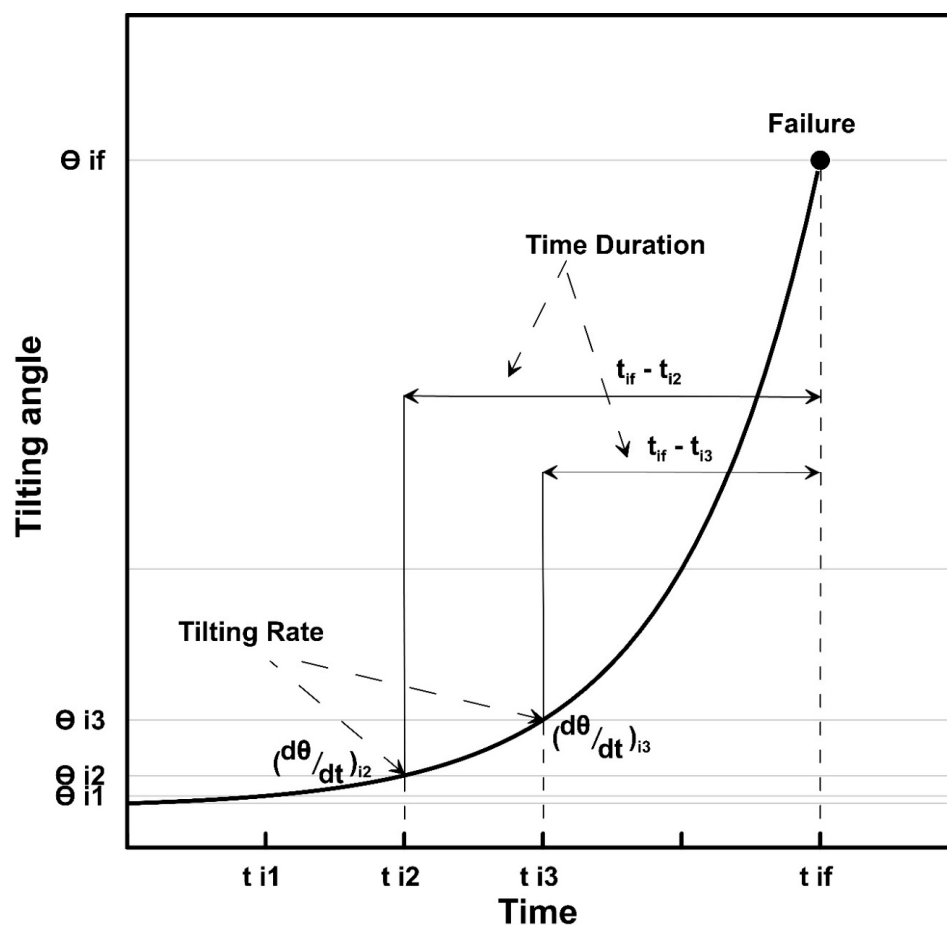
Figure 5. Definition of tilting rate and time duration (modified after Xie et al. (2019) [23]).

This equation will be used to evaluate the time duration within a span at a specific tilting rate before the failure. The graphical representation of the relationship between tilting rate and time duration is shown in Figure 5.

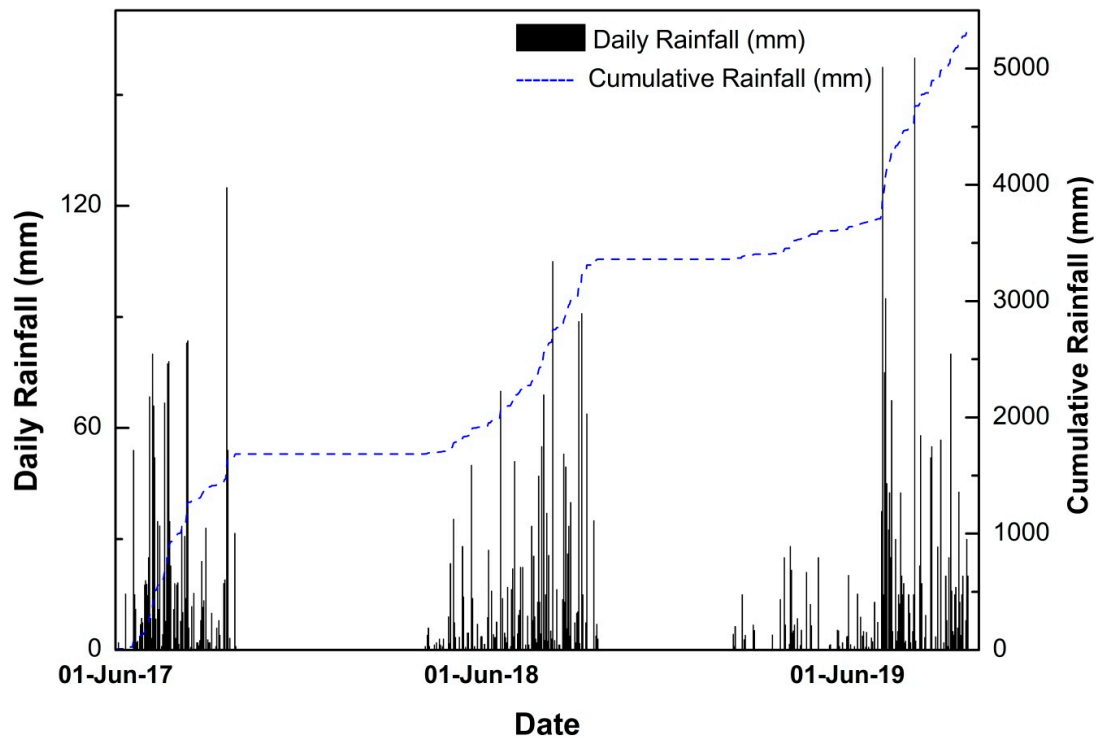
Figure 6. Time history of hourly and cumulative rainfall for the study period.

From Figure 6, it can be inferred that the 2019 monsoon contributed the highest amount of rainfall, and according to India Meteorological Department (IMD), the amount of rainfall was 110% of the Long Period Average (LPA) rainfall [48] received in the country. The data from the tilt sensors (tilting angles in parallel and perpendicular directions) and the volumetric water content sensors are plotted in Figure 7a–c.

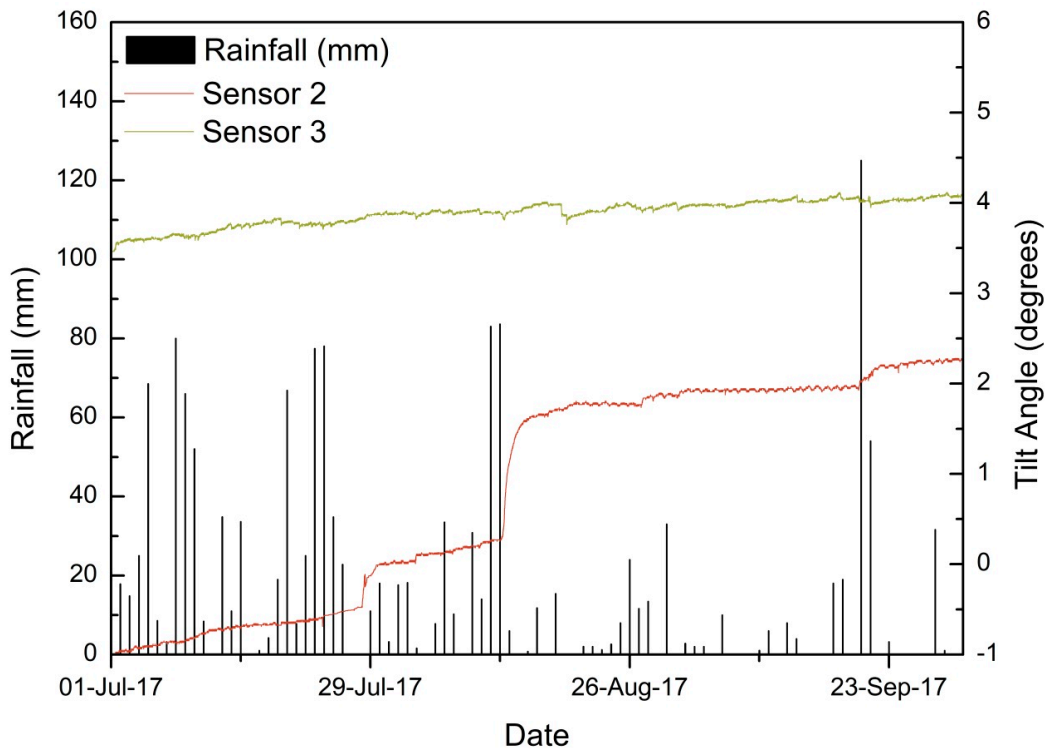
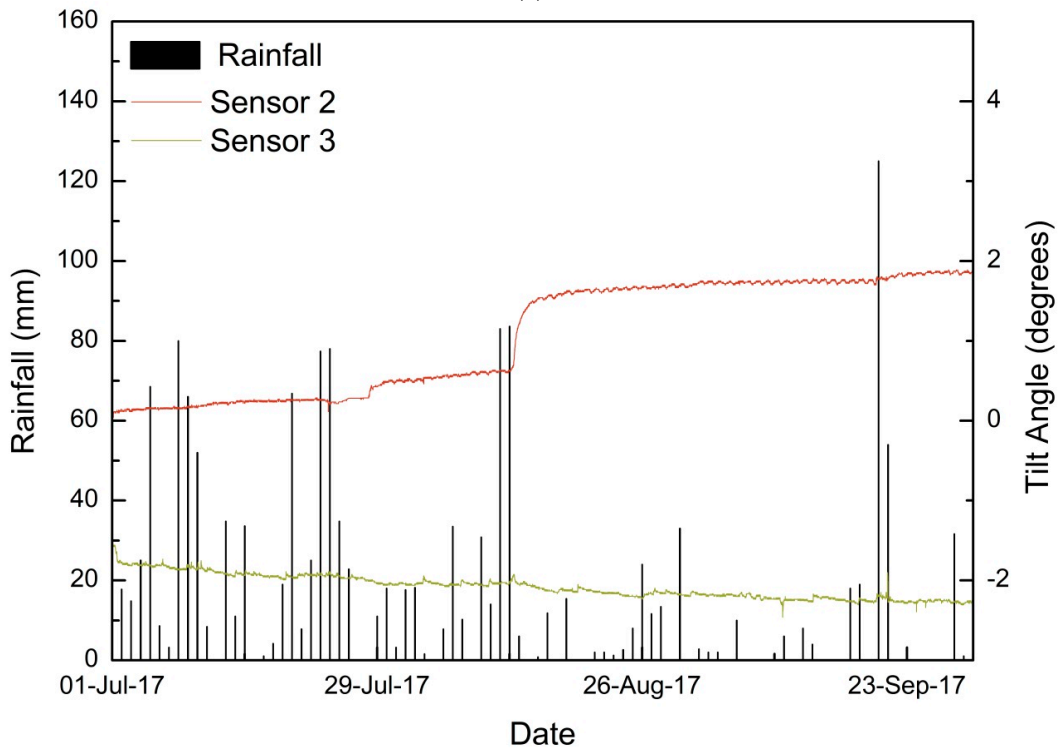
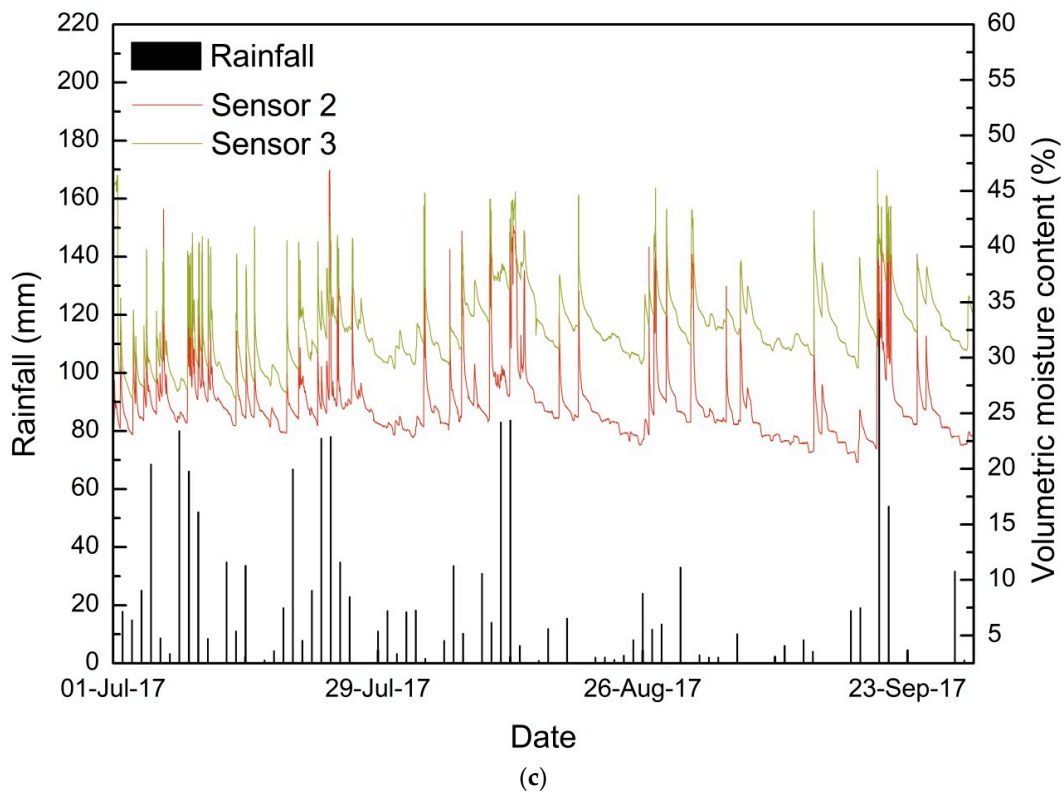
**Figure 8.** Detailed time history for monsoon 2017 of sensors 2 and 3: (a) tilting angle in the direction parallel to the slope, (b) tilting angle in a direction perpendicular to the slope, and (c) volumetric moisture content.

During the 2017 monsoon, the tilting angles of sensors 3 and 2 showed a notable increase in the tilt angles. On 28 and 29 July 2017, a major shift was observed in tilt angle from  $-0.477^\circ$  to  $0.006^\circ$ . The initial tilting rate was  $0.0117^\circ/\text{h}$  which later reduced to  $0.005^\circ/\text{h}$  in the direction parallel to slope. The tilt angle of sensor 3 was found to be increasing at a very slow rate. The rainfalls on the days of displacement were found to be less, with no rain on 28 July 2017 and 11 mm rainfall on 29 July 2017. On the preceding days, starting from 17 July 2017, 336 mm rainfall was recorded until 27 July 2017. The maximum daily intensity of rainfall observed during the event was 77.4 mm. The antecedent rainfall increased the moisture content, as observed in Figure 8c. A second displacement period was noted from 13–17 August 2017. During this period, the tilt angle of the sensor increased from  $1.126^\circ$  to  $1.714^\circ$ . The average tilting rate was  $0.007^\circ/\text{h}$  on the first three days and  $0.001^\circ/\text{h}$  on the last two days. The maximum tilting rates during the initial period of displacement were  $0.018^\circ/\text{h}$  and  $0.017^\circ/\text{h}$  in the parallel and perpendicular directions, respectively. No sudden slope failures occurred during either of the displacement periods. The effect was observed as sinking of roads near the location of the sensor. The cumulative rainfall observed during the sinking period was only 23.6 mm while the antecedent rainfall for three days, five days, and 10 days prior to displacement were 180.6 mm, 211.4 mm, and 264.5 mm, respectively. Maximum water content was observed near sensor 3 during the second displacement period as 44%. The moisture content near sensor 2 remained less than that near sensor 3 during the whole monsoon period, but the variations in moisture content near sensor two was higher than those near sensor 3.

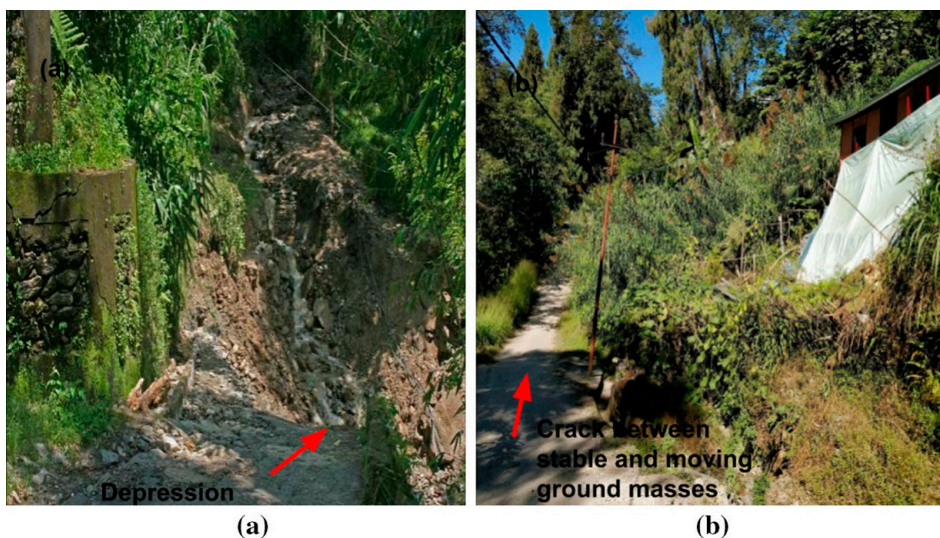
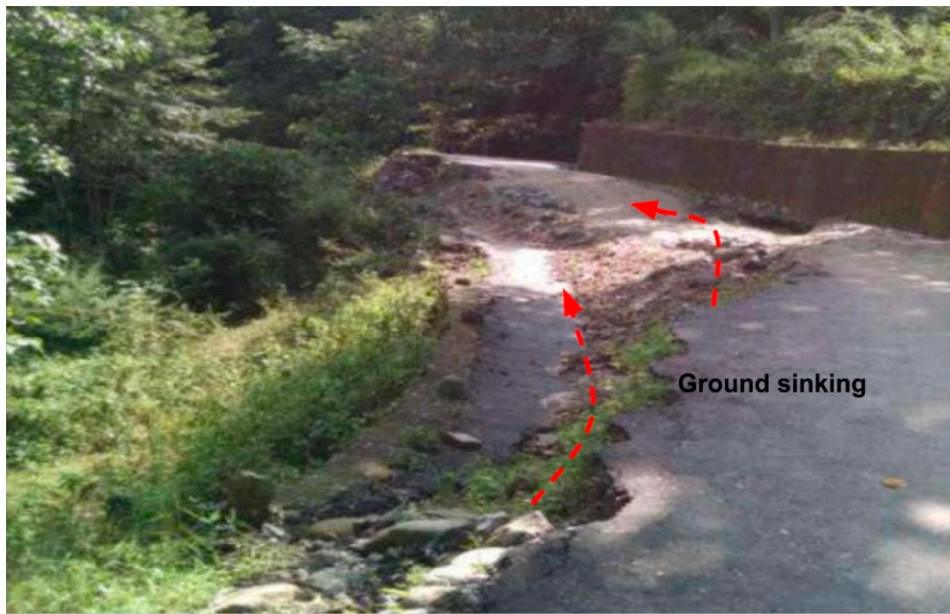
**Figure 9.** Displacements observed at Chibo after 2017 monsoon: (a) depression, (b) crack observed in ground, (c) ground sinking [22].

Figure 9 shows the displacements observed after the 2017 monsoon near the sensors. It was observed that near sensor 2, around 1 m subsidence occurred after the monsoon [22]. The regions near to sensor 2 (top left of Pyarieni jhora) are the most vulnerable among the six sensor locations. Also, the movement of tilt angles in the perpendicular direction of tilt sensors 2 and 3 are in opposite directions, which indicates a possible failure plane between the two. The hypothesis that subsidence and displacements are the results of scouring and erosion by the jhora in between the two sensors is strengthened by this observation.

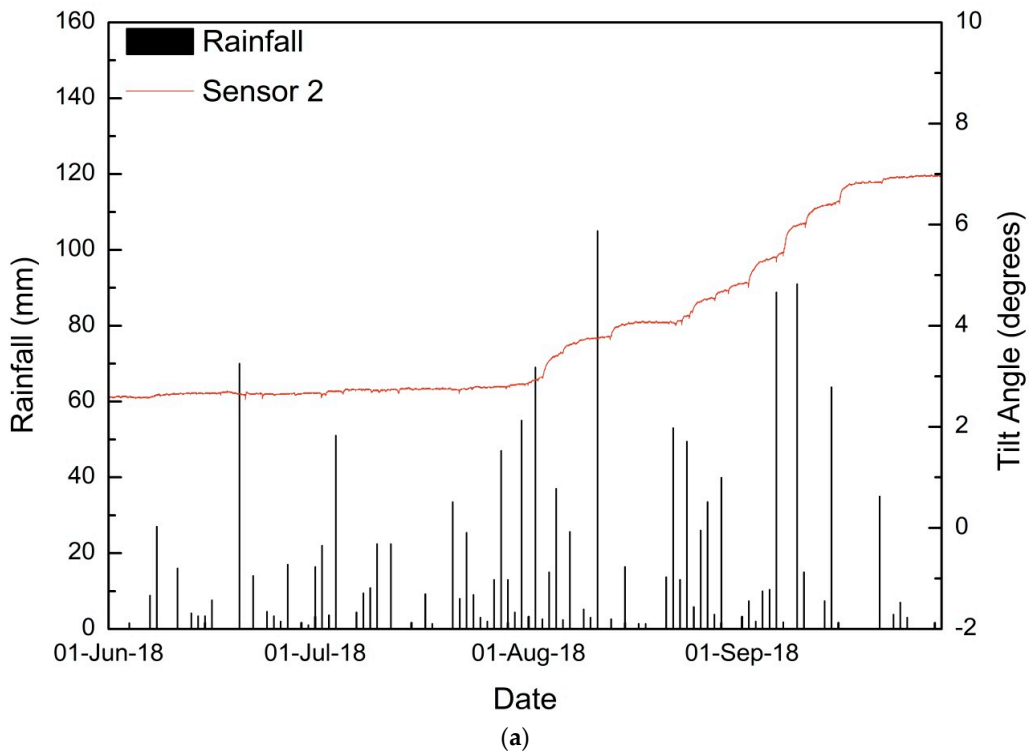
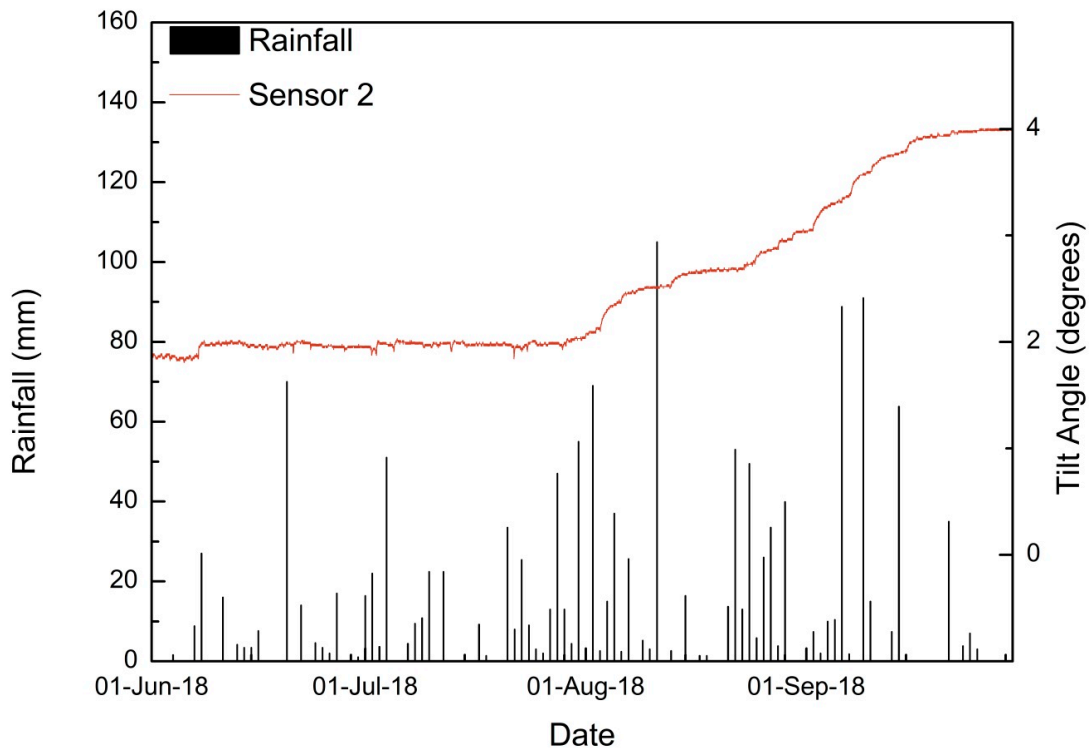
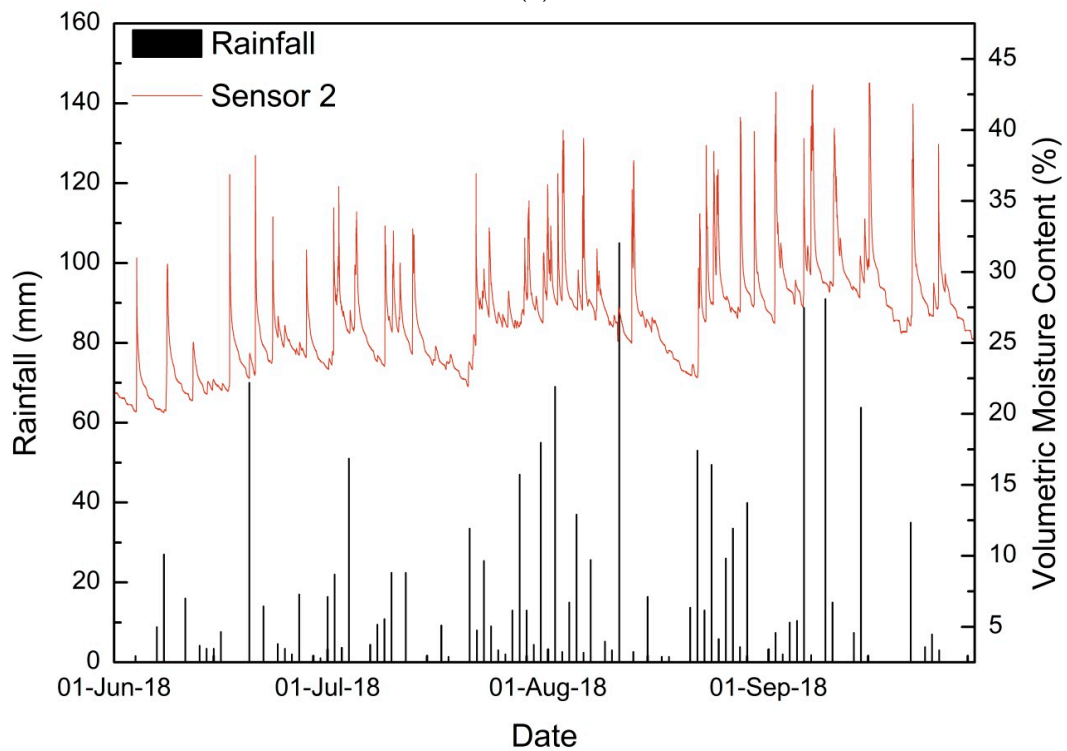
**Figure 10.** Detailed time history for monsoon 2018 of sensor 2: (a) tilting angle in the direction parallel to the slope, (b) tilting angle in the direction perpendicular to the slope, and (c) volumetric moisture content.

During the 2018 monsoon, sensor 2 showed the maximum variations in tilting angles. From 3 August to 15 September 2018, significant changes were observed in tilt angles, with a flat period from 14–24 August 2019. The same trend was observed in both parallel and perpendicular directions to the slope. The detailed time history of tilting angles and volumetric moisture content is shown in Figure 10.

For the first displacement period (3–8 August 2018), the total rainfall was 195.8 mm, with a maximum recorded precipitation of 105 mm on 11 August. The antecedent rainfall 3, 5, and 10 days

prior to displacement were 124 mm, 141.4 mm, and 215.4 mm, respectively. The maximum tilting rate observed was  $0.014^\circ/\text{h}$  on 3 August 2018 in both parallel and perpendicular directions. The maximum moisture content was also recorded on 3 August as 39.97%. It can be inferred that the effect of continuous infiltration prior to the displacement period has more effect on the tilting rate as the maximum tilting was observed on a day with a mere 2.6 mm rainfall.

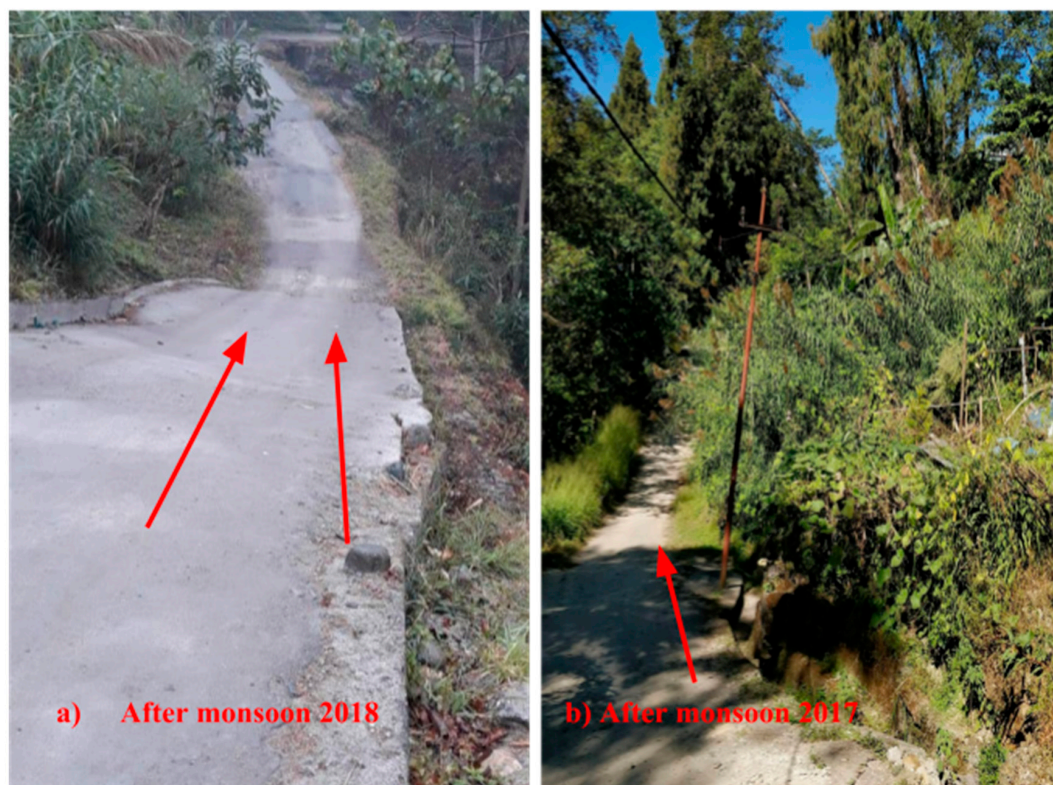
**Figure 11.** Displacements observed after 2018 and 2017 monsoons near sensor 2 (a) after the 2018 monsoon and (b) after the 2017 monsoon.

As shown in Figure 11, the roads near sensor 2 underwent substantial subsidence after the 2018 monsoon season. The other sensor locations remained relatively unaffected. The maximum tilting rate observed after two monsoons is  $0.018^\circ/\text{h}$ .

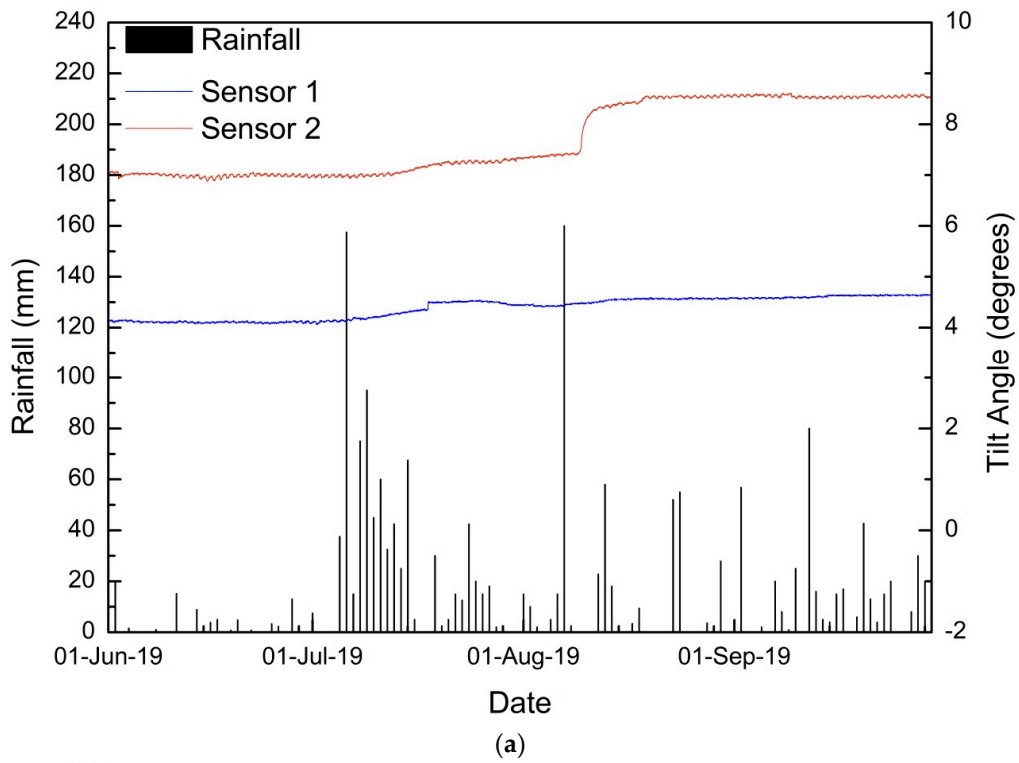
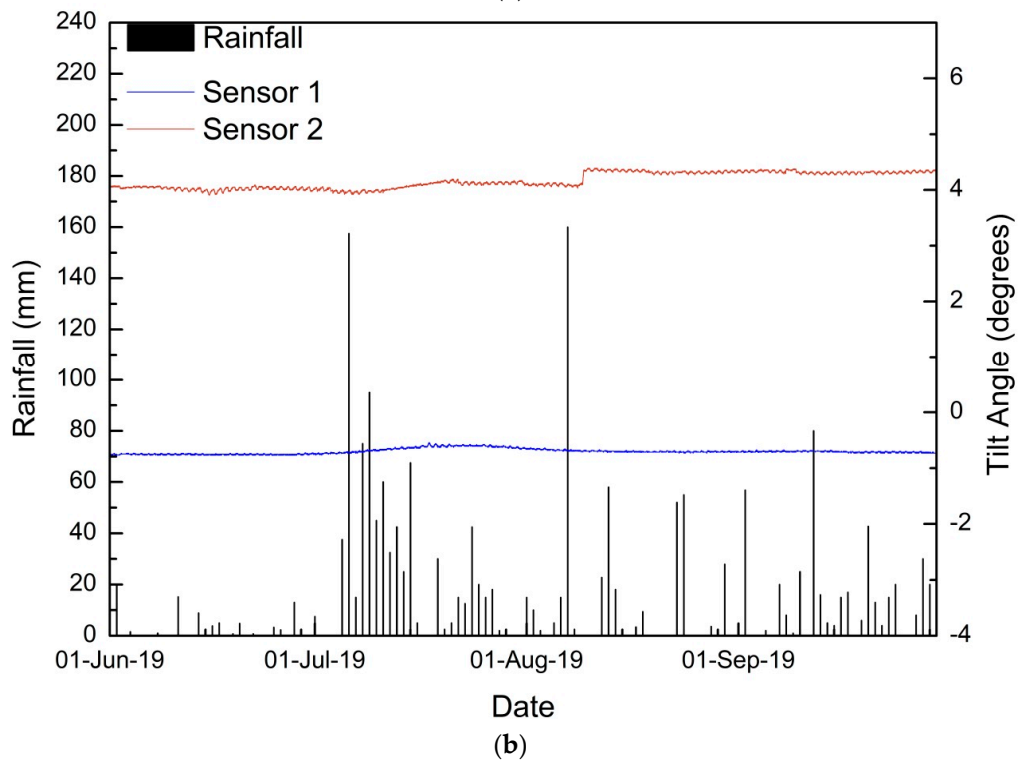
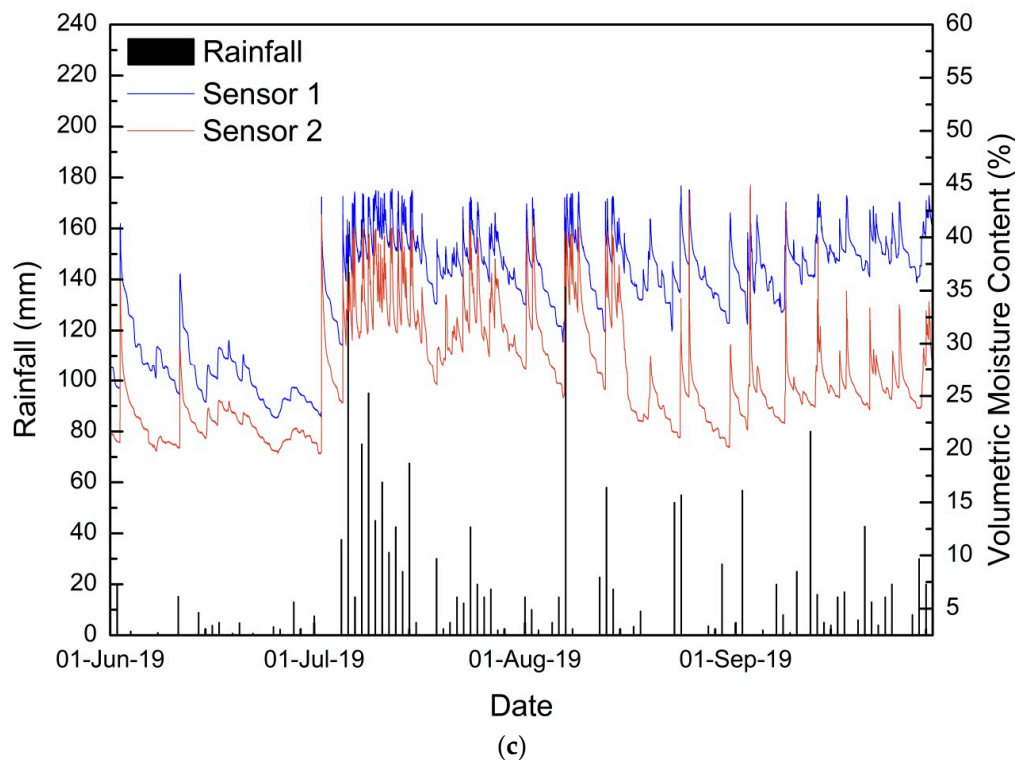
**Figure 12.** Detailed time history for the monsoon 2019 of sensors 1 and 2: (a) tilting angle in the direction parallel to the slope, (b) tilting angle in the direction perpendicular to the slope, and (c) volumetric moisture content.

Similar to the 2017 and 2018 monsoons, maximum tilting was observed in sensor 2 during the 2019 monsoon. Sensor 1 also recorded a minor increase in the tilting angle in the parallel direction to the slope. The detailed time history of tilting angles and moisture content are shown in Figure 12.

During the initial displacement period (12 July 2019–20 July 2019), both sensors 1 and 2 tilt angles in a parallel direction increased at a very negligible rate. The maximum rate observed was  $0.003^{\circ}/\text{h}$  on 20 July 2019 in sensor 2. In sensor 1, a sudden shift in tilt angles was observed in 10 min from  $4.362^{\circ}$  to  $4.502^{\circ}$  on 17 August 2019 23:50 p.m., i.e., a tilting rate of  $0.01395^{\circ}/\text{min}$ , which is exceptionally high. The rate increased very slowly from  $0.005^{\circ}/\text{h}$  on 12 August 2019, and hence it was possible to monitor the sudden shift. Second displacement period was from 9–18 August 2019. A notable change in tilting angle was observed on 9 and 10 August 2019. In the parallel direction, a  $0.0237^{\circ}/\text{h}$  tilting rate was recorded on 9 August 2019, which reduced to  $0.0096^{\circ}/\text{h}$  on 10 August 2019. The tilting progressed at a minor rate until 20 August 2019. In the perpendicular direction, a sudden shift in tilt angle was observed on 9 August 2019 at a rate of  $0.013^{\circ}/\text{h}$ . No rainfall was recorded on 9 August 2019 in the study area and the antecedent rainfall on three days, five days, and 10 days before the peak tilting rate were 177.5 mm, 182.5 mm, and 209.5 mm, respectively. Figure 13 shows the displacements observed after monsoon 2019 near sensor 1 and sensor 2.

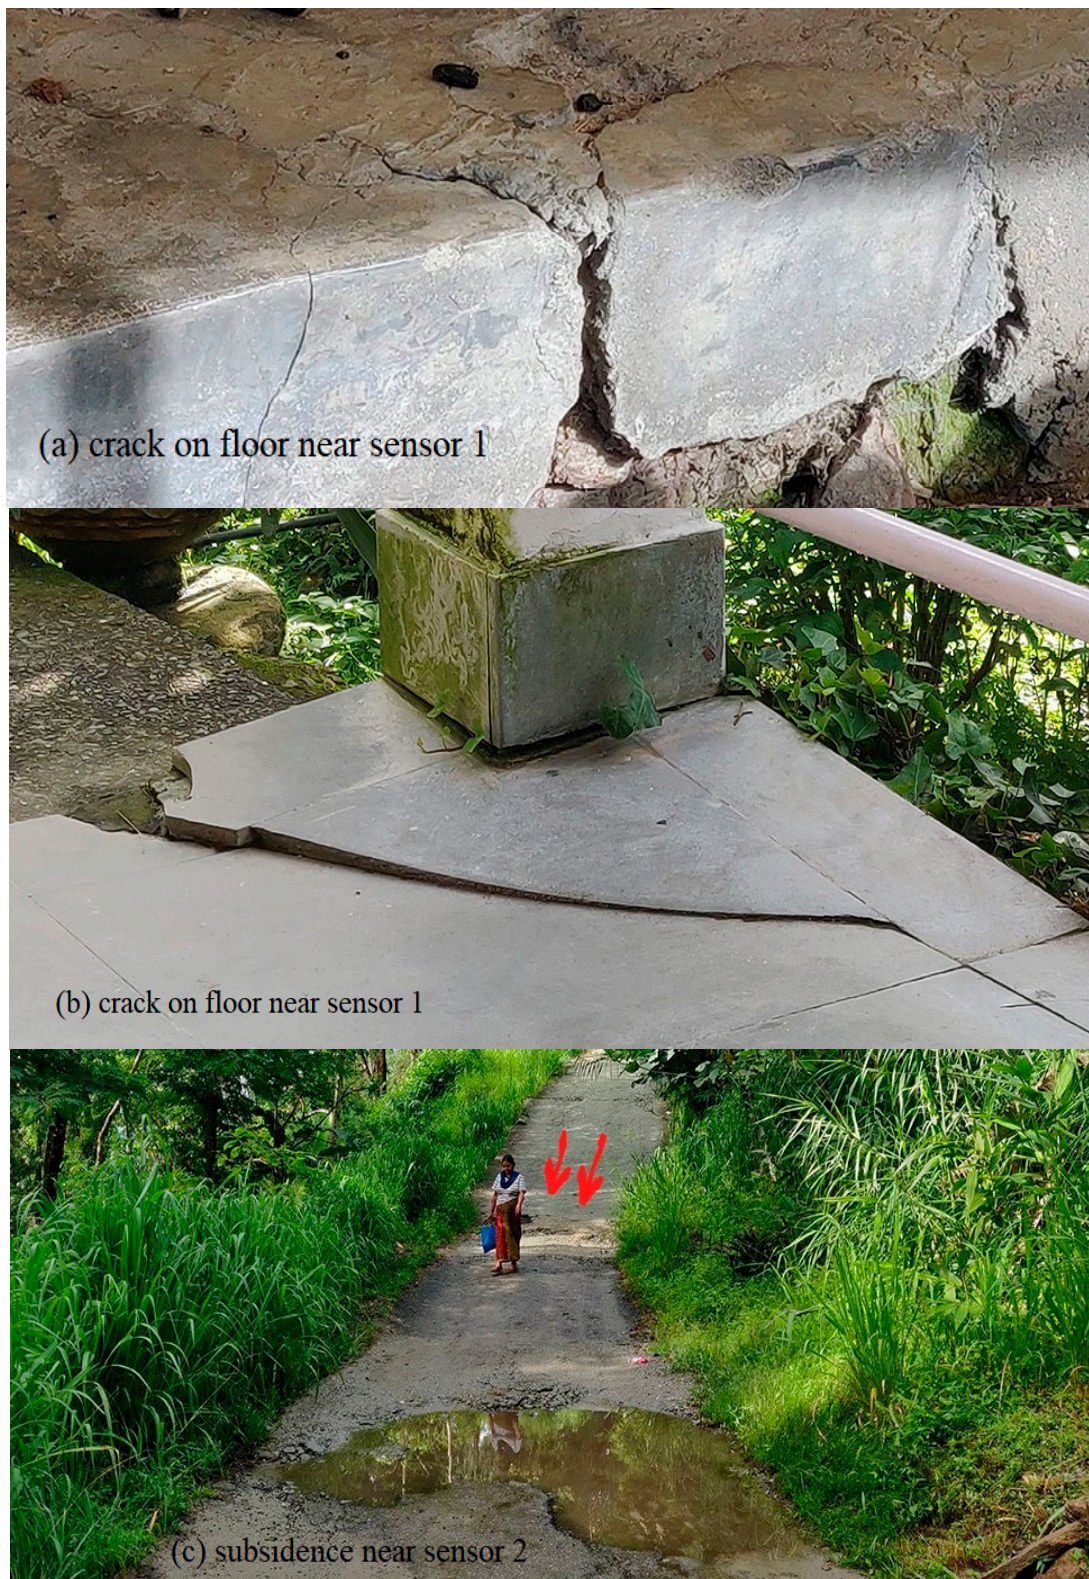
**Figure 13.** Displacements observed after the 2019 monsoon: (a) crack on floor near sensor 1, (b) crack on floor near sensor 1, (c) subsidence near sensor 2.

The displacement near sensor 2 was similar to those observed in 2017 and 2018, as subsidence in roads. In case of sensor 1, the observations are in accordance with the sudden shift observed in the tilt angle reading, i.e., cracks are observed on the floors of two houses nearby.

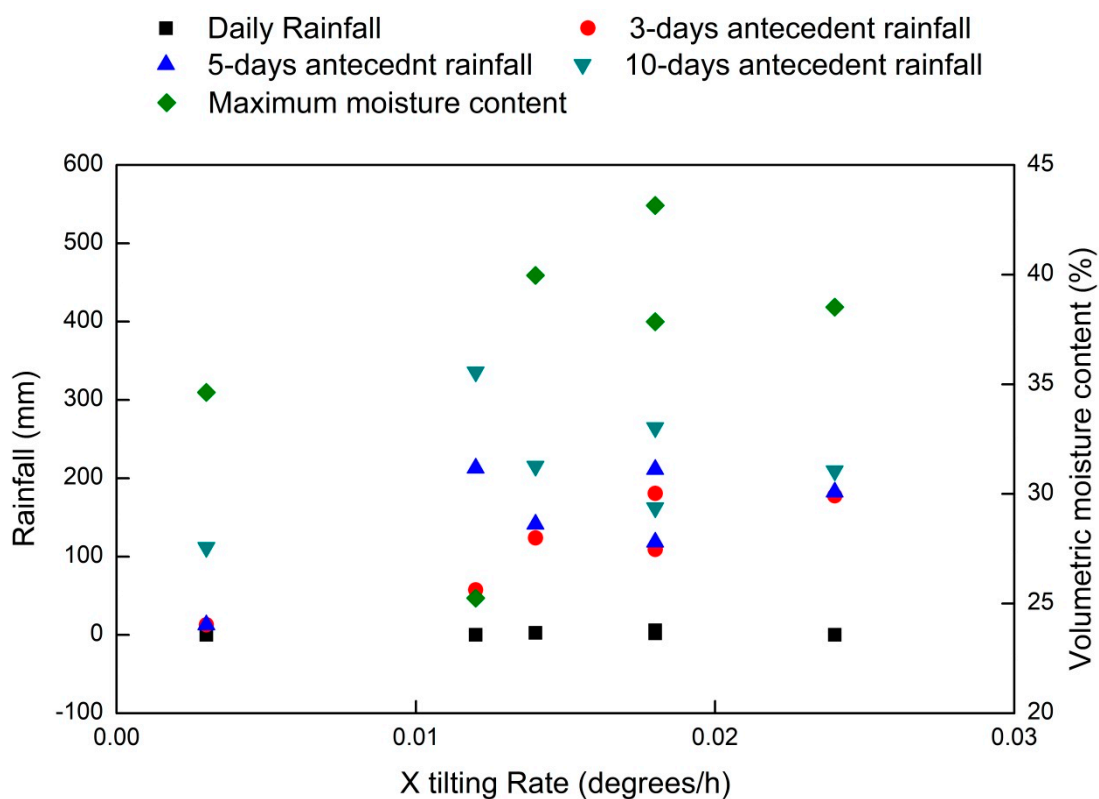
**Figure 14.** Tilting rate variation for sensor 2 for various displacement periods during study period with respect to rainfall and moisture conditions.

From Table 2, the variations in tilting rates with a daily rainfall, antecedent rainfall, and moisture content can be evaluated. The same has been plotted in Figure 14. From the summary, it is clear that antecedent rainfall plays a major role in ground displacement rather than daily rainfall values. Hence, the study points out the significance of using a statistical threshold that considers the effect of both short-term and long-term rainfall as the first line of early warning [49]. Such thresholds can also be conceptually modified by incorporating moisture content [8,14,50] and tilt angle values. The total rainfall received in the study area during the 2018 monsoon period was the least when compared to the other two monsoons. This is evident from the lesser value of antecedent rainfall observed in two displacement periods of 2018. However, continuous precipitation has created the same effect and has increased the tilting rates. All displacements have happened at tilting rates greater than 0.01°/h. The displacements observed were not rapid in nature, except the cracks observed near sensor 1 on 17 August 2019. Hence, the sensors prove effective in detecting very slow ground movements and can be used by the officials to be alert regarding the increasing tilting rates.

From Figure 14, it can be inferred that tilting rates in the X direction (parallel to slope) are higher than those in the Y direction (perpendicular to slope). The tilting rate is found to increase with the increase in volumetric moisture content as well. In all cases, the daily rainfall is clearly much less than the antecedent rainfall. The improper drainage system and water logging leads to an increase in moisture content, which increases the erosion rate. The erosion starts at the downhill area (near sensor 3) and is reflected as subsidence in the upper hilly areas (near sensor 2). The location near sensor 2 (Pyarieni jhora) is identified as the most critical area as it showed displacements in all three monsoon seasons.
