Fractured aluminum nasopharyngeal swab during drive-through testing for COVID-19: radiographic detection of a retained foreign body

Keywords COVID-19 · Nasopharyngeal swab · Radiographs · X-ray · Aluminum · Foreign body

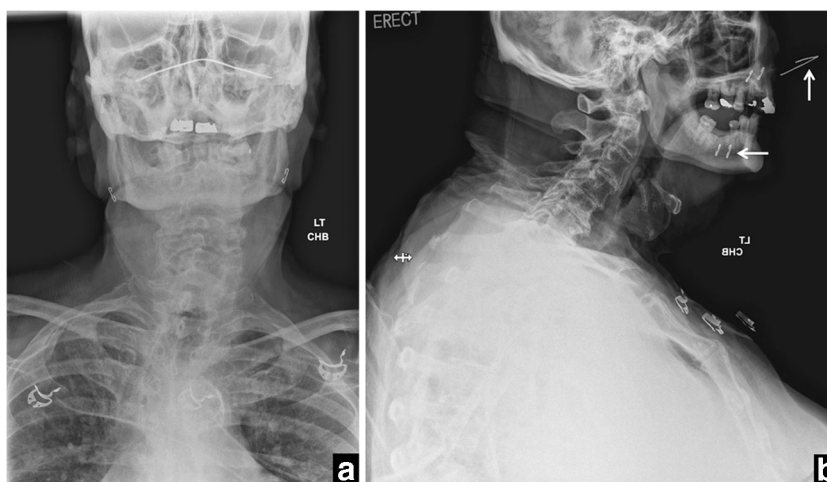
Fig. 1 Frontal view (a) and lateral view (b) radiographs obtained in the emergency department covering the skull base and neck. Note the radiopaque bridge (vertical arrow) and the staples (horizontal arrow) of the face mask the patient was wearing

In the emergency department, the patient remained asymptomatic and denied foreign body sensation. He was afebrile with an oral temperature of 38.3 °C, with oxygen saturation of 95% on room air and respiratory rate of 16 breaths per minute. Repeat inspection of the nose and posterior pharynx using an otoscope and nasal speculum did not reveal the fractured swab. The lungs were clear, heart rate and rhythm were normal, and the remainder of the exam was unremarkable. Radiographs covering the skull base and neck soft tissues (Fig. 1a and b) and radiographs of the abdomen did not show any evidence of radiopaque foreign body by the emergency physician's read which was confirmed by the over reads performed by a radiologist. Chest X-ray did not show foreign body or pneumonia. Because the location of the swab

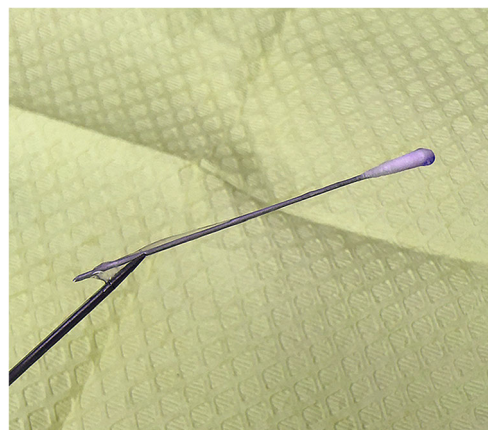
Fig. 2 Photograph of the nasopharyngeal swab after endoscopic removal

was still unclear, the patient was then referred to the otorhinolaryngology clinic. Nasal speculum exam again revealed normal mucosa without evidence of deviation of the nasal septum. The turbinates appeared normal as did the oral cavity, soft and hard palate, tonsils, and posterior oropharynx. There was no evidence of erythema, mucosal injury, or foreign body. The patient was then consented for nasal endoscopy to ensure that there was no foreign body in the nasal cavity or paranasal sinuses that was not visible by anterior rhinoscopy. Cotton pledgets soaked in 0.05% oxymetazoline and 4% topical lidocaine were placed in both nasal cavities. Pledgets were placed in lieu of the traditional lidocaine/oxymetazoline spray to reduce the generation of aerosol in the setting of possible COVID-19 infection. After topical anesthesia, a 0 degree endoscope was advanced into the left nasal cavity revealing a foreign body firmly wedged under the inferior turbinate. The object was oriented with the distal aspect of the swab in the nasopharynx, the mid-portion in the inferior meatus, and the fractured portion pinned between the inferior turbinate and the nasal floor. An alligator forceps was then used to remove the fractured swab which measured nearly 5 cm (Fig. 2). There were no complications.

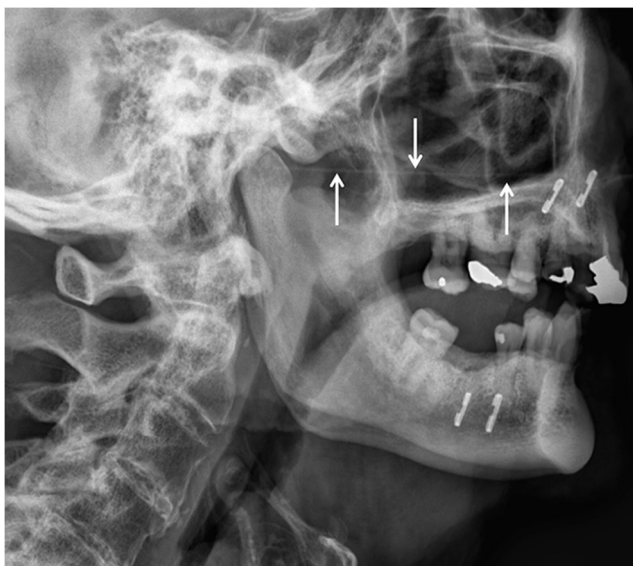
Fig. 3 Magnification of the lateral view radiograph obtained in the emergency department covering the skull base and neck showing a thin minimally radiopaque line in the nasal cavity representing the retained nasopharyngeal swab (arrows)

reveal a minimally radiopaque thin line at the inferior aspect of the nasal cavity representing the aluminum shaft of the swab (Fig. 3). For this radiograph, exposure was set at 65.9 kVp and 28 mAs, and the field of view extended from the skull base to the upper chest without collimation. Notably, the patient was wearing a surgical-type face mask during the examination, and the bridge piece and staples retaining the bands of the mask were easily visualized as dense radiopaque objects.

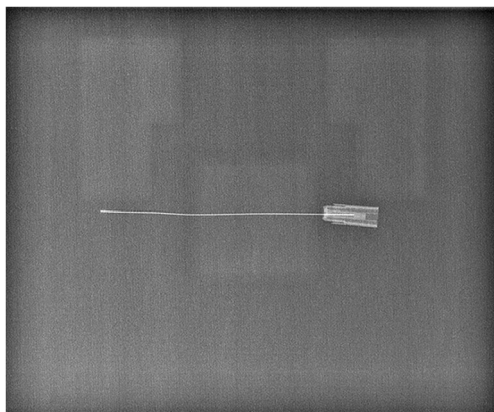
Fig. 4 Radiograph of a standard standard BBL™ rayon-tipped aluminum shaft CultureSwab™ obtained at 66 kVp and 1 mAs

Recognizing this, we can tailor the radiograph technique in our advantage to give the best chance for detection of a suspected aluminum foreign body such as a nasopharyngeal swab. We therefore performed an experiment to identify the best imaging technique to visualize an aluminum shaft nasopharyngeal swab used for COVID-19 drive-through testing. First, we image a standard BBL™ rayon-tipped aluminum shaft CultureSwab™ at 66 kVp and 1 mAs (Fig. 4). Then, using a phantom model, we taped the swab onto the side of a skull phantom at the level of the nasal cavity (note that the phantom has no nasal cavity to place the swab into) and obtained radiographs covering the entire skull without collimation with exposure of 66 kVp and 5 mAs (Fig. 5a), 121 kVp and 1 mAs (Fig. 5b), and 56 kVp and 10 mAs (Fig. 5c). We then collimated the field of view to the nasal bones and obtained additional radiographs at 121 kVp and 3 mAs (Fig. 6a) and at 56 kVp and 77 mAs (Fig. 6b). Those parameters were chosen to illustrate the effect of high versus low tube voltage (kVp) and collimation on swab conspicuity. The parameters matched the tube voltage used for the clinical radiograph that was obtained in the emergency department (66 kVp) and the tube voltage routinely used for chest radiographs (121 kVp) and for extremity radiographs (56 kVp) at our institution. The mAs was adjusted to provide similar exposure and noise in the radiographs. After review, it was clear that the collimated images obtained at lower tube voltages produced the best visualization of the aluminum shaft of the nasopharyngeal swab. Collimation reduces scatter, which in turn improves image contrast and shaft conspicuity. Low tube voltage results in lower mean energy of the X-ray beam, which increases the probability of photoelectric interaction with the swab shaft and thus also improves contrast and swab conspicuity.

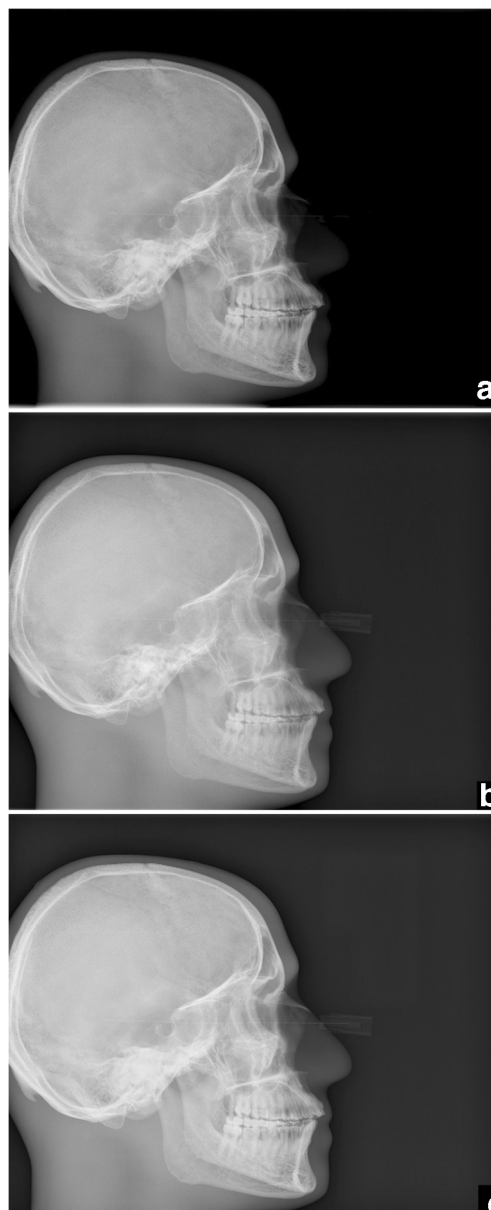
Fig. 5 Uncollimated radiographs of a phantom model with aluminum nasopharyngeal swab obtained with tube voltage of 66 kVp (a), 121 kVp (b), and 56 kVp (c)

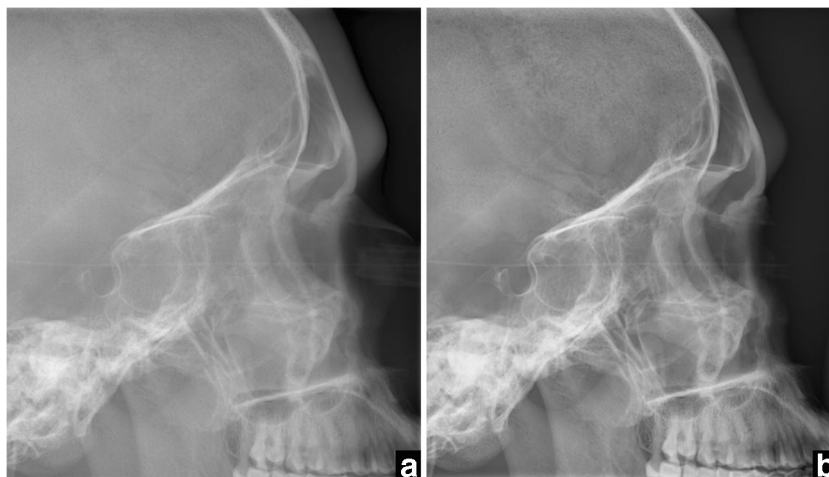
Fig. 6 Collimated radiographs of the phantom model with aluminum nasopharyngeal swab obtained with tube voltage of 121 kVp (a) and 56 kVp (b)
