Review

Synthesis of Repair Materials and Methods for Reinforced Concrete and Prestressed Bridge Girders

Azin Ghaffary and Mohamed A. Moustafa *

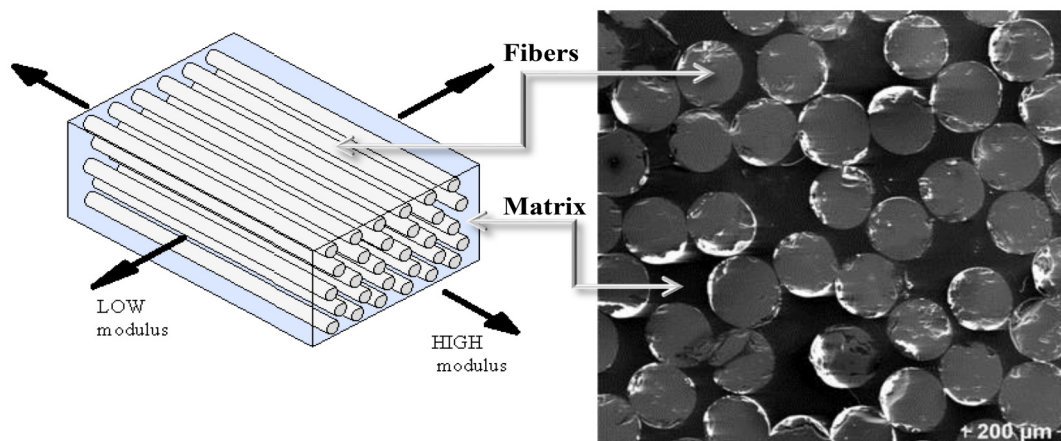
Fiber-reinforced composites, as shown in Figure 1, are a combination of two different materials (i.e., the reinforcing fibers and the matrix). The type of matrix and fiber, orientation of the fibers, as well as the ratio of matrix to fiber content will affect the properties of the resulting composite [1]. Strengthening of concrete members using fiber-reinforced composites, initially used for aerospace applications, started in the mid-1980s, and it has gained popularity in recent years, especially for bridge repair applications, due to their superior characteristics such as: high strength-to-weight ratio, anti-corrosive properties, high tensile strength, insect and fungal resistance, low thermal conductivity, ease of installation, and flexibility in application. Fiber-reinforced composites are about 85% to 73% lighter than the steel. This means an ease of handling and less equipment and workforce requirements on site. Despite their higher cost compared to steel, they are usually the preferred strengthening approach for long-term repair projects due to their superior characteristics listed above. This is while steel materials with proper corrosion treatment might be a better choice for short-term retrofit projects [19,25–32].

Figure 1. Schematic of fiber-reinforced composites [1].

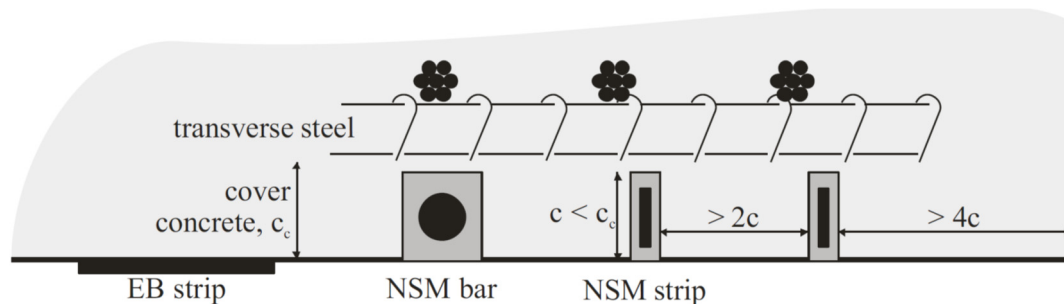
Figure 2. Schematic of EB and NSM bar and NSM strips for the strengthening of reinforced concrete (RC) members [46].

The NSM method improves the fire resistance and impact damage resistance of the strengthened member compared to the EB method since the repair material is placed inside of the concrete instead of being exposed on the concrete surface, and also as a result of the increased contact area. Additionally, there is no change of dimensions in this technique, keeping the cross-section of the girder the same [28,50,54]. However, Jones [19] indicated that although this technique leads to decreased material use, the increased labor cost might offset the savings in the material cost. An example is cutting in grooves overhead which is difficult to implement for the workers. From a different perspective, Sobieck, Atadero [1] indicated that the additional time and effort that is spent on surface preparation for making the grooves will usually be compensated with the increase in the flexural properties in case the NSM rods are pretensioned.

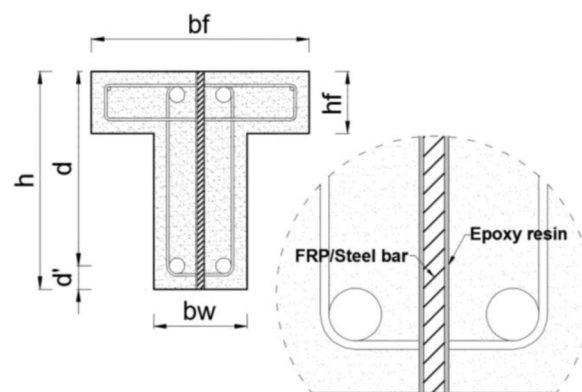
Even when using the NSM method, premature debonding can still occur, resulting in incomplete use of the tensile capacity of the common FRP repair material. This is more likely to happen in beams with T-shaped or I-shaped cross-sections. Additionally, studies have indicated that in the NSM method, detachment of the cover concrete in which the NSM reinforcement is used might occur which prevents the repair approach to work in full capacity. Therefore, it might not be possible to fully utilize the tensile strength of the repair material using the NSM or EB methods, unless proper anchorage is provided. This motivated another method which is embedding reinforcing materials well inside the girder, i.e., into the concrete core beyond the cover or surface grooves, to increase the bonding. This is because the concrete core handles the stress transfer to the strengthening material, and compared to the concrete cover, it can provide better confinement, and thus improved bond behavior. Additionally, in this deep embedment technique, protection against fire and vandalism is even more effective than the NSM method [30,57]. Figure 3 shows an example application of the deep embedded reinforcement method for RC T-beams.

Figure 3. Schematic of the deep reinforcement embedment technique for T-beams [58].

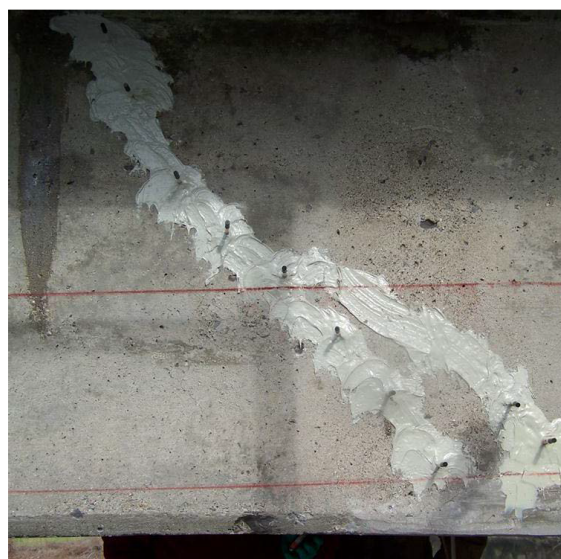
In case there are cracks on the girder, they should be filled with proper materials, i.e., patching. There are several patching methods and the most common five ones are discussed. (1) The dry pack method: which is suitable for holes having a depth nearly equal to the smallest dimension of the section, such as the core or bolt holes. The method should not be used on shallow surfaces or for filling a hole that extends entirely through the section or member. (2) The mortar patch method: which is appropriate for concrete members with shallow defects that require a thin layer of patching material such as in honeycombs, surface voids, or areas where concrete has been pulled away with the formwork. (3) The concrete replacement method: where the defective concrete is replaced with machine-mixed concrete that will become integral with the base concrete. This is preferred when there is a void extending entirely through the section, or if the defect goes beyond the reinforcement layer, or in general if the volume is large. (4) Synthetic patching: this method is beneficial where Portland cement patches are difficult or impractical to apply. Examples are patching at freezing temperatures or patching very shallow surface defects. In these situations, epoxy- and latex-based products can be used. Epoxies can be used for a variety of purposes such as bonding agent, binder for patching mortar, adhesive for replacing large broken pieces, or as a crack repair material. Small deep holes can be patched with low-viscosity epoxy and sand, whereas shallower patches require higher-viscosity epoxy and are more expensive. Although epoxies offer excellent bond and rapid strength development, they are hard to finish and usually result in a color difference between the patch and the base concrete. Therefore, it is suggested that epoxy mortars be used only in situations where exceptional durability and strength are required. Latex materials are used in mortar to increase its tensile strength, decrease its shrinkage, and improve its bond to the base concrete, thus helping to avoid patch failure due to differential shrinkage of the patch. Latex is especially useful in situations where feathered edges cannot be avoided. (5) Epoxy injection: this method is used to repair cracks or fill honeycombed areas of moderate size and depth. It becomes an important part of the repair process, specifically for corrosion-damaged girders in which cracking and spalling of the concrete is commonplace. Epoxy injection should be done only by appropriately trained personnel [46,62]. Figure 4 shows an example of a concrete girder surface after epoxy injection.

Figure 4. Example of RC girder crack filled with low-viscosity epoxy [63].

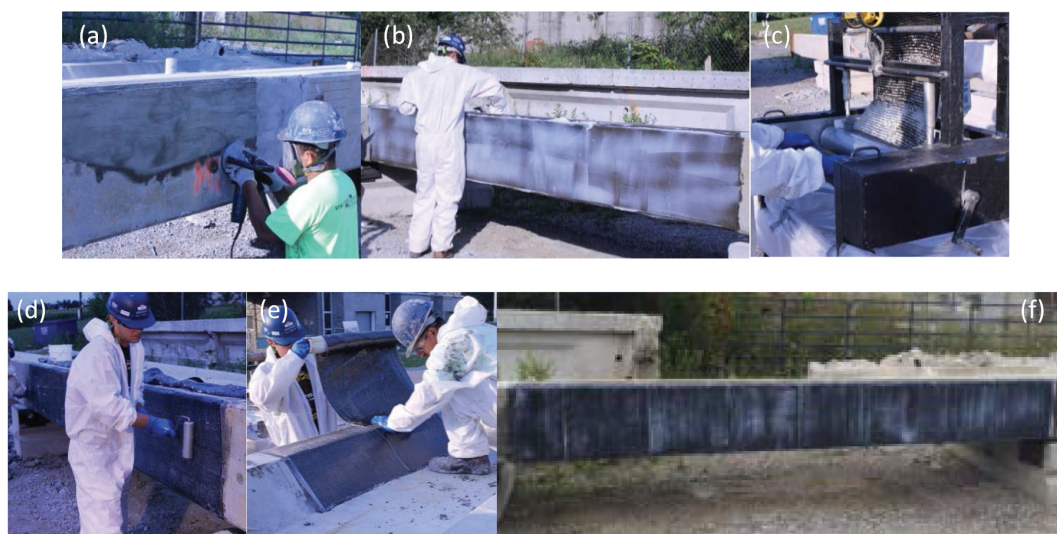
The EB repair techniques using FRP materials are usually implemented in three ways: (1) wet layup, (2) pre-preg, or (3) pre-cured. In the wet layup approach (see Figure 5), the resin serves to both saturate the fibers and bind the sheet to the concrete surface. Dry fiber sheets are impregnated with a saturating resin on-site and bonded to the concrete substrate using the same resin to be cured. Usually the saturating and curing processes are done on-site, but they also might be implemented at the manufacturer's facility off-site. This method has the advantage of the flexibility of the FRP sheets. Thus, it is appropriate for application on surfaces that are relatively smooth, but have an abrupt or curved geometry. The relatively smooth surface is a requirement here to make sure that a proper bond is achieved between the concrete and the strengthening material. Wet layup applications are suitable for column wrapping and U-wrap applications, but not recommended in general for flexural repair for prestressed concrete girders [1,19,28,46]. In the pre-impregnated or commonly referred to as pre-preg approach, the fiber sheets are saturated off-site and partially cured. On the site, they are bonded to the concrete surface using resin and they often require additional heating to complete the curing [19]. In the pre-cured approach, the resin is only used for gluing the procured (fiber and matrix already combined) laminates, strips, or sheets to the concrete surface. The fibers are saturated and cured off-site like precast concrete members. Pre-cured strips are available from a variety of manufacturers in discrete sizes and a number of grades. As for CFRP strips, high-strength (HS), high-modulus (HM), and ultra-high-modulus (UHM) grades are commercially available. In this method, the repair material is rigid and cannot be bent if a more flexible application is needed. Therefore, the application is limited to straight or slightly curved surfaces. This method is used when the surface of the structure is smooth and flat or when using the wet layup method is not practical [1,19,28,46,61].

Figure 5. Illustration of wet layup for applying carbon fiber-reinforced polymer (CFRP) sheets for flexural strengthening: (a) surface preparation (b) surface primer application (c) FRP sheet saturation (d) longitudinal FRP layer (e) transverse FRP layer (f) final strengthening configuration (adopted from [70]).

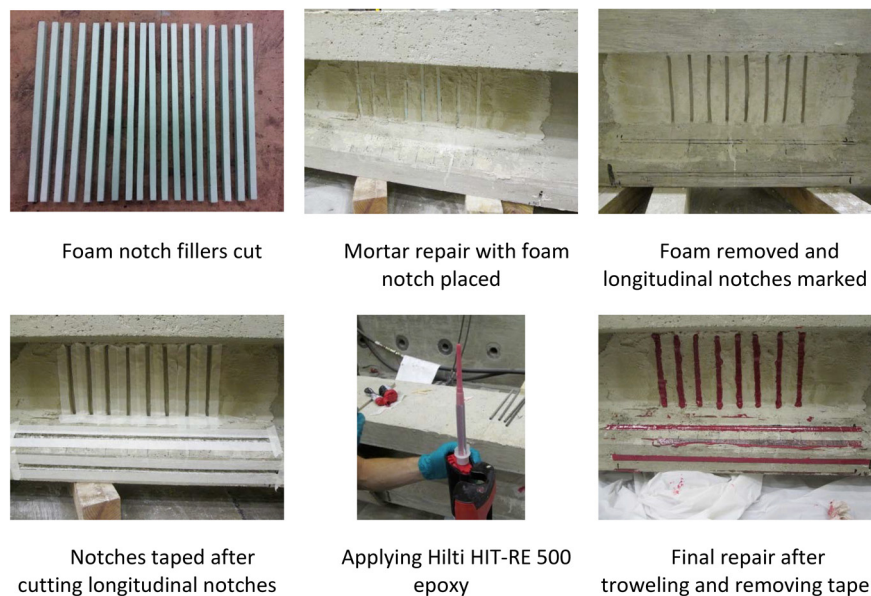
First, grooves are made into the concrete surface, and the concrete in between the cuts is chiseled away. Then, the groove is cleaned, and dust is removed using compressed air. In order to have a clean final appearance, tape can be applied to the sides of the grooves. The strengthening material (bar, thin strip, etc.) is fastened into the groove using a filler material (epoxy resin, cement grout, etc.). Finally, the adhesive surface is leveled using a trowel and the tape is removed prior to the curing of the adhesive [28]. The procedure for an example application of NSM repair is shown in Figure 6.

Figure 6. Example of the FRP NSM repair process [28].

The NSM technique is used for the shear repair of RC bridge girders by making vertical or inclined grooves filled with a proper repair material on the web of the damaged girder, as illustrated in Figure 6 shown above. Similar to the EB method, the inclination of the grooves as well as the spacing between them are important design considerations.

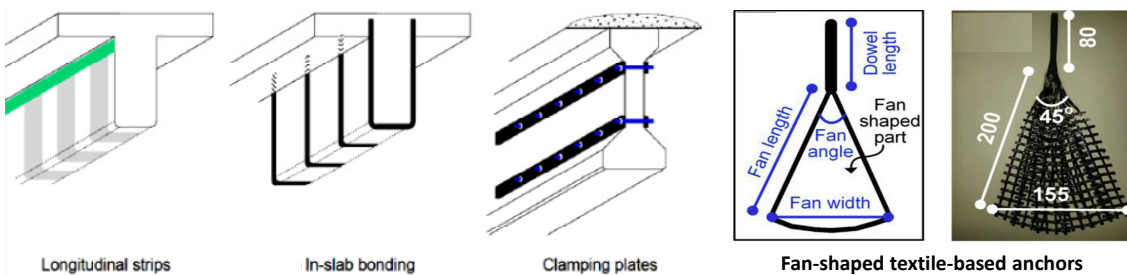
For cases of high peeling or shear stress, an anchorage system might be used in order to delay the debonding of the strengthening system such as FRP materials. A proper anchorage system might allow the use of a strengthening plan that otherwise would not meet the design code provisions, allowing the repair material to continue carrying load even after debonding occurs and thereby increasing its contribution. It can enable greater strengthening or the use of a wider range of possible configurations and material properties. Different anchorage systems have been introduced so far depending on the strengthening approach that they are used with. Some examples include: additional horizontal strips of the repair material, embedment of the repair material into the beam flange through precut grooves with adhesive bonding, various mechanical anchorage systems involving bolts and plates, and fan-shaped textile-based anchors [28,34,71,73]. Figure 8 shows a schematic of these systems. Moreover, Figure 9 shows real-life applications of the horizontal strips, which is the most common approach [28], as well as the application of fan-shaped textile-based anchors to the web–bottom flange interface of an RC girder [7].

Figure 8. Schematic of the common anchorage methods (adopted from [7,34]).

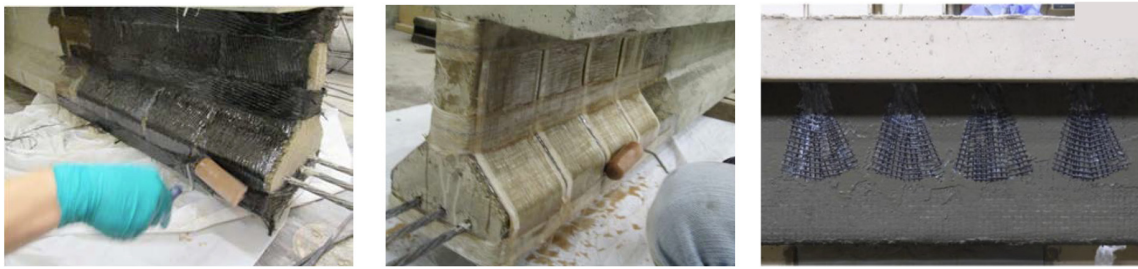
Figure 9. End anchorage system using CFRP or glass FRP (GFRP) strips [28], and plugs of fan-shaped CFRP anchors inserted into holes inside the concrete surface [7].

The fiber-based anchors have the advantage of being light-weight and non-corrosive. Additionally, since the use of FRP-based or textile-based materials is commonplace for girder repair, using a compatible anchor material is also advantageous [7]. A drawback of the use of many anchorage systems is the added cost and complexity of installation [34].

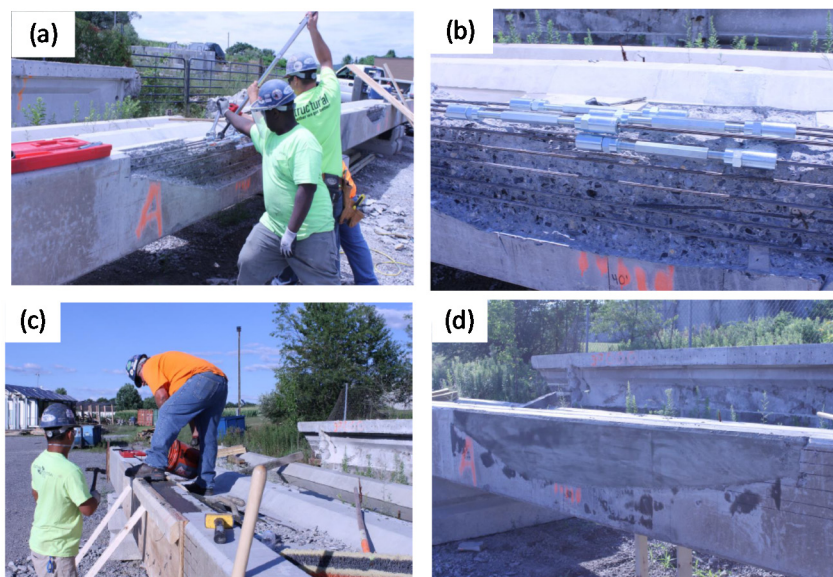
Figure 11. Repair procedure using strand splices: (a) installation of the strand splices, (b) completed installation of splices, (c) placing the repair concrete, and (d) completed repair after form removal (adopted from [19]).

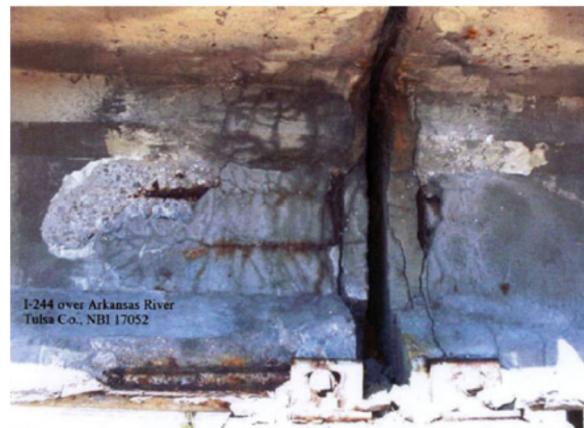
Shear deficiency of RC girders can be caused by an insufficient amount of shear reinforcement, low concrete strength and/or increased design load, and corrosion of existing shear reinforcement [7,8]. Corrosion of the shear reinforcement is the main reason for shear deficiency and is mainly caused by corrosion at girder ends which can expose the shear reinforcement. The end regions of the girders are more susceptible to corrosion due to the proximity to the deck joints which exposes them to the seepage and chlorides from deicing salts in cold climates. Since the 1960s, when officials started applying deicing salts in the winters to bridge structures, the deterioration rate of concrete girders has increased significantly. This has caused both economic and technical issues for bridge structures. On the other hand, the shear demand of the girder in the end regions is the highest, making the situation critical. This becomes even more critical for prestressed girders since the load is transferred to the beam through a bond between the prestressing strands and the concrete in the end zones of such girders, causing even more shear demands. High potential for corrosion together with high shear demands makes the girder end regions in need of special care in terms of shear capacity requirements. Other situations that can make the shear deficiency of the girder ends more crucial include: (1) failure of the expansion joint that can cause all of the deicing salts to drain over the girder end, (2) a partially fixed girder end, such as one created by a frozen bearing, may impose additional stress at the girder end and when the build-up stress is relieved, the girder might crack in tension or in shear, and (3) when the beams are transversely post-tensioned in the horizontal plane and made contiguous within a deck. This is a common typology of bridge girders used for railways under bridges, with simply supported spans ranging from 6 to 20 m [2,21,28,57]. Figure 12 shows an example of a typical damage at the end of a standard AASHTO girder.

Figure 12. Damage in the end region of an AASHTO bridge girder [21].

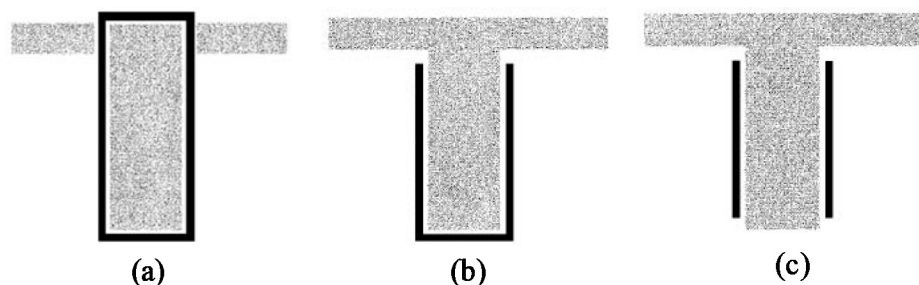
If this method is used for shear repair, it might be used in the three following common forms: complete wrapping, three-sided U-wraps, and two-sided face plies as illustrated in Figure 13. The full wrapping approach is the most efficient shear strengthening scheme. This is because it is capable of achieving the failure mode of the repair material and, in turn, utilizing the material's full strength. However, debonding most likely occurs first. Standards and design guidelines from ACI and AASHTO, for instance, recommend the use of closed wrapping in beams whenever possible. However, most RC beams are cast monolithically with slabs, and therefore the technique is rarely adopted in the field. U-wrap is popular in practice because of its wide applicability and ease of installation. Nevertheless, most U-wraps and almost all the two-sided retrofits result in a debonding mode of failure with very little ductility. In these cases, anchoring the fibers, preferably in the compression zone, can be used to increase the effectiveness of the system. Properly designed anchors can result in the repair material reaching its tensile capacity prior to debonding like in a full-wrap system. Additionally, it should be noted that in most T-beams, the neutral axis occurs within the depth of the flange. While the U-wrap terminates below the flange, the anchorage region of the U-wrap is thus located below the neutral axis, i.e., in the tension region of the beam. This also means that the tension and compression regions of the beam will not be connected by the wrap [8,28,34,51,57,73].

Figure 13. Wrapping schemes for EB FRP shear laminates: (a) complete closed wrapping, (b) 3-sided U-wraps, and (c) 2-sided face plies [28].

Any of the three EB configurations shown in Figure 13 and described above can be implemented with different details. They can be applied continuously or discontinuously along the length of

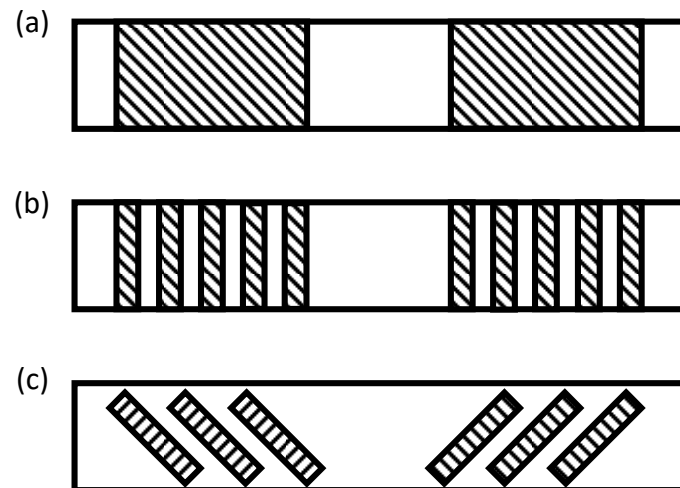
the girder (see Figure 14). In the case of the discontinuous application, the spacing between the strips becomes important. The strengthening strips can also be applied vertically or inclined to the surface of the damaged girder as illustrated in Figure 14. Continuous or discontinuous application of the repair material, spacing of the repair strips in the case of discontinuous application, and the inclination of the repair strips can significantly affect the effectiveness of the repair and the mode of failure of the repaired girder, and are thus considered important design parameters.

Figure 14. Different strengthening schemes: (a) Continuous wraps (b) discontinuous vertical strips (c) discontinuous inclined strips.

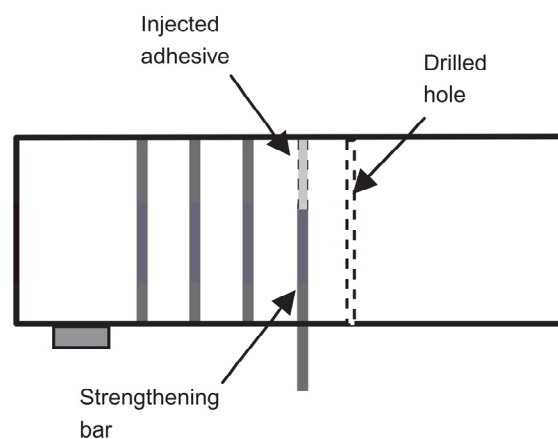
This method is mainly used for the shear strengthening of girders, especially where access to the girder web is not possible [57]. In this method, as explained in Section 2.3, vertical or inclined holes are drilled into the concrete section, in the shear zone, upwards from the soffit as shown in Figure 15. The bond between the strengthening bars and concrete is achieved using epoxy resin.

Figure 15. Shear strengthening using deep embedment techniques [57].

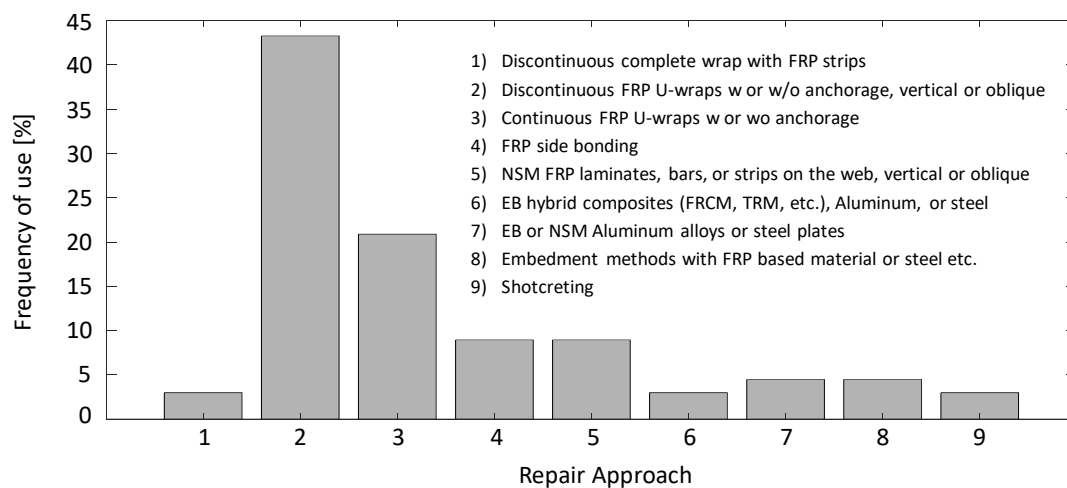
For a complete discussion of implementation techniques of the main repair material, all the different repair techniques found in the literature are summarized and grouped in Figure 16 to indirectly rank which methods are more popular or common. The methods summarized in the figure along with the respective studies or references are: (1) discontinuous complete wrap with FRP strips [67,76]; (2) discontinuous FRP U-wraps with or without anchorage, vertical or oblique [3,10,12,14,28,47,51,62,64,66,73,77–94]; (3) continuous FRP U-wraps with or without anchorage [8,21,62,68,78,95–103]; (4) FRP side bonding [12,102,104–107]; (5) NSM FRP laminates, bars, or strips on the web, vertical or oblique [28,85,108–111]; (6) EB hybrid composites (FRCM, TRM, etc.), aluminum, or steel [3,7]; (7) EB or NSM aluminum alloys or steel plates [9,21,112]; (8) embedment methods with FRP-based materials, steel, etc. [30,58,68]; and (9) shotcreting [113,114].

Figure 16. Summary of shear repair techniques of cracked RC girders and frequency of use in the literature.

As seen from Figure 16, the most utilized shear repair method is FRP U-wraps. While discontinuous U-wraps (installed vertically or obliquely) are the most common approach, continuous U-wraps have also been used quite extensively. However, Mofidi and Chaallal [78] indicated that there is no need for using additional material for continuous U-wraps or side-bonded sheets since the discontinuous wraps were shown to be more effective in increasing the shear capacity, but they come at a price of relatively increased deflections. The use of discontinuous wraps also provides a better condition for future visual inspection of the repair performance. Moreover, the width, thickness, spacing, and inclination of the FRP strips are other design parameters that affect the performance of the repair. Mofidi and Chaallal [78] and Qapo, Dirar [10] indicated that wider strips or higher width-to-spacing

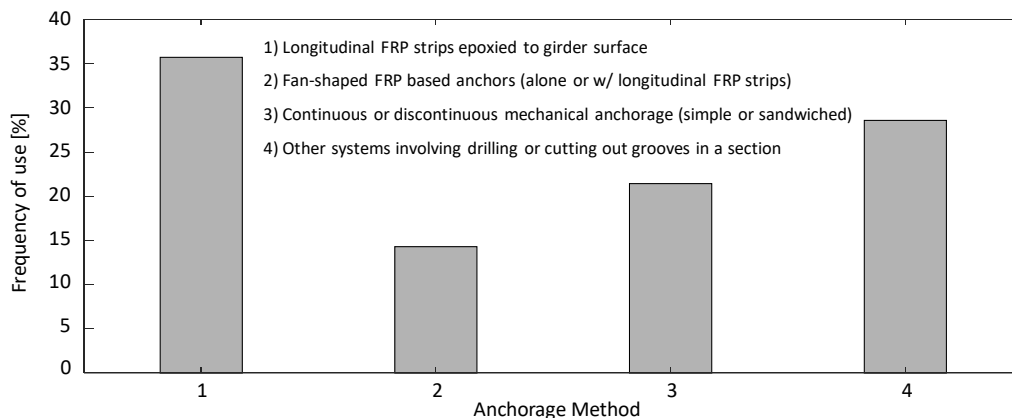
As for the anchorage system that might be used in conjunction with the main shear repair method, the different methods and their frequency of use as found in the literature are summarized in Figure 17. Four methods are found: (1) longitudinal FRP strips epoxied to the girder surface [28,47,73,77,83,84]; (2) fan-shaped FRP-based anchors (alone or with longitudinal FRP strips) [3,115]; (3) continuous or discontinuous mechanical anchorage (simple or sandwiched) [47,73,77]; and (4) other anchorage systems involving drilling or cutting out grooves in the section [8,51,84,94]. Figure 17 shows that the longitudinal FRP strips are the most common utilized approach, but in general, there is not a significant difference between the frequency of use of the methods. Accordingly, it can be inferred that there is no single dominant anchorage system that can be applied to the majority of shear repair projects. Additional horizontal FRP strips are very easy to install and require the least amount of labor among all anchorage systems. Yet, different levels of effectiveness have been observed in various studies [47,73]. The mechanical anchorage systems have shown good performance in some cases but can cause damage to the FRP material [115]. This is where the fan-shaped FRP-based anchors can be useful. Other anchorage systems involving drilling or cutting out grooves in the section such as in-slab bonding have also been proposed in the literature. However, the authors believe that, in the case of spending money and labor work in the complex installation on-site such as cutting grooves, the NSM techniques can provide a more efficient way of repair compared to an EB method with a complex anchorage system.

Figure 17. Frequency of use of different anchorage systems found in the literature.

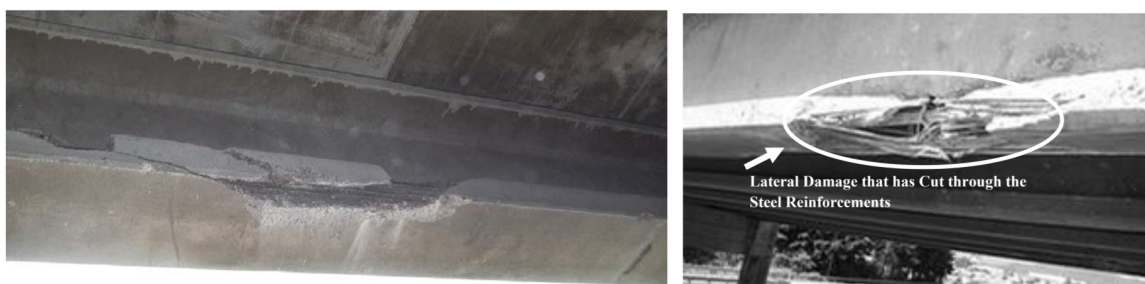
Vehicle impact can cause damage to the girder concrete cover or cut through the steel reinforcement and/or prestressing cables [24]. Figure 19 shows an example of impact damage with two different severities: damage to the concrete cover, and damage to the steel reinforcement. In general, impact damage does not cause immediate collapse of the structure. However, when untreated, it can result in further or accelerated deterioration often resulting in significant prestressing steel corrosion [116]. It would be best to prevent any collision damages to occur, but it is important to have practical, quick, and cost-effective repair schemes in case overheight vehicle impacts occur [19]. The following section identifies common methods for the repair of bridge girders that have flexural deficiencies due to vehicle impact damage or other causes.

Figure 19. Severe concrete spalling due to overheight truck impact damage [6], and example of lateral impact damage on steel reinforcement [24].

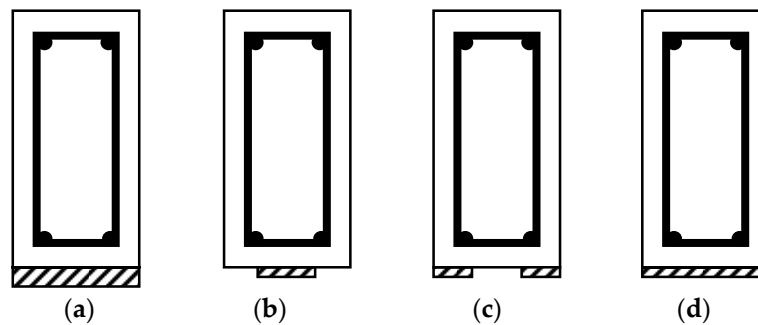
For flexural repair using the EB technique, it is often recommended that the repair material is applied to the soffit of the girder since the material near the neutral axis is less efficient in strengthening the element [75]. This is considered as the earliest and most basic method for upgrading and retrofitting the beams in the flexure [25]. Extending the repair material vertically up the web will reduce the efficiency and does not affect the ultimate debonding limit state [56]. Figure 20 shows three different EB configurations of FRP laminates with different widths attached to the bottom of the girders through epoxy adhesives for repair or strengthening purposes. The EB configurations shown in Figure 20 are usually used in conjunction with transverse wraps for enhancing the bond behavior between the repair material and the girder.

Figure 20. CFRP laminates for the flexural strengthening of girders: (a) two-layer sheet (b) one-layer strip (c) one-layer strips (d) one-layer sheet.

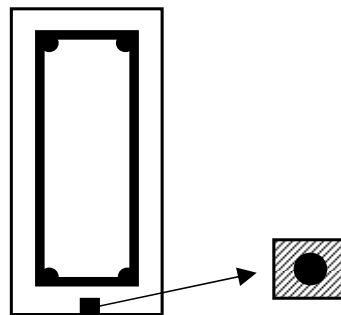
In this method, similar to the flexural repair using the EB technique, the repair material should be applied to the soffit of the girder through grooves to have the best efficiency. Figure 21 shows an example for a repair configuration using NSM techniques.

Figure 21. Schematic of application of prestressed NSM rods in cross-section (left) and inside the groove (right) for the flexural strengthening of rectangular beams.

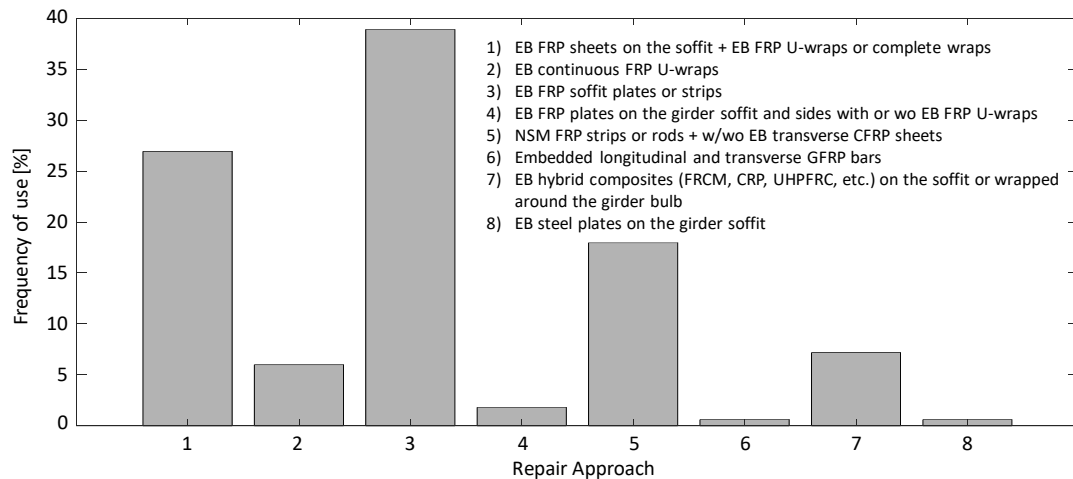
This section provides recommendations for the repair of girders with flexural deficiency, based on the repair case studies found in 151 studies, including both research and real-life applications of the repairs which are both critical for achieving a sufficient understanding of a repair technique. Eight different methods were found in the literature: (1) EB FRP sheets on the soffit + EB FRP U-wraps or complete wraps [24,46,65,67,75,76,89,101–103,111,117,120–152]; (2) EB continuous FRP U-wraps [17,38,60,65,70,103,153–156]; (3) EB FRP soffit plates or strips [27,31,39,67,101,111,121,122,133,144,149,157–210]; (4) EB FRP plates on the girder soffit and sides with or without EB FRP U-wraps [63,126,211]; (5) NSM FRP strips or rods with or without EB transverse CFRP sheets [16,35,36,50,53,54,59,71,125,135,139,140,145,157,176,181,182,189,195,212–222]; (6) embedded longitudinal and transverse GFRP bars [6]; (7) EB hybrid composites (FRCM, CRP, UHPFRC, etc.) on the soffit or wrapped around the girder bulb [17,19,29,33,38,40,41,70,176,223–225]; and (8) EB steel plates on the girder soffit [204]. Figure 22 shows the frequency of use of those different repair approaches in the literature. The most utilized repair method for a flexural deficiency in girders is FRP plates or strips externally bonded to the girder soffit. It can also be seen that EB techniques, with or without transverse wraps, have been used more frequently compared to the NSM techniques. The reasons for this are the relatively easier implementation of EB methods, lower costs, and their ability to act as additional sacrificial reinforcement to prevent damage due to the future potential impacts. However, upon the availability of the resources (e.g., equipment) and expertise, the implementation of an NSM technique could be more suitable than an EB method. This is because the NSM technique, in general, can lead to a higher increase in the girder capacity due to the enhancement in the bond behavior which

Figure 22. Frequency of use of flexural repair techniques of damaged RC girders in the literature.

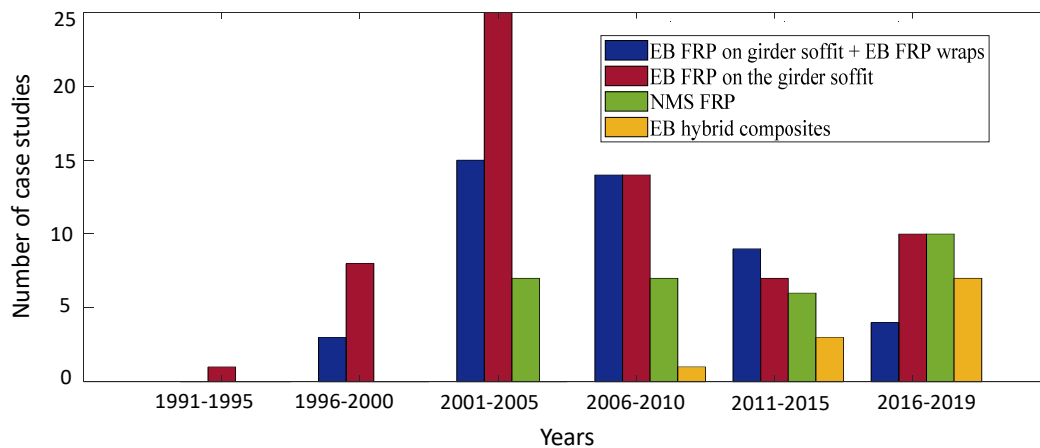
The most commonly used material for the repair of impact-damaged girders seen in the literature is CFRP in the form of sheets and strips. However, as mentioned before, the choice of the repair approach, including the repair material and repair adhesive, highly depends on the specific project requirements and available resources. Figure 22 shows that the use of hybrid composites has also been quite frequent for the flexural repair of girders. This can be beneficial due to the enhanced properties of such materials compared to ordinary FRP, including improved ductility. The four most common repair approaches out of the eight methods shown in Figure 22 are also tracked over time to find their frequency of use over five-year increments starting in 1991 and up to 2019, as illustrated in Figure 23. The 2001–2005 range is shown to be the popular timeline for study and applying flexural repair methods for RC bridge girders. It can also be seen that FRP soffit bonding, with or without FRP wraps, is the most well-researched method of repair for flexures within that time range. It can be inferred from Figure 23 that the NSM FRP method and the EB hybrid composites are the two emerging methods since 2005. It is evident that in spite of the advantages that these two methods might have, their use will most likely involve more uncertainties compared to the well-studied FRP soffit bonding methods.

Figure 23. Evolution of case studies of the most common flexural bridge girder repair approaches over the past three decades.
