A unique cause of Gamma 3 cut-out: A case report and literature review

Ioannis Papaioannou^{*}, Thomas Repantis, Panagiotis Korovessis

Orthopedic Department, General Hospital of Patras, Greece

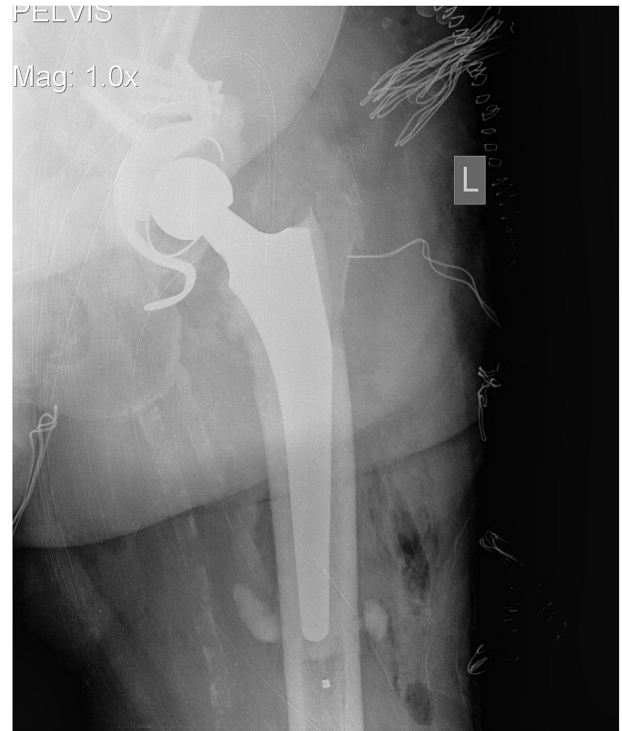
Fig. 3. Anteroposterior postoperative x-ray of left hip and proximal femur demonstrates the total hip arthroplasty (cemented femoral stem and an acetabular Müller reinforcement ring) after the removal of the Gamma 3 nail.

senior surgeon opted to use a part from the head as autograft to stabilize the acetabular component of the total hip arthroplasty (Fig. 3). Based on our intraoperative findings we believe that the possible cause of this Gamma 3 failure was the malposition of the set screw and the uncontrollable rotation of femoral head-lag screw unit. We managed to confirm this with the previous radiographic evaluation of the patient (Fig. 4a and b, Fig. 5a,b). The patient was discharged 5 days after surgery without any complications. At the follow up at 12 months postoperatively, the patient was able to ambulate with one crutch, the Harris Hip score was fair (71/100), while the radiographic evaluation was also satisfactory.

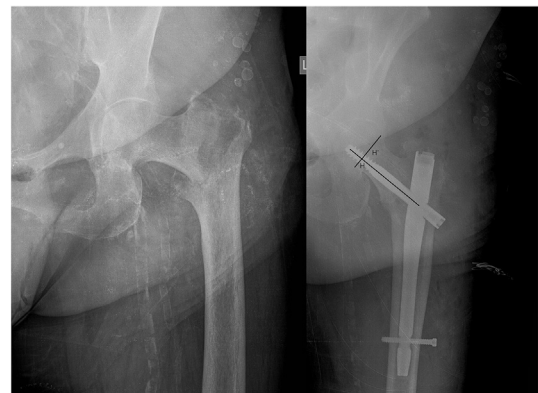
Fig. 4. a. Anteroposterior x-ray of left hip and proximal femur demonstrates the initial intertrochanteric fracture of AO type 31 A1.1, a fracture type which traditionally has been considered as rotationally unstable, **b.** Anteroposterior x-ray of left hip and proximal femur after Gamma 3 nail implantation demonstrates good reduction of the fracture, a low-near to calcar lag screw position, while the H'/H ratio is 3.25.
