Influence of CBCT metal artifact reduction on vertical radicular fracture detection

Purpose: This study evaluated the influence of a metal artifact reduction (MAR) tool in a cone-beam computed tomography (CBCT) device on the diagnosis of vertical root fractures (VRFs) in teeth with different root filling materials.

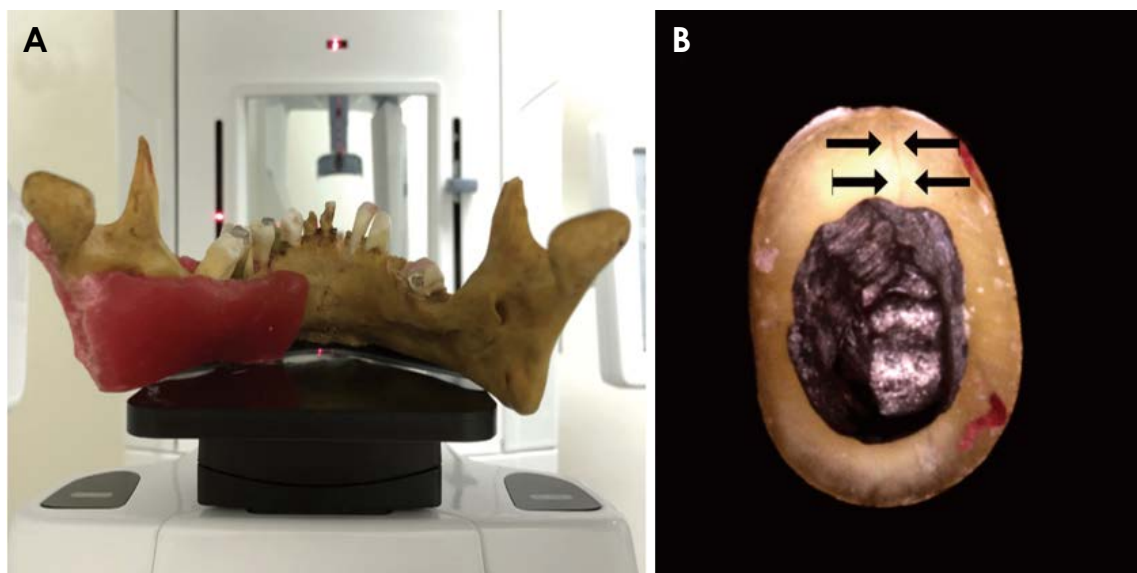
Fig. 1. A. The phantom is positioned in the Orthopantomograph[®] OP 300. B. Premolar bonded after fracture.

To simulate clinical conditions, the periodontal ligament space was artificially reproduced with the addition of silicone fluid, and the roots²⁵ were placed randomly into dry mandibular sockets. The human mandible was covered with a 5.3-mm-thick layer of wax on the lingual and buccal sides to simulate soft tissue attenuation. Subsequently, CBCT images were acquired using an Orthopantomograph[®] OP300 (Instrumentarium Kavo Kerr Corp, Tuusula, Finland) device (Fig. 1A), with the following technical parameters: a field of view (FOV) of 6 cm × 4 cm; a voxel size of 0.085 mm; 90 kVp; 10 mA; and 6.1 s. CBCT scans were obtained from the 45 teeth before they were fractured, first without selecting the MAR tool, and then with MAR tool selection.

Fractures were induced on a Universal Instron (Instron, Canton, MA, USA) testing machine using a 500 N load cell with a cross-speed of 1 mm/min. A tapered metal tip was inserted into the canal's coronal opening, and as soon as the fracture occurred, the machine stopped automatically. Fractures were confirmed by direct visual inspection of each tooth. In cases with fragment separation, the teeth were bonded with cyanoacrylate (Fig. 1B). After being fractured, all the samples underwent new CBCT acquisitions, following the same technical parameters, with and without MAR, resulting in a total of 180 CBCT volumes (Fig. 2).

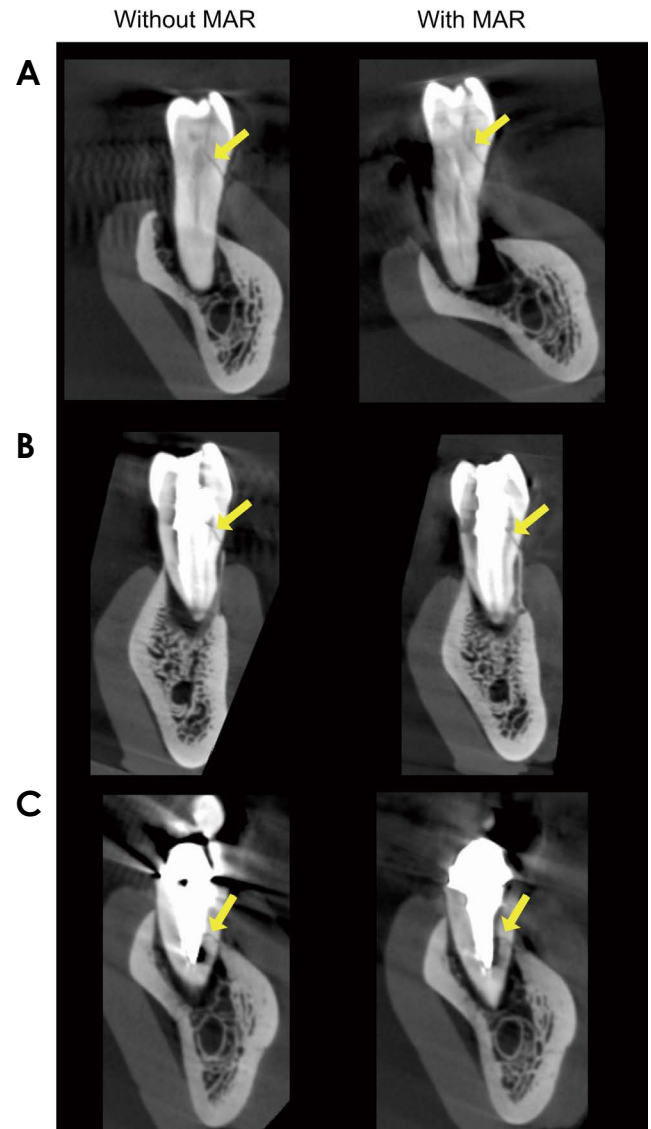
Fig. 2. Coronal slices show root fracture (arrows) in cone-beam computed tomography acquisitions with and without MAR. A. No filling. B. Gutta-percha. C. Metallic post.

threshold will be corrected, changing the values corresponding to very hypodense bands or very hyperdense streaks of hyperdense materials, such as gutta-percha and metallic posts.³¹ However, this reduction of gray values, apparently, does not lead to a more accurate diagnosis. In this study, when MAR was used, the fracture line and dentin density became similar, which is the most probable explanation for the decreased accuracy.

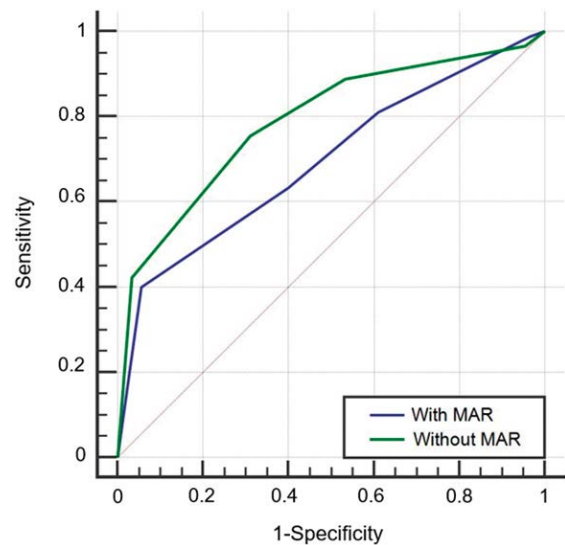
The ROC curves of the images with and without MAR are shown in Figure 3. The areas under the curve were 0.695 and 0.789 for CBCT with and without MAR, respectively. The DeLong test revealed a significant difference between the two groups ($P < 0.05$) with better performance found when MAR was not used group. The inter-examiner kappa value showed substantial agreement for images with (0.737) and without (0.786) MAR. Intra-examiner reproducibility indicated moderate agreement for images with MAR and without MAR (0.533 and 0.433, respectively). Figure 4 shows the ROC curves in the 3 different subgroups. No significant difference was found between images with and without MAR for either the no filling or gutta-percha subgroup ($P > 0.05$). In contrast, in the metallic post subgroup, images with MAR showed a significant difference com-

Fig. 3. Receiver operating characteristic curves for all observers based on cone-beam computed tomographic image with and without metal artifact reduction (MAR).

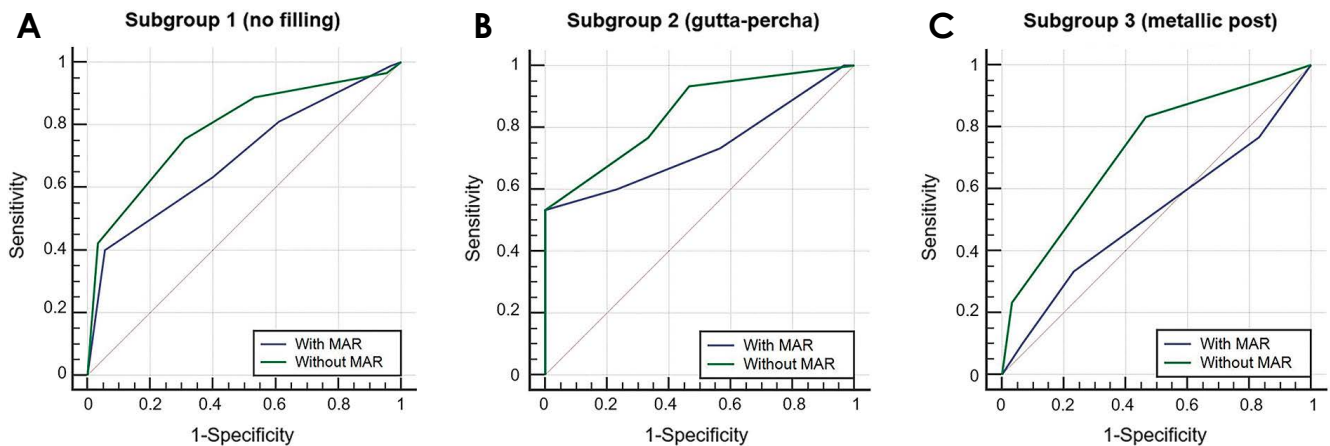
Fig. 4. Receiver operating characteristic curves for groups with and without MAR, showing detailed performance for each of the 3 subgroups. A. No filling. B. Gutta-percha. C. Metallic post.

The diagnostic test values showed slight differences according to whether MAR was used in each of the 3 subgroups evaluated individually, except in the metallic post subgroup, which showed a considerable difference for all tests. This result was also noticed in the ROC curve comparison, since the metallic post subgroup was the only subgroup that showed a statistically significant difference according to MAR use. These findings indicate that, paradoxically, the MAR tool had the greatest negative impact in the subgroup with higher artifact production. These results impacted the overall results for VRF detection when using the MAR tool. Since the other 2 subgroups (no filling and gutta-percha) showed no significant difference according to MAR use, the metallic post subgroup was primarily responsible for the poor overall accuracy.
