A New Laser Ultrasonic Inspection Method for the Detection of Multiple Delamination Defects

Tianfang Gao, Yishou Wang and Xinlin Qing *

Abstract: Delamination is one of the most common types of defects for carbon fiber reinforced plastic (CFRP) composites. The application of laser techniques to detect delamination faces difficulties with ultrasonic wave excitation because of its low thermal conductivity. Much of the research that can be found in the literature has only focused on the detection of a single delamination. In this study, aluminum foil was pasted onto the surface of the composite so that it was vulnerable to ablation and could acquire a usable signal. Using a fully noncontact system with laser excitation at a fixed point and a scanning laser sensor, the effects of different aluminum foil sizes and shapes on the wavefield were studied for the composites; we decided to use a rectangle with 3 mm length and 5 mm width for laser excitation experiments. Wavefield characteristics of the composite plates were analyzed with single- and multi-layered Teflon inserts. Taking the time window for standard ultrasonic testing as a reference, the algorithms for localized wave energy w

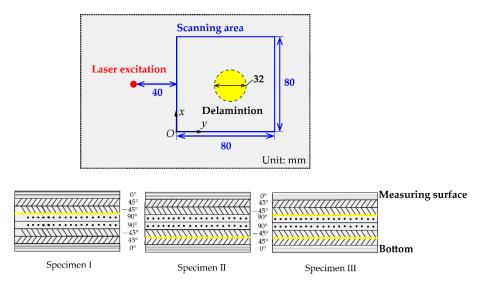
Figure 2. A schematic of the sensing layout and details of composite specimens containing the Teflon insert. There were three composite specimens with a stacking sequence of $[0/\pm 45/90]$ s. From the perspective of the through-thickness panel layup, a single Teflon insert was added to specimen I between the fifth and sixth layer, and to specimen II between the second and third layer; two Teflon inserts were added to specimen III, one between the second and third layer, the other between the fifth and sixth layer.

The specimens were the 1.5 mm crossply CFRP made of T300 prepreg materials with a stacking sequence of $[0/\pm45/90]$ s, as shown in Figure 2. Since the material properties of CFRP are not known in advance, two specimens with single delamination defect at different layer positions were made to study the wavenumber characteristics related to the e material properties. Additionally, its purpose was also to analyze the wavenumber characteristics in the composite specimen with multiple delamination defects. Specimen I and specimen II were the composite plates with a single defect, and specimen III was the composite plate with multiple defects. From the perspective of the through-thickness panel layup, a single Teflon insert was added to specimen I between the fifth and sixth layer, and to specimen II between the second and third layer; two Teflon inserts were added in specimen III, one between second and third layer, the other between the fifth and sixth. The diameter of all delamination defects was 32 mm, and the distance between two Teflon center in specimen III was 10 mm. The TWM laser interferometer scans an area of 80 mm \times 80 mm with a spatial resolution of 1 mm.

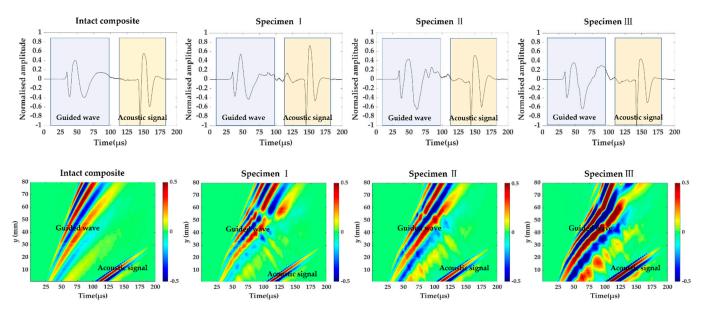
Figure 3 shows the signals measured at (40 mm, 55 mm) and time–space wavefield at x = 40 mm in the intact composite plate and three specimens. The total signal includes guided wave and acoustic signal. The acoustic wave here refers to the signal propagated through the air. The measurement time of the acoustic signal coincides with the time taken for the wave to travel a distance of a certain distance at a speed of 340 m/s in the air.

Figure 3. The signals measured at (40 mm, 55 mm) and time–space wavefield at x = 40 mm in the intact composite plate and three specimens.

In addition to the acoustical signal, the prominent component of guided wave is the A_0 mode because it is the main component of the out-of-plane displacement. The guided wave velocities in the intact composite plate are different from one in three damaged composite plates. Additionally, the velocity of the guided wave becomes slower for specimen I, II and III, because the slope of the line is smaller compared to one in the intact composite.

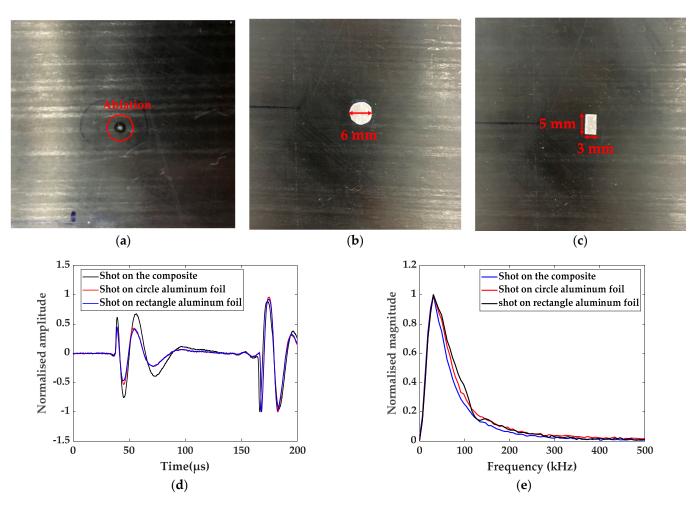
Figure 4. (a) Ablation caused by 20 consecutive laser radiation on the composite, (b) circular aluminum foil with 6 mm diameter, (c) rectangular aluminum foil with 3 mm length and 5 mm width, and (d) the signal of laser shot on composite, circular aluminum foil and rectangular aluminum foil, (e) corresponding signals in the frequency domain

The aluminum foil with thickness 0.1 mm was pasted onto the surface of the composite to obtain the wavefield. In order to eliminate the influence of aluminum foil size and shape on the wavefield, the circular aluminum foil with 6 mm diameter and the rectangular one with 3 mm length and 5 mm width were prepared in the experiment, as shown in Figure 4b,c. Figure 4d shows the signals of laser shot on the composite, circular and rectangular aluminum foil with the same power intensity and average times. The arrival time of the ultrasonic wave peak and valleys acquired by laser shot on aluminum foil is basically the same as one by laser shot on the composite. Figure 4e gives corresponding signals in the frequency domain. There is no difference in terms of the signals of laser shot on aluminum foil in the frequency domain. The frequency band of the signal obtained by laser shot on aluminum foil is wider, which may be related to the properties of the materials. For the three signals, the position of main frequency is the same. It can be concluded that the aluminum foil can be used for delamination detection and the size and shape of aluminum foil have no effect on the signal.

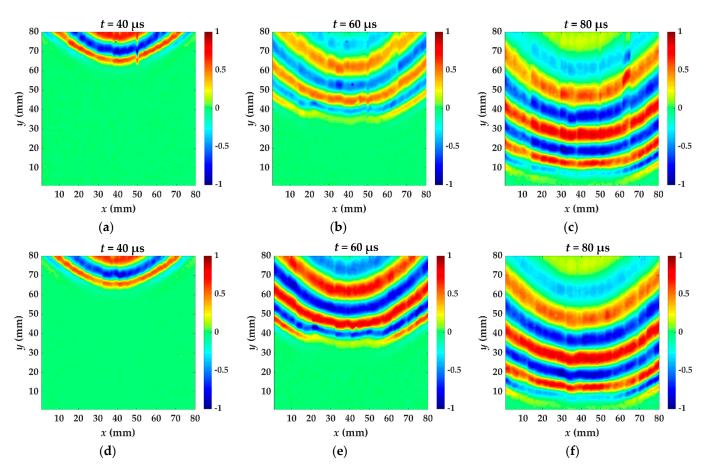
The aluminum foil was replaced every two lines of laser scanning and the acquired wavefield snapshots at 40, 60 and 80 μs by laser shot on two aluminum foils are shown in Figure 5. The wavefront shapes of two wavefields are almost the same. The wavefield at 60 μs and 80 μs acquired by the rectangle shape is smoother, because the replacement position has a small deviation from the preset. The rectangle with 3 mm length and 5 mm width is a better choice for obtaining the wavefield.

Figure 5. The wavefield snapshots (**a–c**) are at 40, 60 and 80 μs acquired by laser shot on circular aluminum foil. The wavefield snapshots (**d–f**) are at 40, 60 and 80 μs acquired by laser shot on rectangular aluminum foil.

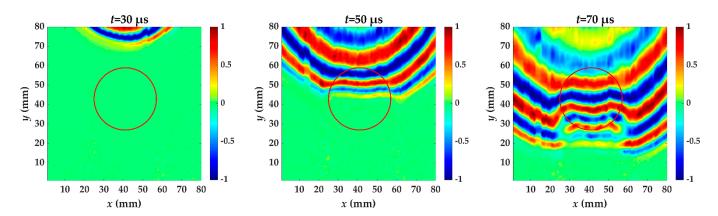
For specimen I, Teflon insert is between the fifth and sixth layer. Figure 6 shows the wavefield snapshots acquired from scanning area at different times. The red circle is the delamination made artificially in specimen I. In the out-of-plane displacement, the acquired wavefield shows a stronger A_0 mode. A_0 mode with higher amplitude has reached the delamination region at $t=50~\mu s$, and the wavelength is reduced. This is because the delamination causes the incident waves to split and propagate independently through the upper and lower laminates [8], and the thickness of the measured side changes. Therefore, the wave in the delamination region propagates at a velocity lower than that in the undamaged region. Each moment subsequently is accompanied by wave pattern anomalies and a reduced wavelength.

Figure 6. Snapshots of propagating guided wave in specimen I at different times. The red circle is the delamination made artificially in specimen I.

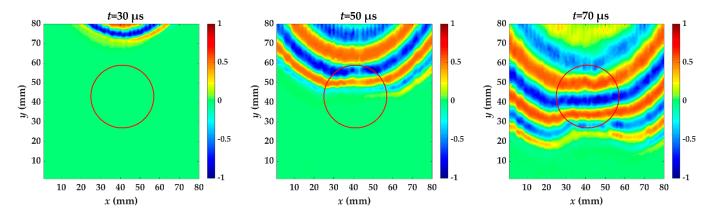
For specimen II, Teflon insert is between the second and third layer. Figure 7 shows snapshots of propagating guided wave at different times in specimen II. The red circle is the delamination made artificially in specimen II. The wave in the delamination region propagates at a velocity lower than that in the undamaged region. The degree of velocity slowdown in specimen II is weaker than in specimen I at $t=70~\mu s$.

Figure 7. Snapshots of propagating guided wave in specimen II at different times. The red circle is the delamination made artificially in specimen II.

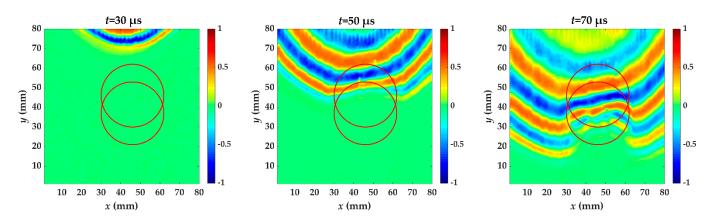
For specimen III, two Teflon inserts are added, one between the fifth and sixth layer, and the other second and third layer. Figure 8 shows wavefield snapshots of the propagating guided wave in specimen III at different times. The red circles are the delamination made artificially in specimen III. When the guided wave meets the delamination, a lower velocity and a reduced wavelength are also found. At $t=50~\mu s$, the guided wave mainly propagates in the composite with first delamination. The propagation distance for the second crest of the guided wave is farther than specimen I and it is almost the same as specimen II. The first Teflon insert is added between the second and third layer. At $t=70~\mu s$, the guided wave has passed through two delamination defects. Additionally, the wave pattern anomalies are similar to specimen I. The second Teflon insert is added between the second and third layer.

Figure 8. Snapshots of propagating guided wave in specimen III at different times. The red circle is the delamination made artificially in specimen III.

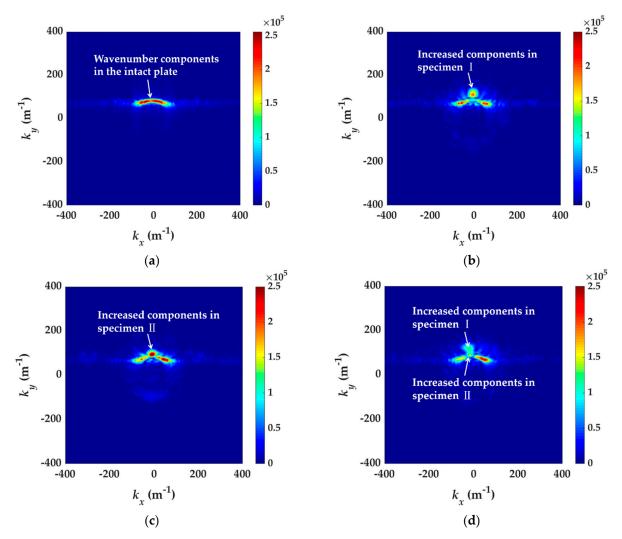
Frequency–wavenumber analysis methods can enable further analysis of wave modes and wavenumber distribution. By using the three-dimensional (3D) Fourier transform (FT), the acquired time–space wavefield is converted to a frequency–wavenumber field. The change in wavenumber can be extracted from the diagram of k_x and k_y at a specific frequency. Figure 9 shows the k_x - k_y spectrum at 98 kHz of the intact plate and three specimens. In the damaged plates, as shown in Figure 9b–d, some wavenumber components are obviously increased in addition to the original curve. The increased wavenumber component is related to delamination defects. The value of the increased wavenumber in specimen I is higher than that in specimen II. This can be explained by that the structural thickness above the delamination in specimen I is lower than that in specimen III. The increased wavenumber components appearing in specimens I and II are both found in specimen III.

Figure 9. The k_x - k_y spectrums at 98 kHz. (a) The intact plate, (b) specimen I, (c) specimen II and (d) specimen III.

The main wavenumber that exits in the intact plate, specimen I, II and III, is shown in Table 1, which is acquired from the k_x - k_y spectrums at 98 kHz. The wavenumber 85.94 m⁻¹ is in all four specimens. The wavenumber 93.75 m⁻¹ is in specimen II and III. The wavenumber 117.2 m⁻¹ is in specimen I and III. It has been known in advance that the delamination defect in specimen I is preset between the fifth and sixth layer and specimen II between the second and third. From the value of increased wavenumber 93.75 m⁻¹ and

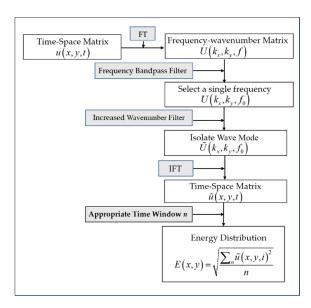
Taking the time window for standard ultrasonic testing as a reference, the algorithms of localized wave energy with appropriate time windows are present. The algorithm gathers wave energy anomalies caused by delamination defects at a certain frequency. Figure 10 shows the algorithms of localized wave energy with appropriate time windows.

Figure 10. Algorithm of localized wave energy with appropriate time windows for delamination detection.

First, experimental equipment is used to acquire the 3D measurement matrix. Then, the signal processing steps below are followed.

(1) The 3D full-wavefield matrix u(x, y, t) is transformed from the space–time domain to the frequency–wavenumber domain using the 3D Fourier transform and the mathematical formula is expressed as Equation (1). To obtain the wavenumber field information at frequency f_0 , a narrow frequency bandpass filter W_F is applied, shown as Equation (2).

(2) Wavenumber filter $W_{\mathbf{k}}(k_x,k_y,f_0)$ is applied in the wavenumber domain to extract the increased wavenumber, described as Equation (3). Additionally, the wavenumber filter $W_{\mathbf{k}}(k_x,k_y,f_0)$ is given in Equation (4). The *Threshold* is decided by the wavenumber of A_0 mode at frequency f_0 in the intact plate. The frequency f_0 used in this study is 98 kHz. Other frequencies can also be selected and the effect of the frequency on the quality of the results has not been studied.

(3) An inverse Fourier transform is then applied, so that the wavefield with increased wavenumber components can be obtained by Equation (5). By observing the energy diagrams at different times, the appropriate time windows n can be selected to highlight the energy anomalies and i represents the selected moment. The energy anomalies can be called localized wave energy. The energy anomalies distribution can be calculated by Equation (6), and delamination defects can be identified by localized wave energy.

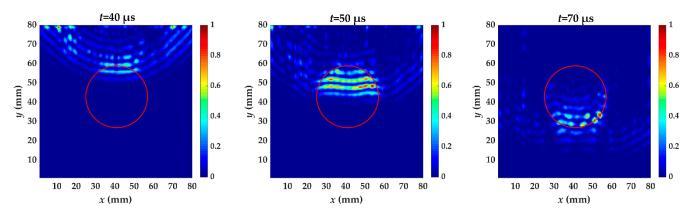
In specimen I, the energy caused by increased wavenumber component is becoming larger when passing through the delamination, as shown in Figure 11. This is because the thickness of guided wave penetration on the measured side is reduced. The delamination causes the whole specimen to be divided into two parts and the thickness of the two parts is reduced. What we are concerned about is the thickness change of the measured side. The guided wave excited by a laser is dispersive and the thickness affects the propagation at a certain frequency. When the guided wave has completely passed the delamination, there still exits trapping wave energy. The energy anomalies can be used for locating where delamination damage occurs. From $t = 40~\mu s$ to $t = 70~\mu s$, the phenomenon of energy anomalies is obvious, indicating that these are the appropriate time windows. The test result of specimen I using localized wave energy algorithm is shown in Figure 12. A clear profile of delamination defect can be obtained by this algorithm. The value of increased wavenumber (117.2 m $^{-1}$) indicates that the Teflon insert is between the fifth and sixth layer.

Figure 11. The energy distribution of specimen I caused by the increased wavenumber at t = 40, 50 and 70 μ s. The red circle is the delamination made artificially in specimen I.

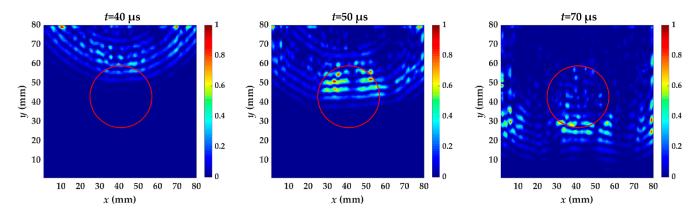
Similar to the phenomenon of specimen I, the energy caused by increased wavenumber component in specimen II is also becoming larger when passing through the delamination and it is less obvious, as shown in Figure 13. The time windows from $t=40~\mu s$ to $t=70~\mu s$ can also be used for specimen II. The test result of specimen II using the localized wave energy algorithm is shown in Figure 14. The delamination profile is visually close to the actual one. The value of increased wavenumber (93.75 m⁻¹) indicates that the Teflon insert is between the second and third layer. The result can show a successful identification of delamination location, size and depth.

Figure 13. The energy distribution of specimen II caused by the increased wavenumber at t = 40, 50 and 70 μ s. The red circle is the delamination made artificially in specimen II.

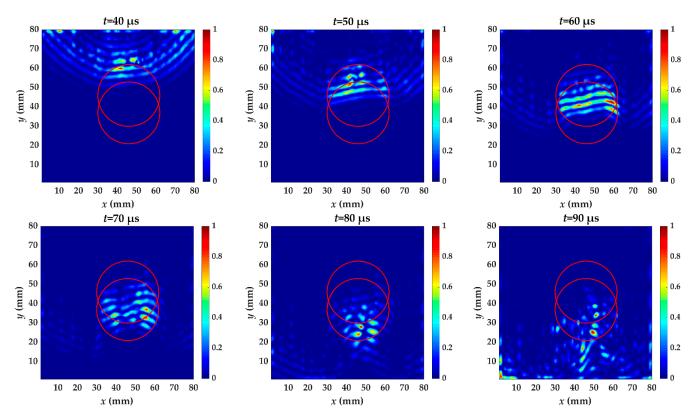
For specimen III, there are two artificial delamination defects, one located between the fifth and sixth layer, and the other between the second and third. The energy distribution caused by the increased wavenumber at $t=40{\sim}90~\mu s$ with $10~\mu s$ intervals is shown in Figure 15. When the guided waves pass through the first delamination, the energy caused by the increased wavenumber component is becomes large in the first delamination region from $t=40~\mu s$ to $t=60~\mu s$. The energy discontinuity of the defect area at 70 μs is obviously different from previous time and the contour of the energy accumulation has changed,

indicating that the guided wave has spread to the second defect. When the wavefield caused by the increased wavenumber has passed through the second defect, shown at 90 μ s, some energy still remains inside the delamination. The second time windows are from $t=60~\mu$ s to $t=90~\mu$ s. Figure 15 shows the localized wave energy distribution when the time windows are from $t=40~\mu$ s to 90 μ s, and the result is not affected by the choice of time windows. The defect overlap region shows high energy anomalies. The imaging results of two defects are shown in Figure 16a, b, respectively. The appropriate time window is meaningful for identifying each delamination defect.

Figure 15. The energy distribution of specimen III caused by the increased wavenumber at $t = 40 \sim 90 \,\mu s$ with 10 μs intervals. The red circles are the delamination made artificially in specimen III.

Combined with the wavefield characteristics in Section 3 and the value of the increased wavenumber components (93.75 and 117.2 m⁻¹ at Table 1), the first delamination is between the second and third layer, and the second is between the fifth and sixth. Different from the methods in the previous studies, two delamination profiles can be obtained, respectively, by the algorithm. If the upper (laser measurement side) delamination fully covers the lower one, the localized wave energy of the overlapping area is high. The region of high localized wave energy is the lower delamination defect. If the boundaries of the delamination defects coincide, the number of delamination defects and coincidence degree should be determined by increased wavenumber value and the localized wave energy.

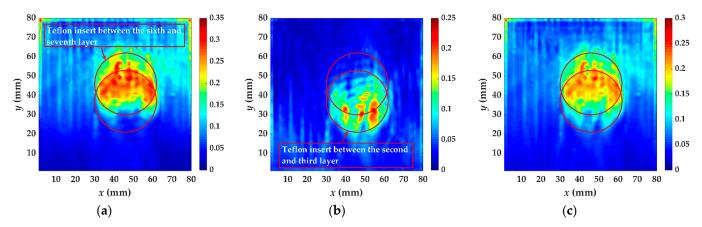
Figure 16. The test result of specimen III using localized wave energy algorithm: (**a**) the time windows are from t = 40 μs to t = 60 μs, (**c**) the time windows are from t = 40 μs to t = 90 μs. The red circles are the delamination made artificially in specimen III.
