# An Early Periprosthetic Fracture of a Cementless Oxford Unicompartmental Knee Arthroplasty: Risk Factors and Mitigation Strategies

**Case Report:** This case report describes an early post-operative tibial periprosthetic fracture through the keel slot, which we believe may be contributed by the deep implant keel design and the presence of a narrow metaphysis in the Asian knee. The patient subsequently underwent a revision total knee replacement and fixation of the periprosthetic fracture.

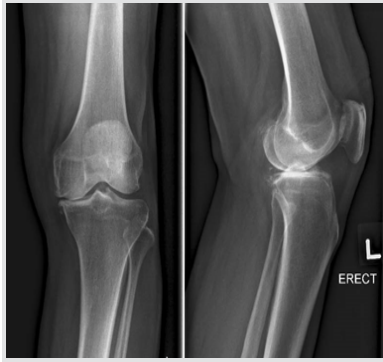
**Figure 1:** Anteroposterior and lateral radiographs of the pre-operative knee.

An 80-year-old Chinese lady with symptomatic left medial knee osteoarthritis confirmed on weight-bearing knee radiographs (Fig. 1) presented to our outpatient clinic.

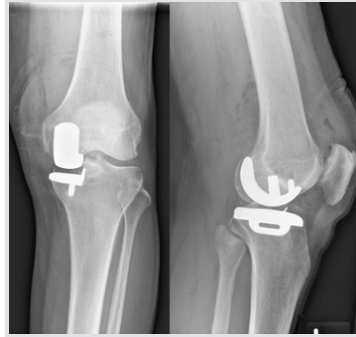
**Figure 2:** Anteroposterior and lateral radiographs of the post-operative knee after Oxford unicompartmental knee arthroplasty.

Having failed a period of conservative treatment, she subsequently underwent a left medial OUKA successfully. A cementless size XS femoral implant and a cementless size AA tibial implant with a 5 mm mobile bearing insert were used. Post-operative recovery was uneventful, and radiographs done showed satisfactory prosthesis positioning with no evidence of periprosthetic fractures (Fig. 2). The patient managed to ambulate well on the 1st post-operative day and was transferred to a step-down facility for further rehabilitation.

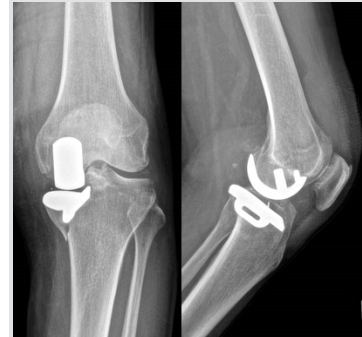
**Figure 3:** Anteroposterior and lateral radiographs of the periprosthetic fracture following after the onset of worsening ambulatory pain.

The patient underwent further therapy in the step-down facility and showed good progress and recovery with tolerable levels of knee discomfort. However, 2 weeks on, she started complaining of worsening knee pain with decreased ambulatory distances while still being able to weight bear and ambulate. There were no preceding instances of trauma or injury. A repeat plain radiograph showed a displaced proximal tibial periprosthetic fracture (Fig. 3). She was immediately placed on a non-weight-bearing status and transferred back to our hospital for further management. A pre-operative computed tomography (CT) scan was deemed unnecessary as the periprosthetic fracture was

In this case report, the periprosthetic medial tibial fracture has rendered the implant unstable as seen by the loosening and migration on the post-fracture radiograph. An option for internal fixation with restoration of the implant positioning can be considered. However, a period of non-weight-bearing is required for fracture healing and may negatively affect the arthroplasty outcomes. Furthermore, with the pre-existing anatomical issue of the narrow bone bridge and decreased volume of supporting bone beneath the tibial implant, the risk of recurrence and refracture will be significant. Therefore, we opted to revise this UKA into a TKR with fixation of the medial tibial fracture fragment. A stemmed tibial implant was used as well to offload the fractured medial tibial metaphysis onto the diaphyseal cortex instead. This will aid in fracture healing as well

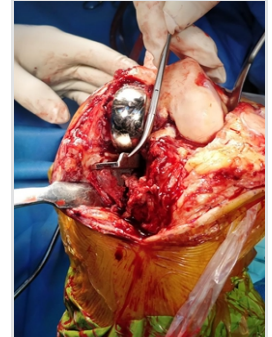
**Figure 4:** Intraoperative images of the tibial periprosthetic fracture through the keel slot.

She was counseled and underwent left revision TKA with fixation of the tibial plateau fracture. Intraoperative findings include a medial tibial periprosthetic fracture with the fracture originating from the keel slot of the cementless tibia implant (Fig. 4). The implants were revised to a cemented size 2.5 Depuy Synthes Press Fit Condylar femur and size 2 Mobile Bearing Tibia tray and 29 mm femur sleeve (Fig. 5). Post-operative full weight-bearing ambulatory physiotherapy was permitted and tolerated well. A dual-energy X-ray absorptiometry bone mineral densitometry, performed to assess the density of the bone architecture as a risk factor for the periprosthetic fractures, showed osteopenia.

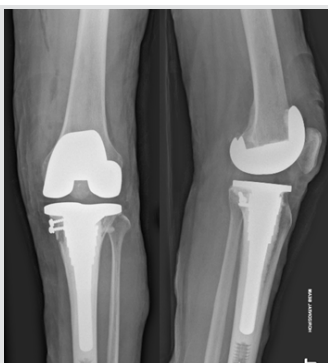
**Figure 5:** Anteroposterior and lateral radiographs of the revision total knee arthroplasty.

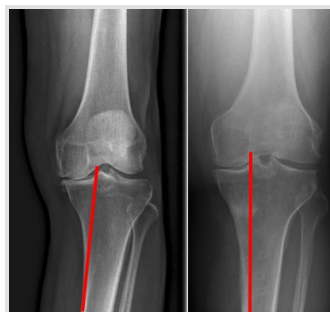
**Figure 6:** Left: Intersection of medial eminence line along tibial long axis just medial to the medial tibial eminence with the medial diaphyseal cortex indicates that cemented tibial tray should be considered.

The medial eminence line (MEL), a vertical line parallel to the tibial axis drawn through the medial intercondylar eminence, has been described. If this line intersects with the medial diaphyseal cortex, the risk of post-operative stress fractures will be increased [16, 17]. In such cases, a cemented tibial component should be considered to increase the loading capacity and dissipate the stresses around the cement mantle [9] (Fig. 6).

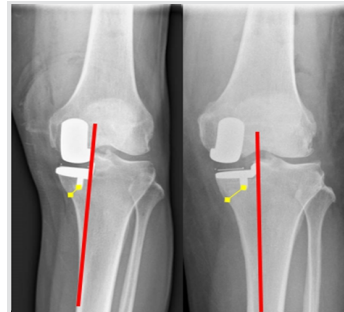
**Figure 7:** Left: The medial eminence line extrapolated from the vertical tibial cut intersecting the medial diaphyseal cortex, demonstrating a small bone bridge. Right: A non-intersecting line showing a larger bone bridge.

This concept can be further extrapolated to the evaluation of the post-operative radiograph, where the MEL coincides with the lateral most border of the tibial implant (Fig. 7). If this line intersects with the medial diaphyseal cortex inferiorly, it usually means that the distance between the tip of the keel and medial tibial metaphyseal cortex is decreased, with a higher risk of fracture propagation. In such patients, a high index of suspicion for periprosthetic fracture should be had when they present with post-operative ambulatory pain, and a more cautious weight-bearing regime should be adopted.

It is also recommended that a more lateralized tibial tray position should be aimed for in the medial OUKA to achieve a larger tibial bone bridge between the keel and the metaphyseal cortex. Often, the vertical tibial bone cut may be erroneously positioned at the base of the medial tibial eminence when it should be positioned instead further lateral just medial to the footprint of the ACL fibers at the apex of the medial tibial eminence. This may result in an overly medialized tibial tray and excessively narrow bone bridge beneath it, greatly increasing the risk of perioperative fracture.

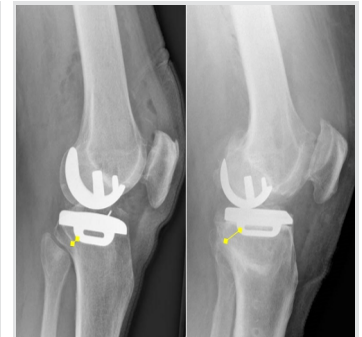
**Figure 8:** Differing posterior metaphyseal cortex morphology, demonstrating a much narrower posterior bone bridge in our patient's Oxford unicompartmental knee arthroplasty on the left.

It is also noted that the anteroposterior diameter of the proximal tibial metaphysis in our Asian knees tends to be narrower and has a more conical morphology. This can often lead to an exceptionally small posterior tibial bone bridge between the posterior-most portion of the keel and the posterior tibial metaphyseal cortex (Fig. 8). This can potentially result in a stress riser due to the narrower bone bridge, leading to a fracture line propagating into the posterior cortex. Similarly, during the preparation of the keel slot or insertion of the tibial implant, the narrow bridge may also lead to an inadvertent breach of or stress to the posterior metaphyseal cortex.

During insertion of the cementless tibial component, the keel slot is often prepared smaller than the actual implant keel to allow for press fit insertion and greater pull-out strength. The impaction forces required to mallet the implant flush with the bone can be as high as 1400 N, which can stress the bone and even result in fractures [19, 20, 21]. To prevent this, we propose placing the tibial implant directly over the tibial slot and using a light mallet to hit gently inferiorly, as opposed to hitting the implant posteroinferiorly to seat it in the slot, which may stress the posterior tibial bone bridge.
