Case report

Breakage of sliding hip screw after fixation of pertrochanteric hip fracture: A rare complication

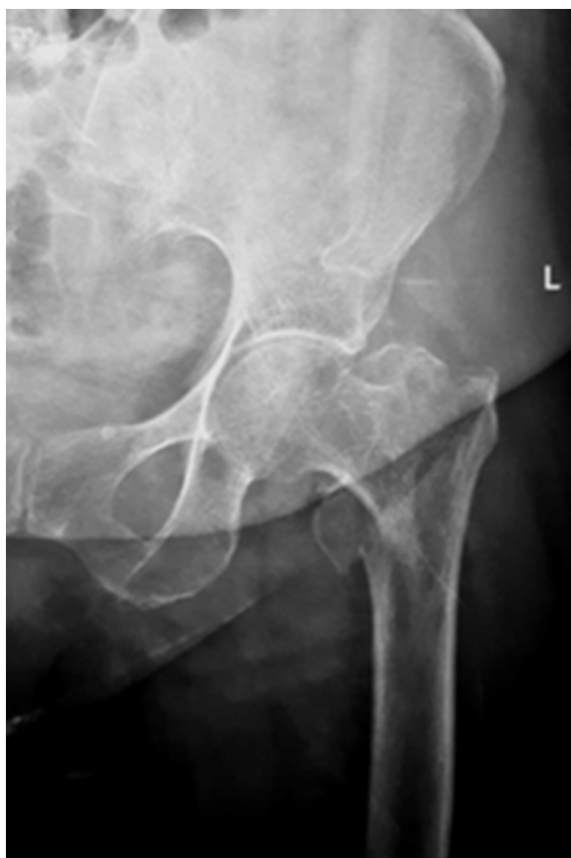
Fig. 1. Antero-posterior radiograph of the left hip showing pertrochanteric fracture with thin lateral wall, AO type A2.

A 67 year-old female was admitted for pain and inability to bear weight on her left hip after falling at home. Radiographic assessment showed pertrochanteric left hip fracture with incompetent lateral wall (Fig. 1), type A2 according to recent modification of AO Classification [8]. Patient was operated 24 h after admission. Under spinal anesthesia with the use of orthopedic table, the procedure consisted on manipulative closed reduction followed by open internal fixation. A sliding lag screw of 95 mm length was first inserted in line with the central axis of

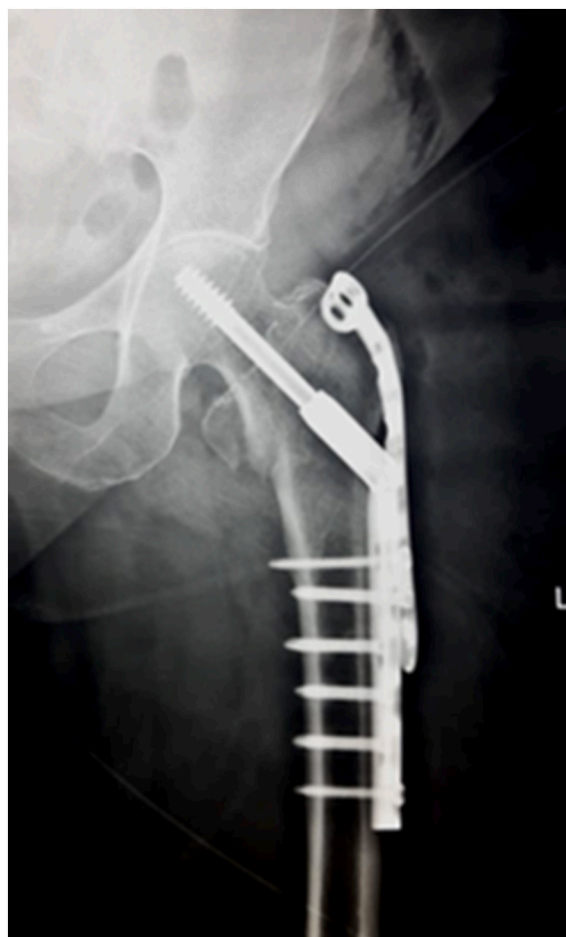
Fig. 2. Post-operative antero-posterior radiograph with satisfactory reduction and good position of the internal fixation hardware. Note the situation of the medial edge of the barrel at the level of the fracture site, the obliteration of the lateral orifice of the barrel by the TSP, and the well molding of the proximal part of the TSP to the lateral aspect of the greater trochanter.

the two plates with the lateral part of the broken lag screw was uneventful. Intra-operative findings confirmed the presence of nonunion. The TSP was obliterating the lateral orifice of the barrel preventing any possible back sliding of the lag screw; in addition its proximal part was perfectly contoured and firmly applied to the lateral aspect of the greater trochanter. The fixation-purchase of the threaded medial part of the broken lag screw into the femoral head was very solid; it was extracted as one unit with the femoral head.

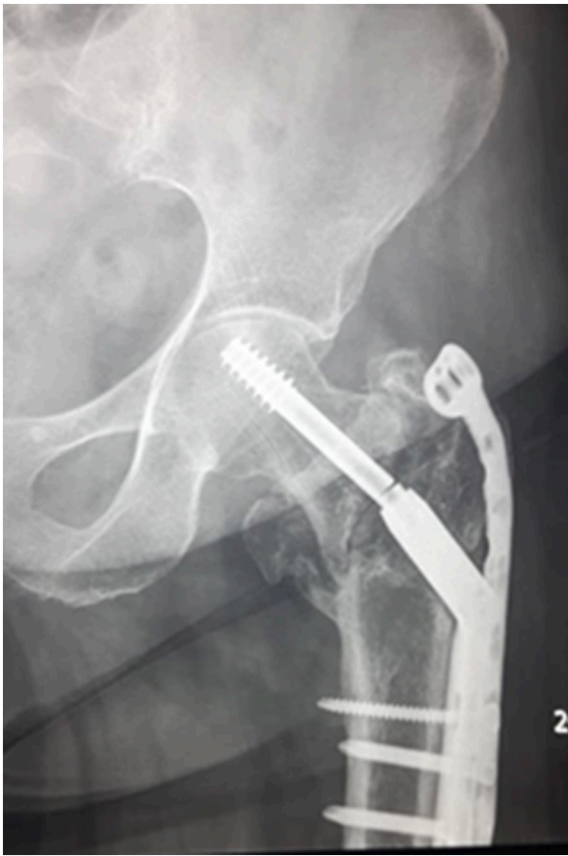
Fig. 3. Antero-posterior hip radiograph at 7 month follow-up demonstrating the nonunion of the fracture with breakage of the lag screw at the junction with the barrel.

We believe this complex mechanical situation has resulted in fracture nonunion in addition to multiple-cycle, low-stress concentration at the junction screw-barrel that finally induced fatigue failure of the lag screw itself.
