# Bent or broken: analysis of set screw fracture in the TFNa implant

**Objectives:** To evaluate set screw fracture in the Trochanteric Femoral Nail Advanced implant (TFNa, Synthes, West Chester, PA) and to identify additional mechanisms of set screw failure in the TFNa.

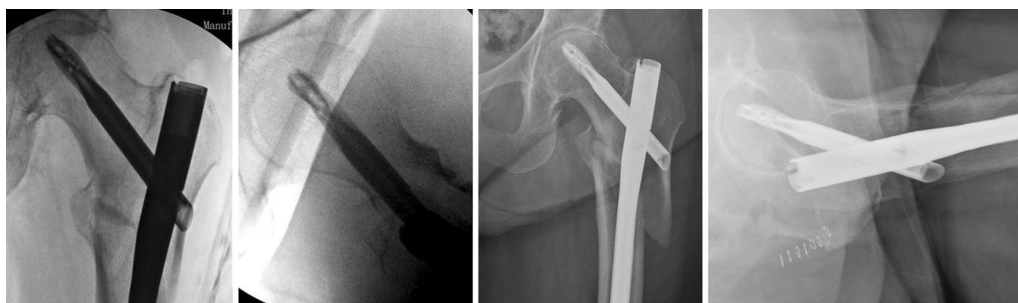
**Fig. 1** Pictured left are the AP and lateral views of the hip obtained following the index procedure. Pictured right are the repeat radiographs taken 2 weeks postoperatively that show interval displacement of the fracture, loss of reduction, and shortening of the proximal femur

postoperative day 12. The repeat radiographs revealed interval displacement of the fracture with loss of reduction and are included as part of Fig. 1. Due to loss of reduction and progressive functional decline, the operating surgeon consulted the local orthopedic trauma service. Upon examination, the patient had severe pain with internal and external rotation of the hip and inability to perform a straight leg raise. Interval X-rays were obtained showing proximal femoral shortening of 1.2 cm as measured by Serrano (Fig. 2) [20].

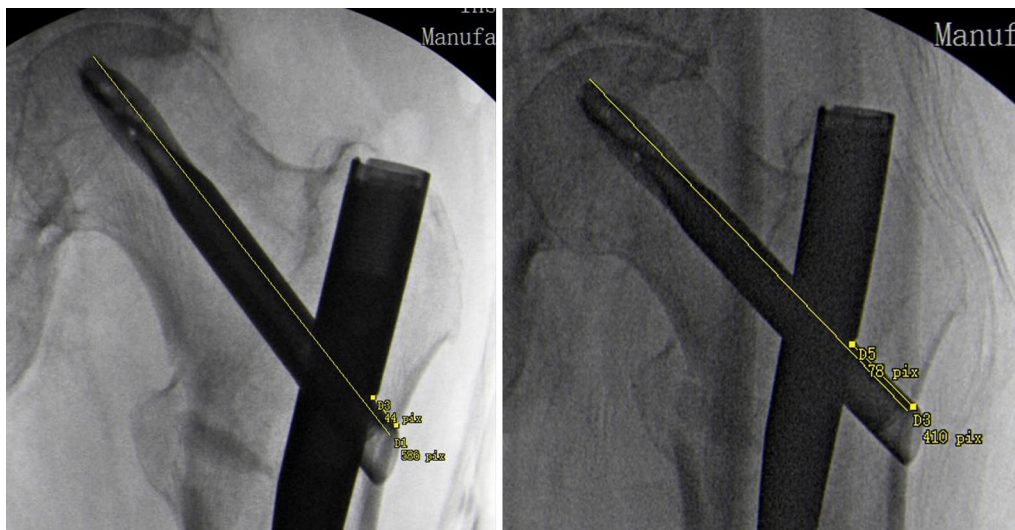
**Fig. 2** Depicted is the technique for measuring proximal femoral shortening as described by Serrano et al. The measurements taken from the drawn lines are compared with the length of the helical blade. The proximal femur has shortened 1.2 cm from the images obtained during the initial procedure (left) to images obtained 12 days later (right)

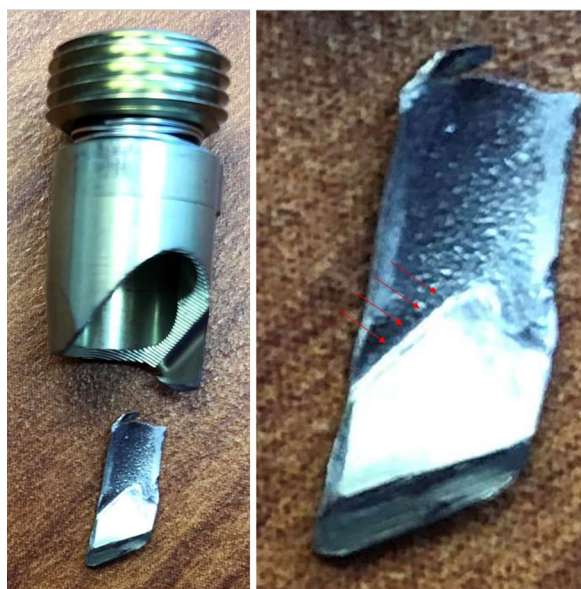
**Fig. 3** A fractured set screw for the TFNa was discovered after removal and disassembly of the implant. Arrows point to engaging defect of the long prong with corresponding lesions on the helical blade consistent with fracture of the prong by the edge of the blade

Urgent revision surgery was performed the following day. The implant was revised to a rotationally stable construct with dual integrated screws, Intertan (Smith and Nephew, Memphis, TN). The failed TFNa implant was fully disassembled and inspected on the back table. The set screw/proximal locking prong was found to be broken at its base (Fig. 3). Following explant of the failed hardware, anatomical reduction of the fracture was achieved with a Verbrugge clamp and cable fixation. Total operative time was 1 h 56 min with 200 cc blood loss.

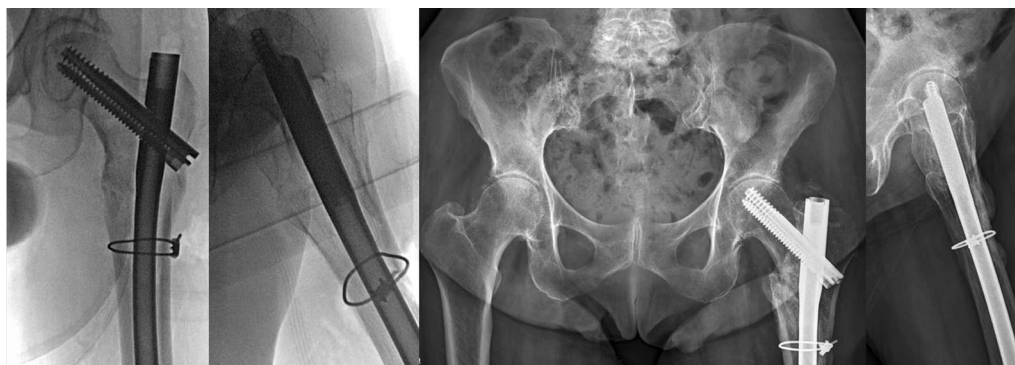
**Fig. 4** (Left) Anteroposterior (AP) and lateral view of the left hip obtained at the time of revision surgery showing restoration of proximal femoral length and neck shaft angle. (Right) AP pelvis and lateral hip X-ray obtained 6 months postoperatively showing full union of the fracture with no interval shortening

After the revision procedure, the patient immediately noted significant pain level improvement from 8–9 to 2–3. Ambulatory distance increased to 50 ft in the early postoperative period, and the patient returned to rehabilitation on postoperative day 3. Continued improvements in functional status were noted as the patient was able to ambulate independently over 150 ft with a walker upon discharge from rehabilitation. The patient eventually returned to baseline functional status with no complaints of hip pain. The X-rays obtained at 6 months after the revision procedure show full union, maintenance of reduction, and no appreciable proximal femoral shortening (Fig. 4).

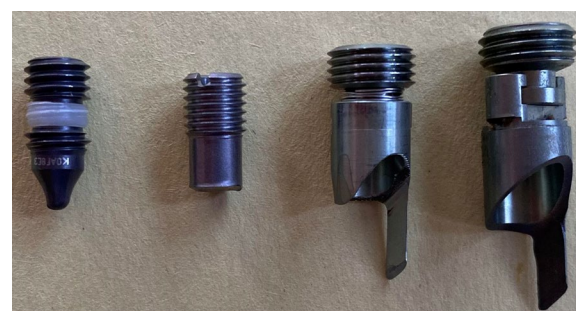
**Fig. 5** Pictured from left to right are the set screws for the Gamma 3, Intertan, TFNa, and TFN cephalomedullary nails. The set screws for the TFNa and TFN are unique as they have two separate pieces. The components are divided into the upper portion, or lock drive, and the lower portion, or lock prong. The lock prong in the TFNa appears smaller and thinner in size than its predecessor, the TFN. A spring has also been added in the TFNa

Although some set screw failures/fractures can be attributed to user technique during insertion, design differences in the set screw themselves may also contribute to additional sources of failure (Fig. 5). Key differences in the newer design include the smaller size of the set screw components in the TFNa compared with the first-generation TFN, and the addition of a coupling spring. During deployment, the lock drive is engaged by a screwdriver and begins to rotate within the threads of the proximal implant while advancing the lower lock prong. While the lock drive is intended to rotate to function correctly, the lock prong is not, and any rotational forces that are translated to the lock

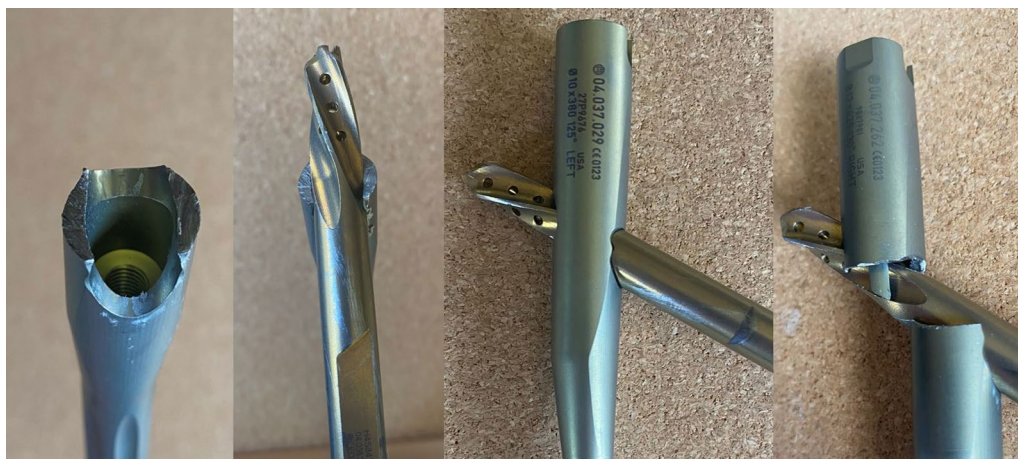
**Fig. 6** Pictured from left to right: (1) Looking down at the lateral aspect of the lower half of a sectioned TFNa implant thru the proximal screw aperture. (2) The diameter of this sectioned proximal screw aperture is completely filled with insertion of the helical blade. (3) When the set screw is prematurely deployed, it acts as a mechanical block to the advancing helical blade. The blade is unable to advance any further than pictured without fracture of the locking prong. (4) Sectioned TFNa implant that has been displaced to show the direct contact of the helical blade against the locking prong when it has been deployed prior to blade/screw insertion

The locking mechanism for the TFNa is composed of two major components coupled by a spring, an upper portion or “lock drive” and a lower portion or “lock prong.” Per the manufacturer, the reported fractures

occur when the lock prong is advanced into the proximal screw aperture prior to blade/screw insertion (Fig. 6). Either the blade/screw or the stepped reamer can strike the lock prong as they pass through the proximal aperture, resulting in prong fracture at its base. This occurs when the wrong screwdriver is mistakenly used to attach the aiming arm to the implant, thereby advancing the lock prong into the bore of the proximal screw aperture. By design, the screw driver to advance to set screw can still pass through the various pieces of the aiming arm assembly and engage the locking mechanism. Additionally, breakage of the lock prong can occur during implant extraction when the lock prong has not been fully retracted prior to blade/lag screw removal. Under these circumstances, breakage of the lock prong would not be associated with an adverse event unless the broken piece escaped the surgical field and remained in the patient as a retained foreign body (Fig. 7). To prevent locking mechanism fractures when using the TFNa implant, we recommend the surgeon inspect the proximal screw aperture after attachment of the proximal aiming arm prior to insertion of the implant to ensure the locking prong has not been deployed.

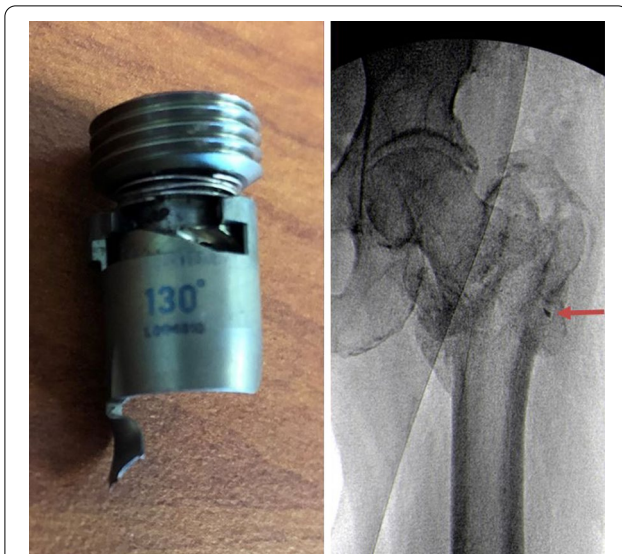
**Fig. 7** Visualized on the left is the characteristic deformity and fracture of the TFNa set screw that occurs if the lock prong is damaged during implant extraction. Failure to fully elevate the set screw prior to helical blade removal will cause the lock prong to deform and fracture more distally toward its tip. The fractured lock prong in this case remained within the patient as a retained foreign body visible on X-ray marked by the arrow in the image to the right

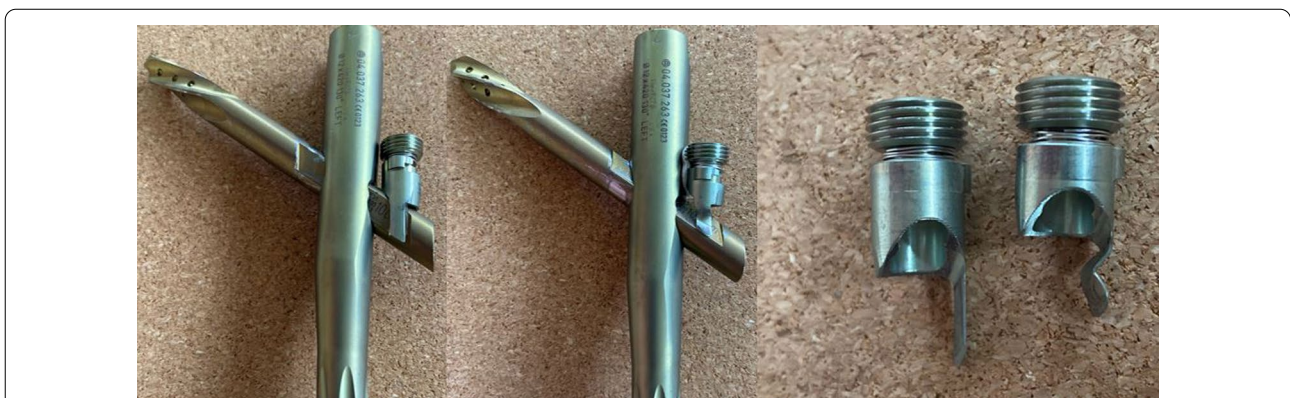
**Fig. 8** Far left, the helical blade has been inserted correctly so that the orientation of the recess on the side of the helical blade docks with the locking prong correctly and allows the set screw to be seated fully. Pictured middle, with an under-inserted helical blade, this recess is no longer aligned with the trajectory of the set screw. In this scenario, the set screw will advance until the lock prong contacts the superior aspect of the blade/screw resulting in deformation. Pictured right, a comparison of an intact locking prong and a deformed locking prong

In addition to implant breakage, the locking prong can also bend or deform if it is advanced against a helical blade/lag screw that is not fully seated into position. The aiming arm of the TFNa is designed so that, when the blade is fully seated, the recess on the lateral side of the blade/screw will be oriented to allow passage of the advancing lock prong (Fig. 8). If the operating surgeon attempted to insert a helical blade that was too long and stopped short of being fully inserted, the recess on the helical blade would not be oriented correctly to allow for passage of the locking prong into position. In this scenario, the tip of the locking prong would engage the blade/screw along its superior aspect, and deform even when inserted with a torque limiting screw driver. A deformed locking prong would compromise rotational control of the helical blade/lag screw and the ability to resist shortening. Backing off the set screw in these circumstances, which is recommended by the manufacturer to allow for blade/screw sliding, would then result in a completely unlocked proximal construct with lack of rotational control.
